Harness Structural test Report - EN

Inspection certificate number: **PH_396.2023**

Name: **STAY UP PRO MODEL 3.0**
 Type: **ABS**
 Size: **One size**
 Serial number: **K10 009**
 Impact pad type: ⁽¹⁾ **Koroyd**
 Clip-in weight [kg]: **100**

Summary of Structural test

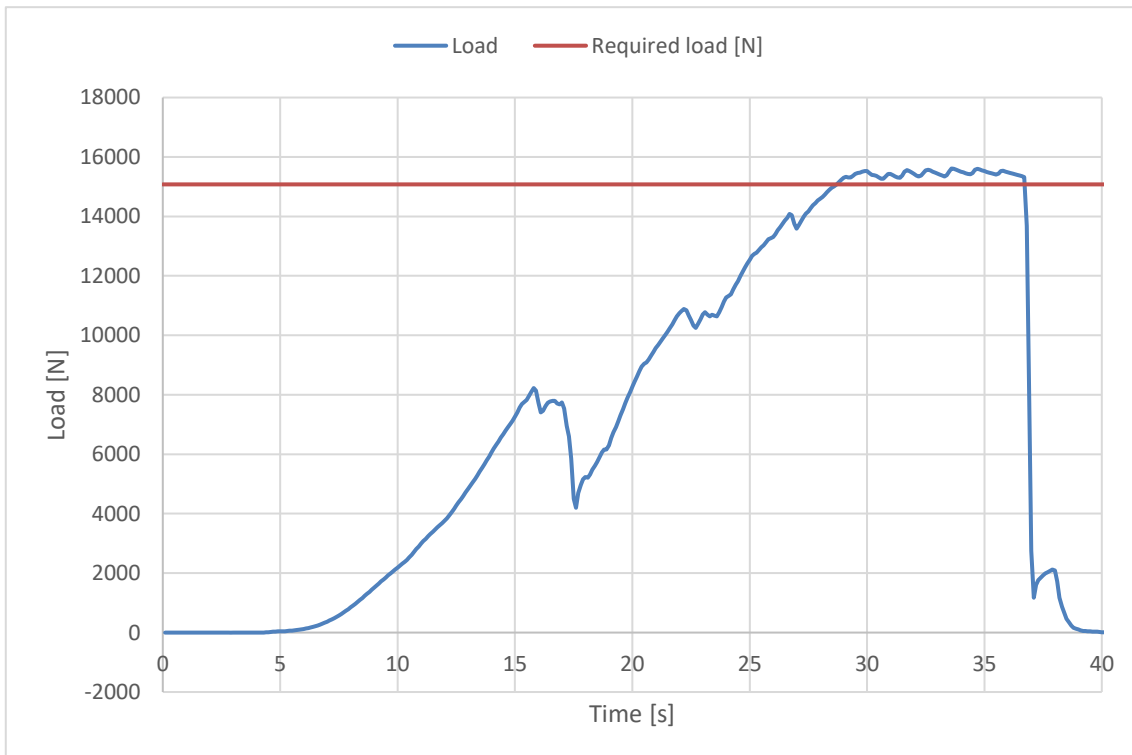
Test ID 03

Standard **EN 1651**
 Reference in standard **5.5.1.1b**
 Test setup **Positive symmetric load**
 Attachment points **Both main riser attachment (3,4)**
 Anchor points **Dummy (B1, B2)**

Required load [g] **15**
 Required load [N] **15000**
 Minimum test duration [s] **5**

Test duration [s] **8**
 Any signs of structural failure **No**
 Slippery test OK **Yes**
 Test results **POSITIVE**

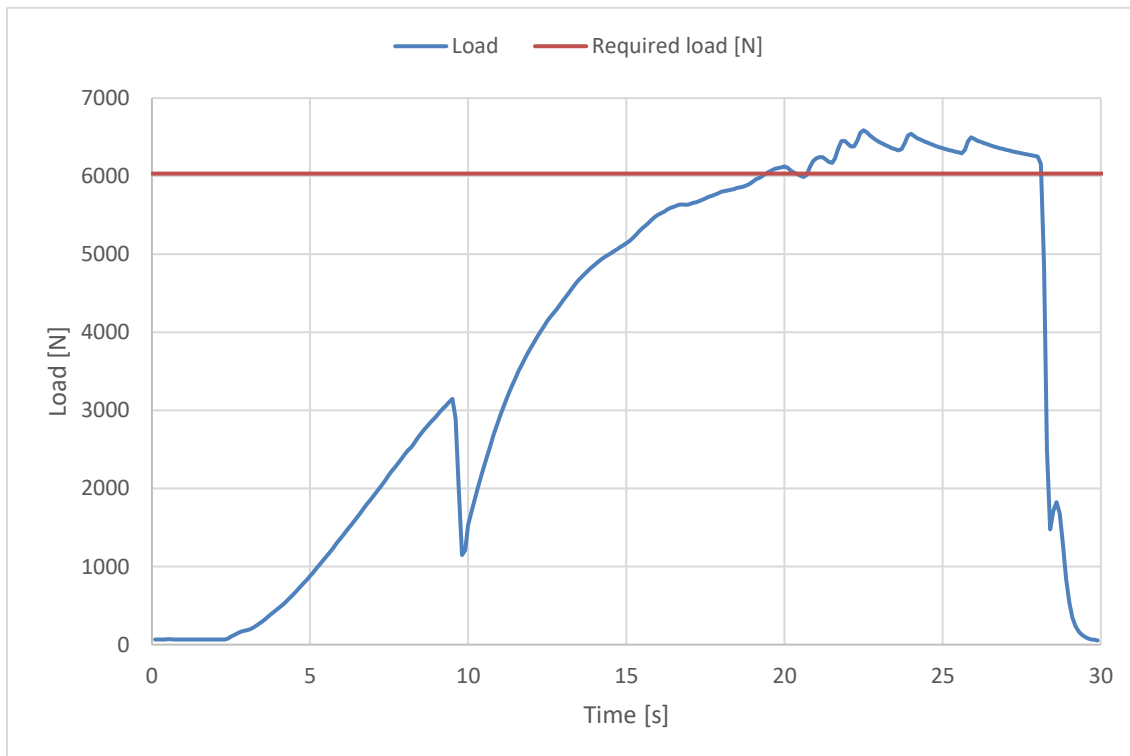
Test ID 05

Standard	EN 1651
Reference in standard	5.5.1.2
Test setup	Positive asymmetric load
Attachment points	One riser attachment (3 or 4)
Anchor points	Dummy (C)
Required load [g]	6
Required load [N]	6000
Minimum test duration [s]	5
Result	
Test duration [s]	7.4
Any signs of structural failure	No
Test results	POSITIVE

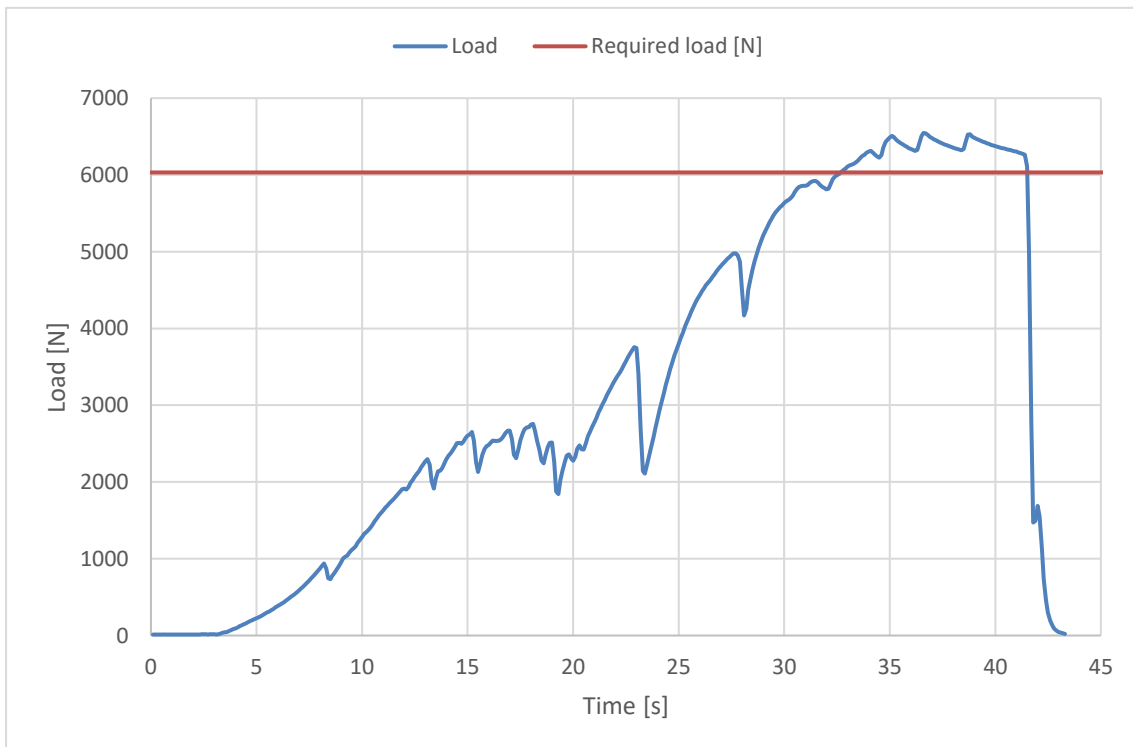
Test ID 06

Standard	EN 1651
Reference in standard	5.5.1.6
Test setup	Negative symmetric load
Attachment points	Both main riser attachment (3,4)
Anchor points	Dummy (A)
Required load [g]	6
Required load [N]	6000
Minimum test duration [s]	5
Result	
Test duration [s]	8.9
Any signs of structural failure	No
Test results	POSITIVE

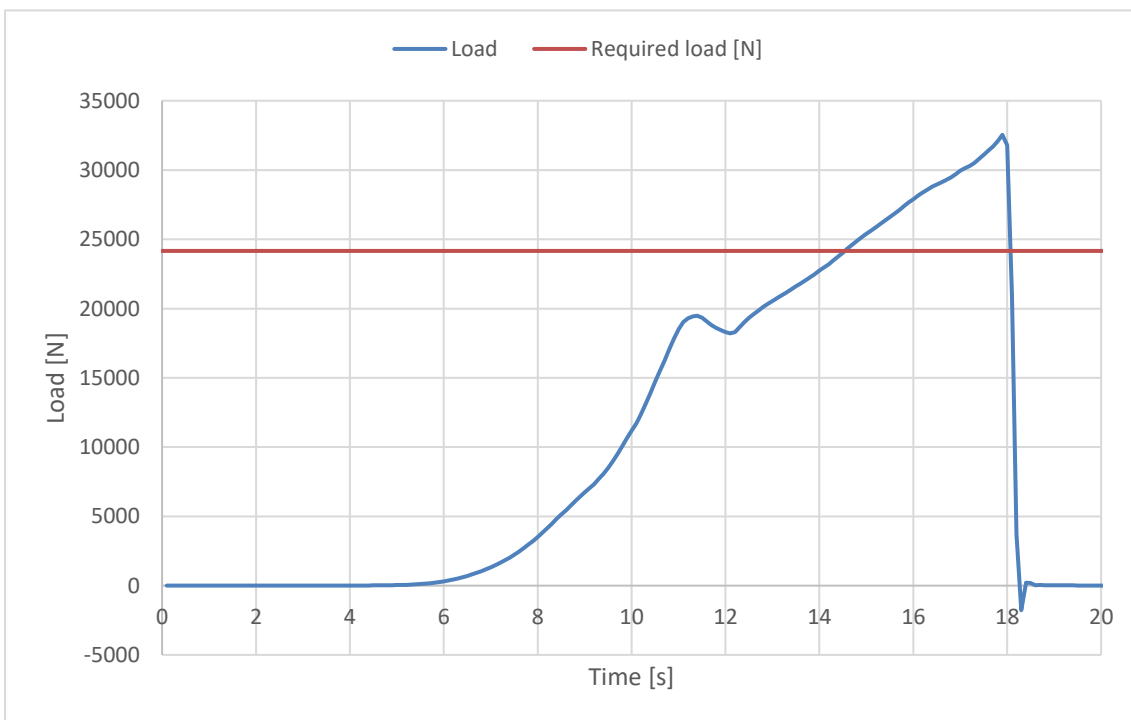
Test ID 11

Standard	EN 1651
Reference in standard	5.5.1.8
Test setup	Connecting element for rescue
Attachment points	End point (emergency parachute)
Anchor points	Both attachment to harness
Required load [g]	n/a
Required load [N]	24000
Minimum test duration [s]	0.3
Type of connecting element	a) two single elements
Result	
Test duration [s]	3.5
Any signs of structural failure	No
Test results	POSITIVE

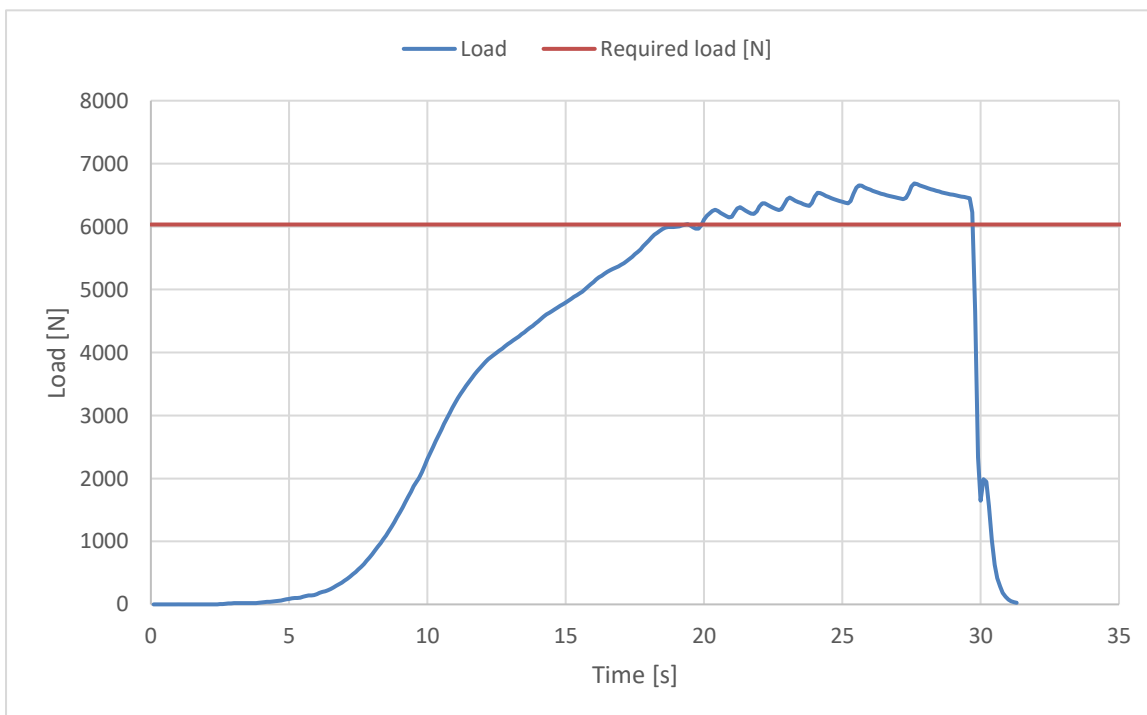
Test ID 12

Standard	EN 1651
Reference in standard	5.5.1.7
Test setup	Upright (landing) position load
Attachment points	Both main riser attachment (3, 4)
Anchor points	Both legstrap of harness (no dummy)
Required load [g]	6
Required load [N]	6000
Minimum test duration [s]	5
Harness type	type b
Result	
Test duration [s]	9.8
Any signs of structural failure	No
Slippery test OK	Yes
Test results	POSITIVE

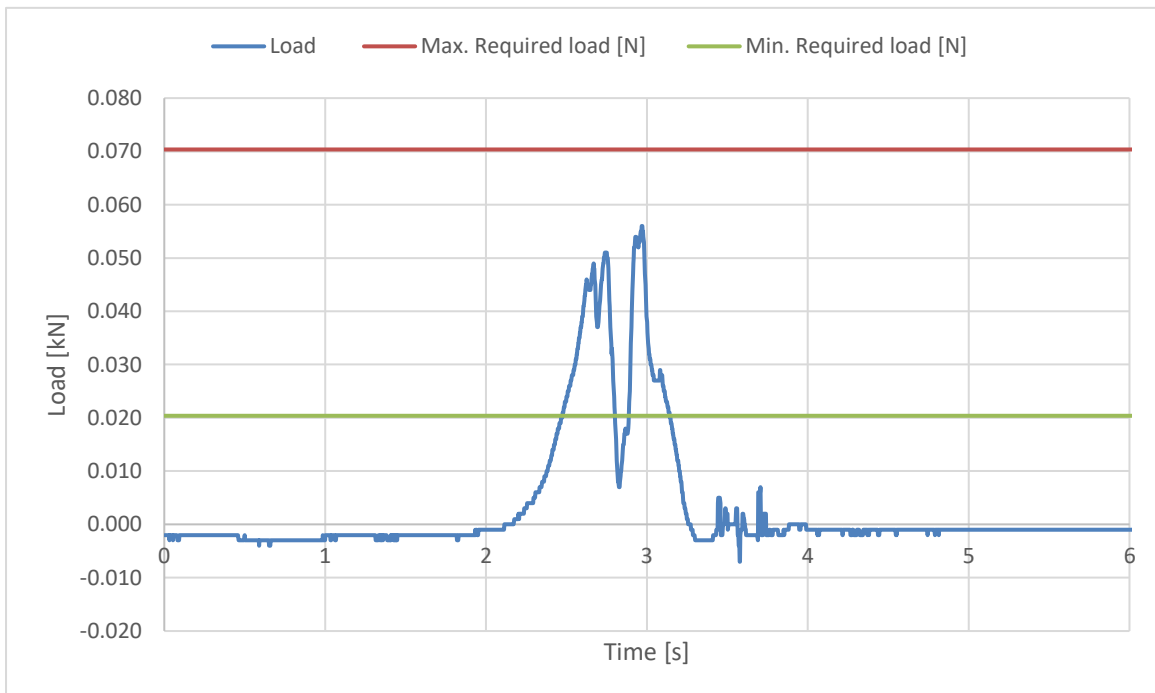
Test ID RRDT

Standard	EN 1651
Reference in standard	5.5.1.11
Test setup	Default flying position
Attachment points	Sensor connect to handle, and pull in opening direction
	The test is to simulate the load required to open the emergency parachute(1st action).
Min. Required load [N]	20
Max. Required load [N]	70
Result	
Load for first action [N]	56.37
Test results	POSITIVE

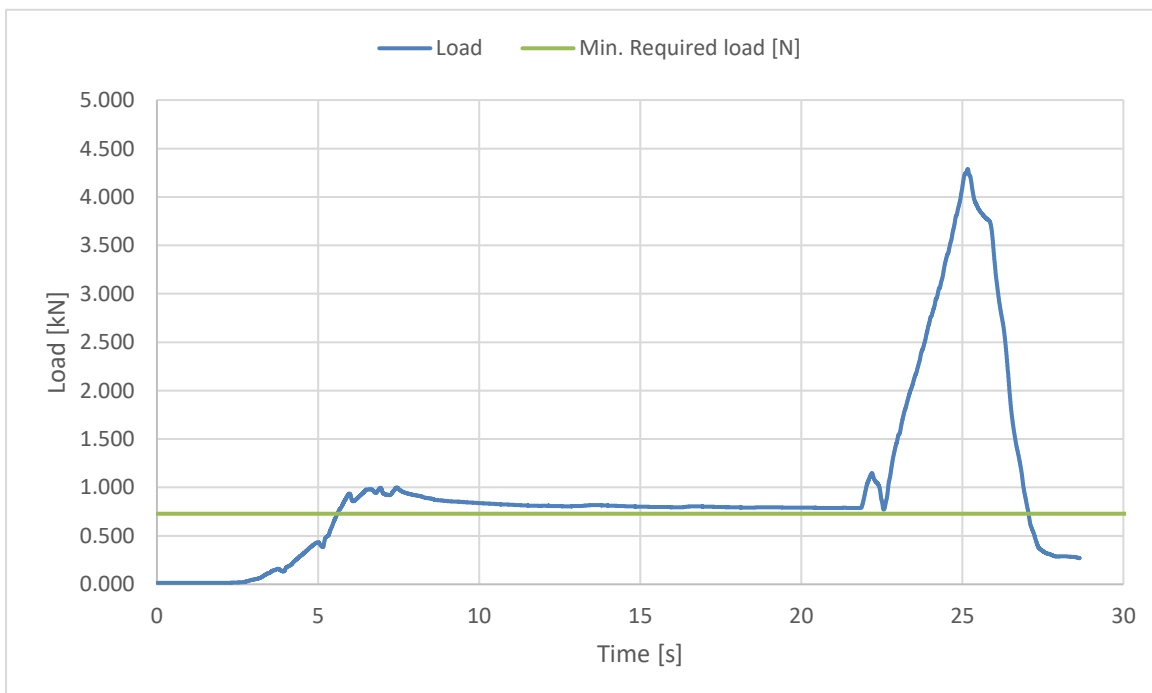
Test ID RRST

Standard	EN 12491
Reference in standard	5.3.2
Test setup	Two end points of handle
Attachment points	Sensor connect to end of handle, pull on the other side
	The handle must support min 700 N for 10 s, after measure breaking strength
Min. Required load [N]	700
Minimum test duration [s]	10
Result	
Test duration [s]:	21.4
Breaking strength [N]	4259.52
Test results	POSITIVE
