Harness Structural test Report - LTF

Inspection certificate number: **PH_306.2020**

Name: **Solos Lite**
 Type: **ABS**
 Size: **M**
 Serial number: **002**
 Impact pad type: ⁽¹⁾ **Inflatable**
 Clip-in weight [kg]: **120**

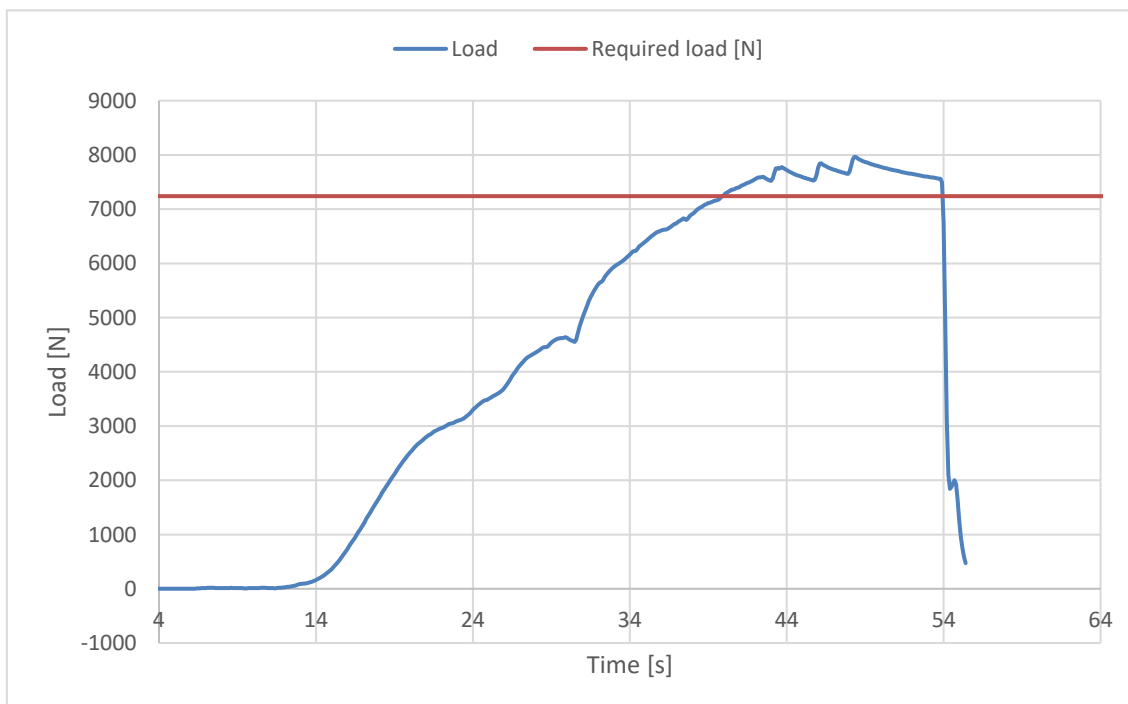
Test ID 02

Standard	LTF NfL II 91/09
Reference	5.3.2.1
Test setup	Default flying position
Attachment points	Both main riser attachment (3,4)
Anchor points	Dummy (B1, B2)
Required load [g]	6
Required load [N]	7200
Minimum test duration [s]	10
Result	
Test duration [s]	14.1
Any signs of structural failure	No
Test results	POSITIVE

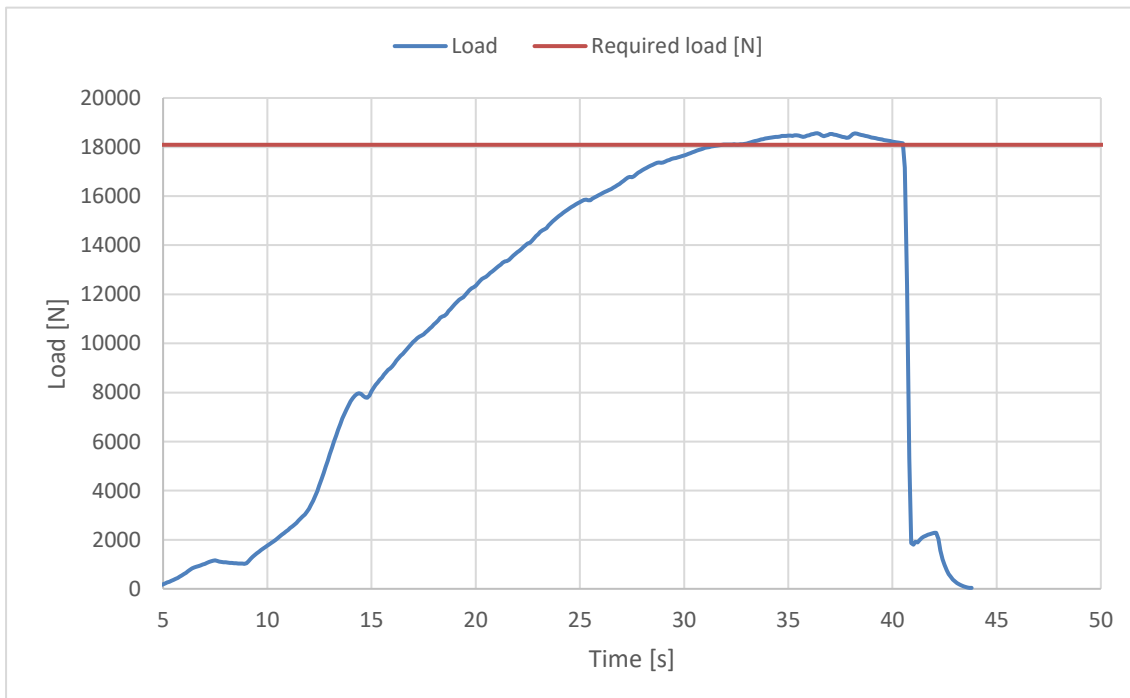
Test ID 03

Standard	LTF NfL II 91/09
Reference	5.3.2.2
Test setup	Default flying position
Attachment points	Both main riser attachment (3,4)
Anchor points	Dummy (B1, B2)
Required load [g]	15
Required load [N]	18000
Minimum test duration [s]	5
Result	
Test duration [s]	8.7
Any signs of structural failure	No
Test results	POSITIVE

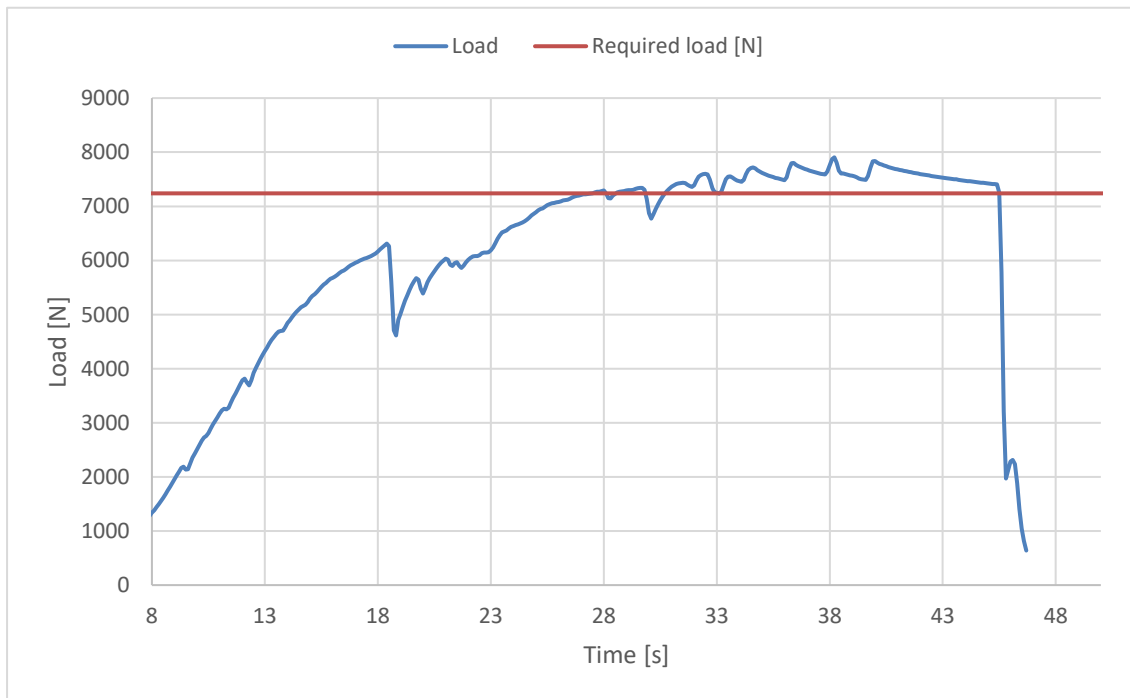
Test ID 04

Standard **LTF NfL II 91/09**
 Reference **5.3.2.3**
 Test setup **Asymmetric, one riser**
 Attachment points **One main riser attachment (3)**
 Anchor points **Dummy (B1,B2)**

Required load [g] **6**
 Required load [N] **7200**
 Minimum test duration [s] **10**

Test duration [s] **12.4**
 Any signs of structural failure **No**
 Test results **POSITIVE**

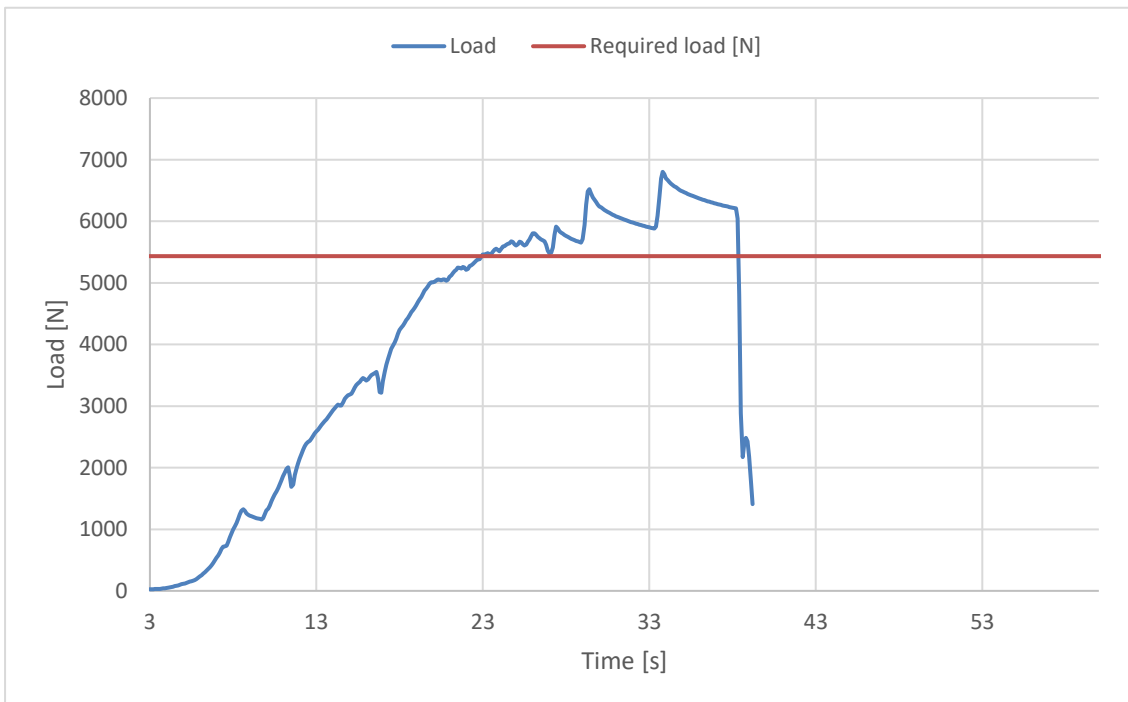
Test ID 07

Reference	5.3.2.6	
Test setup	Asymmetric, negative	
Attachment points	One main riser attachment (3 or 4) downwards	
Anchor points	Dummy (9)	
Required load [g]	4.5	
Required load [N]	5400	
Minimum test duration [s]	10	
Result		
Test duration [s]	15.4	
Any signs of structural failure	No	
Test results	POSITIVE

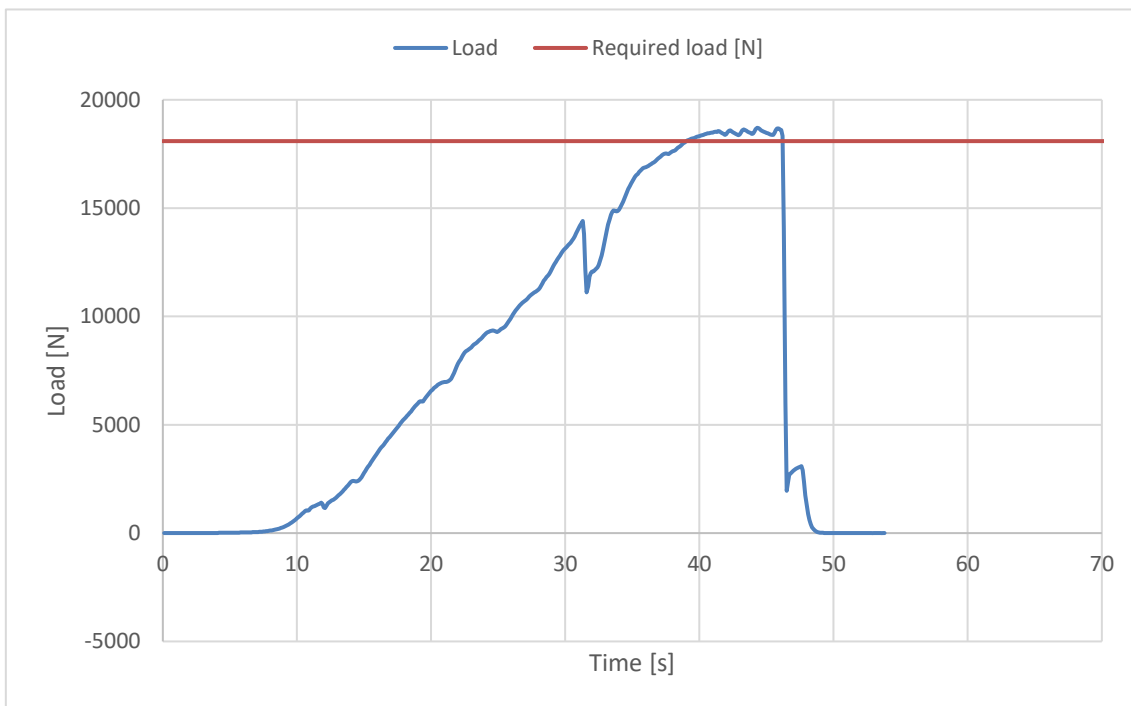
Test ID 09

Standard	LTF NfL II 91/09
Reference	5.3.2.4
Test setup	Rescue attachments
Attachment points	Rescue riser attachment (1,2)
Anchor points	Dummy (B1,B2)
Required load [g]	15
Required load [N]	18000
Minimum test duration [s]	5
Result	
Test duration [s]	7.2
Any signs of structural failure	No
Test results	POSITIVE

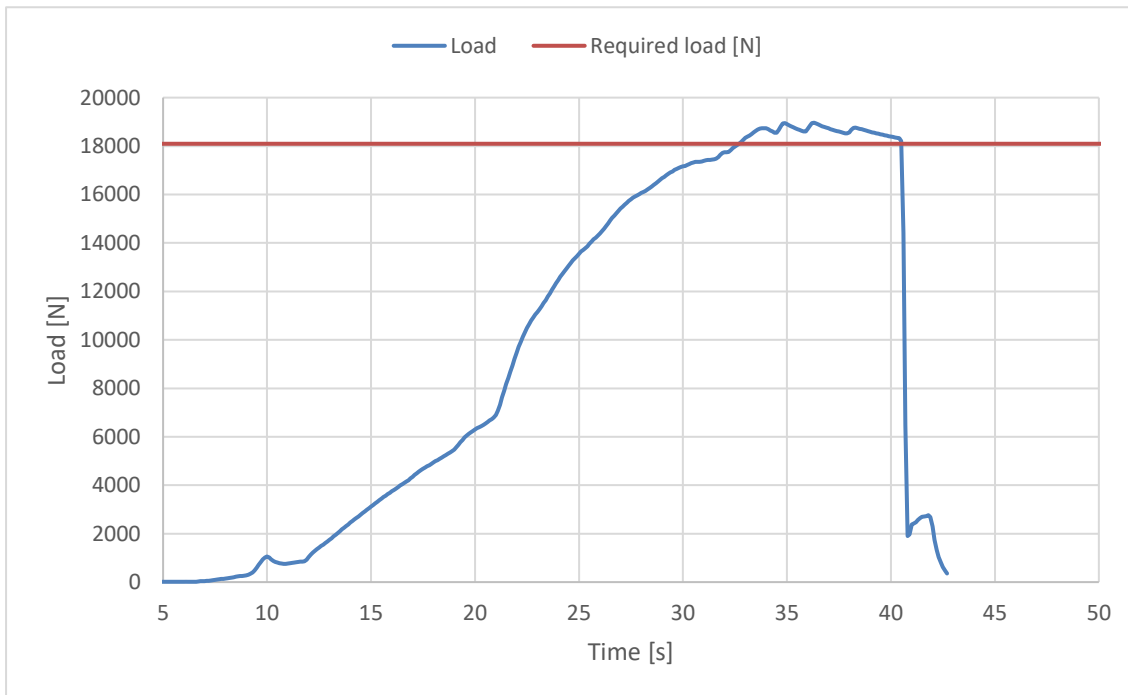
Test ID 13

Standard	LTF NfL II 91/09
Reference	5.3.2.7
Test setup	Flying position before landing
Attachment points	Both main riser attachment (3,4)
Anchor points	Dummy (7,8)
Required load [g]	15
Required load [N]	18000
Minimum test duration [s]	5
Result	
Test duration [s]	7.9
Any signs of structural failure	No
Test results	POSITIVE

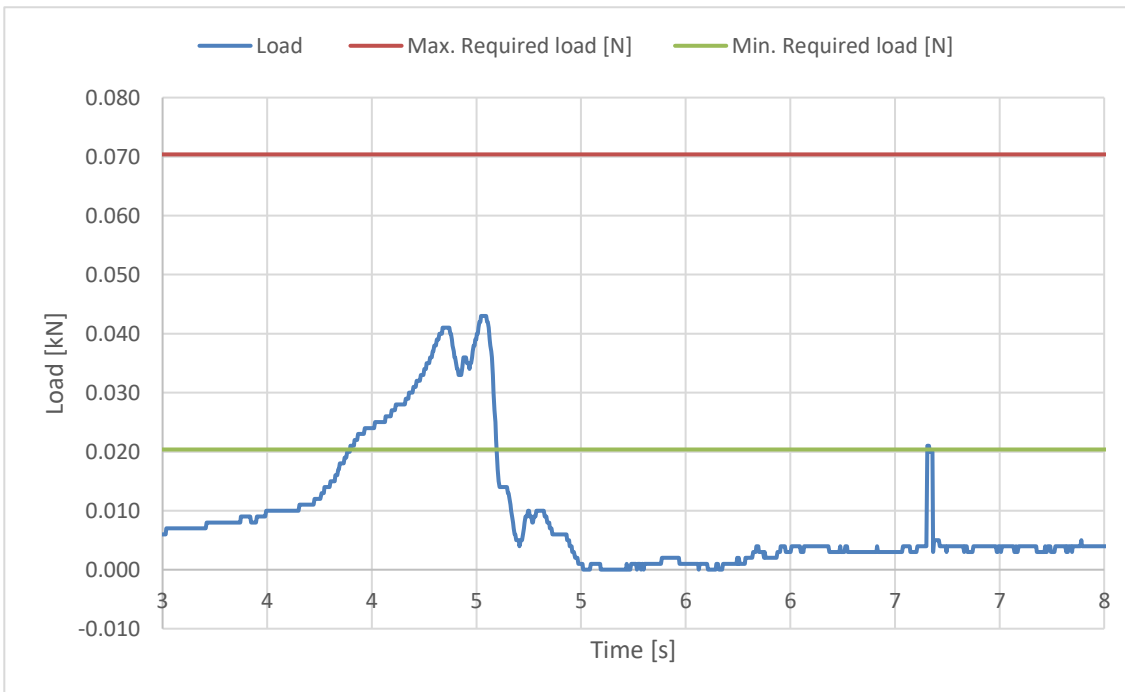
Test ID RRDT

Standard	LTF NfL II 91/09
Reference	6.1.5
Test setup	Default flying position
Attachment points	Sensor connect to handle, and pull in opening direction The test is to simulate the load required to open the emergency parachute(1st action).
Min. Required load [N]	20
Max. Required load [N]	70
Result	
Load for first action [N]	42.63
Test results	POSITIVE

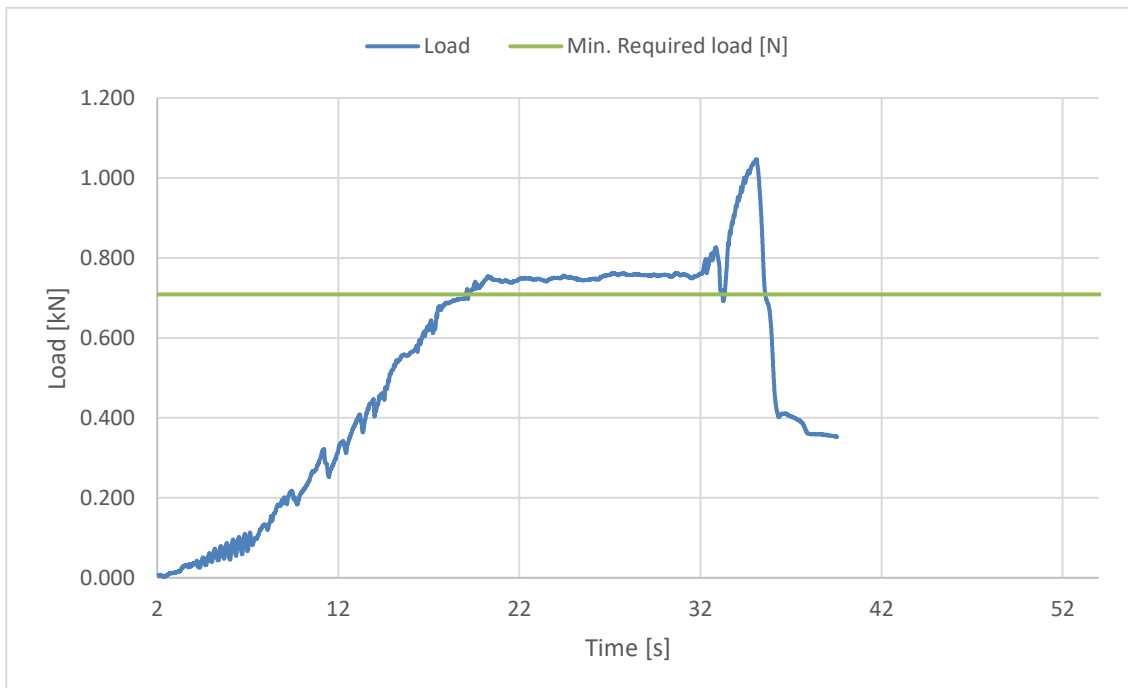
Test ID RRST

Standard	EN12491:2015
Reference in standard	5.3.2
Test setup	Two end points of handle
Attachment points	Sensor connect to end of handle, pull on the other side
	The handle must support min 700 N for 10 s, after measure breaking strength
Min. Required load [N]	700
Minimum test duration [s]	10
Result	
Test duration [s]:	14.0
Breaking strength [N]	1037.92
Test results	POSITIVE
