Harness Structural test Report

Inspection certificate number: **PH_217.2017**
Manufacturer data:

Name: **Alpine Lite**
 Type: **ABS**
 Size: **S**
 Serial number: **175101AD**
 Impact pad type: ⁽¹⁾ **n/a**
 Clip-in weight [kg]: **100**

Summary of Structural test

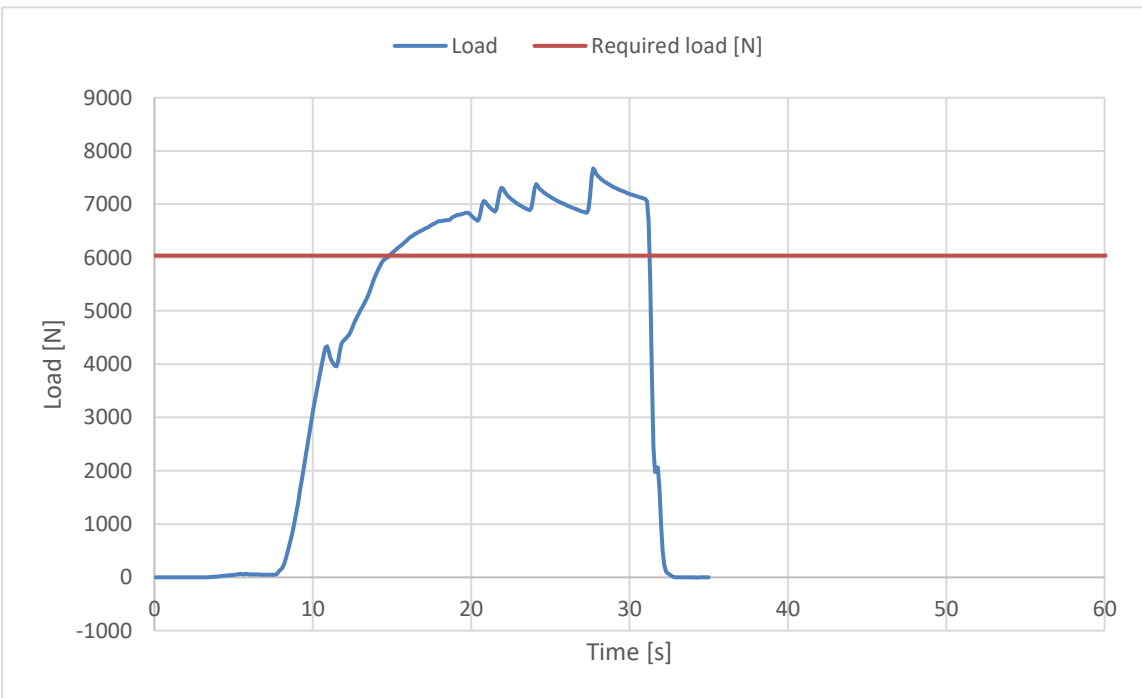
Test ID R0

Reference in standard	5.3.2.1	
Test setup	Default flying position	
Attachment points	Both main riser attachment (3,4)	
Anchor points	Dummy (B1, B2)	
Required load [g]	6	
Required load [N]	6000	
Minimum test duration [s]	10	
Result		
Test duration [s]	16.4	
Any signs of structural failure	No	
Test results	POSITIVE

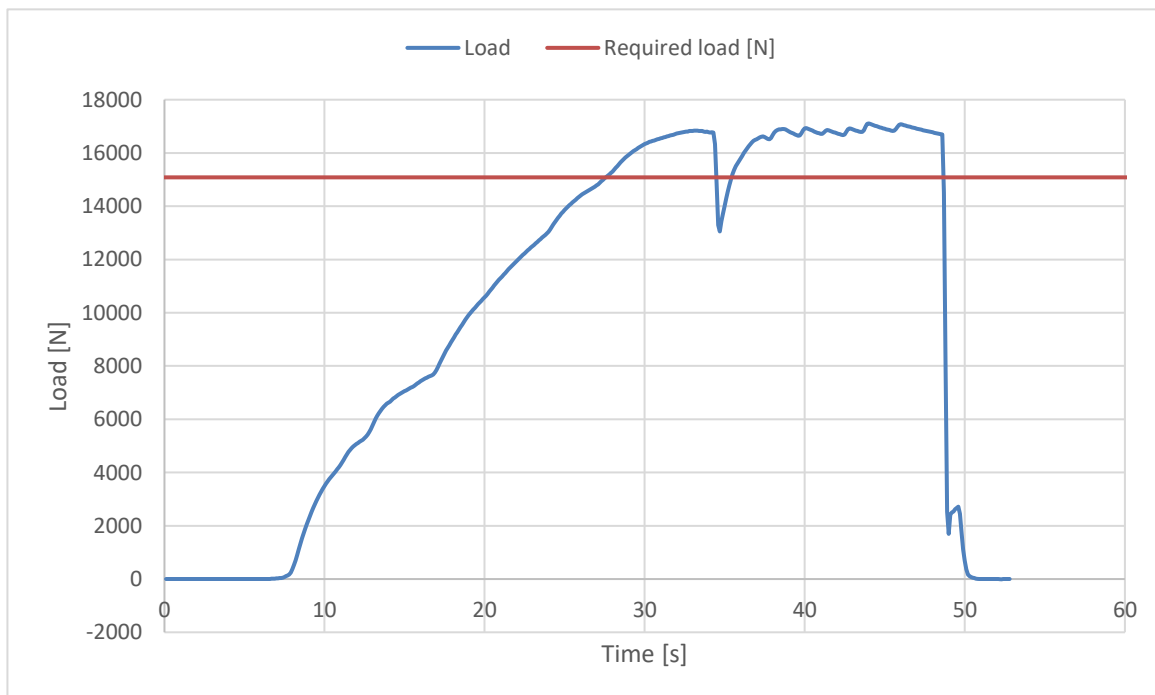
Test ID R2

Standard	EN 1651:1999	
Reference in standard	5.3.2.2	
Test setup	Default flying position	
Attachment points	Both main riser attachment (3,4)	
Anchor points	Dummy (B1, B2)	
Required load [g]	15	
Required load [N]	15000	
Minimum test duration [s]	5	
Result		
Test duration [s]	13.2	
Any signs of structural failure	No	
Test results	POSITIVE

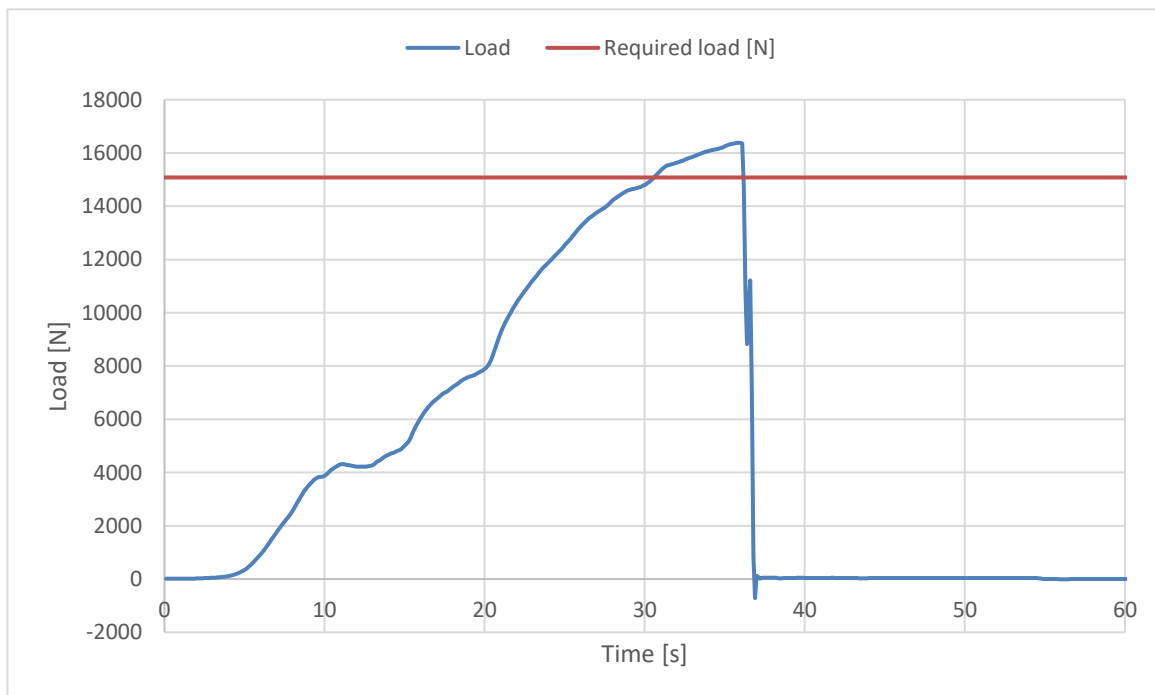
Test ID R4

Standard	EN 1651:1999
Reference in standard	5.3.2.7
Test setup	Flying position before landing
Attachment points	Both main riser attachment (3,4)
Anchor points	Dummy (7,8)
Required load [g]	15
Required load [N]	15000
Minimum test duration [s]	5
Result	
Test duration [s]	5.6
Any signs of structural failure	No
Test results	POSITIVE

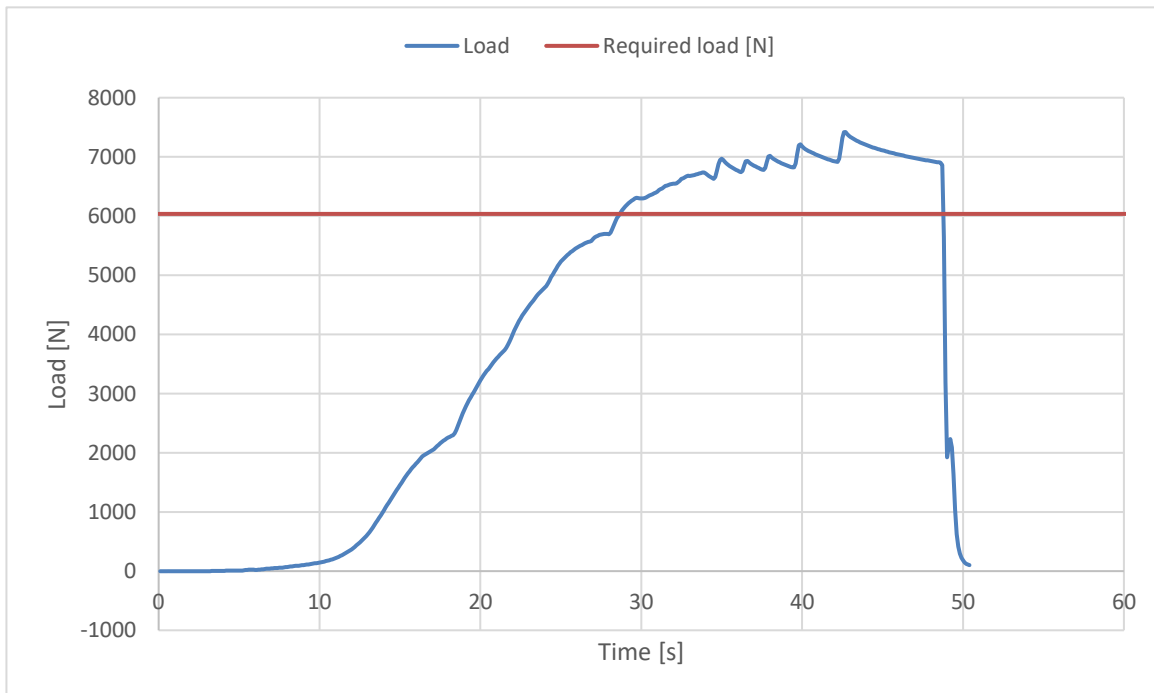
Test ID R8

Reference in standard	5.3.2.3	
Test setup	Asymmetric, one riser	
Attachment points	One main riser attachment (3)	
Anchor points	Dummy (B1,B2)	
Required load [g]	6	
Required load [N]	6000	
Minimum test duration [s]	10	
Result		
Test duration [s]	20.1	
Any signs of structural failure	No	
Test results	POSITIVE

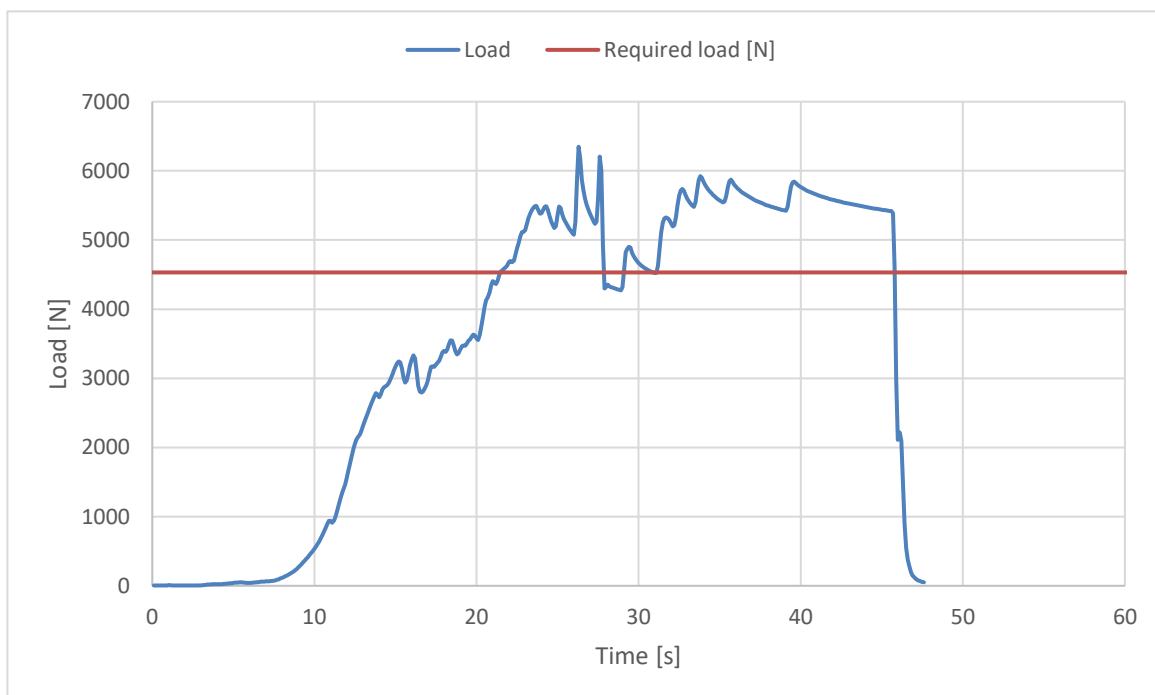
Test ID R10

Reference in standard	5.3.2.6	
Test setup	Asymmetric, negative	
Attachment points	One main riser attachment (3 or 4) downwards	
Anchor points	Dummy (9)	
Required load [g]	4.5	
Required load [N]	4500	
Minimum test duration [s]	10	
Result		
Test duration [s]	14.7	
Any signs of structural failure	No	
Test results	POSITIVE
