Harness Structural test Report - NfL

Inspection certificate number: **PH_377.2022**

Name: **GUIDE**
 Type: **ABS**
 Size: **M**
 Serial number: **SKH-0122-SH-01**
 Impact pad type: ⁽¹⁾ **Inflatable**
 Clip-in weight [kg]: **120**
 Integrated container: **Yes**
 Date of test: **08.02.2022**

Summary of Structural test

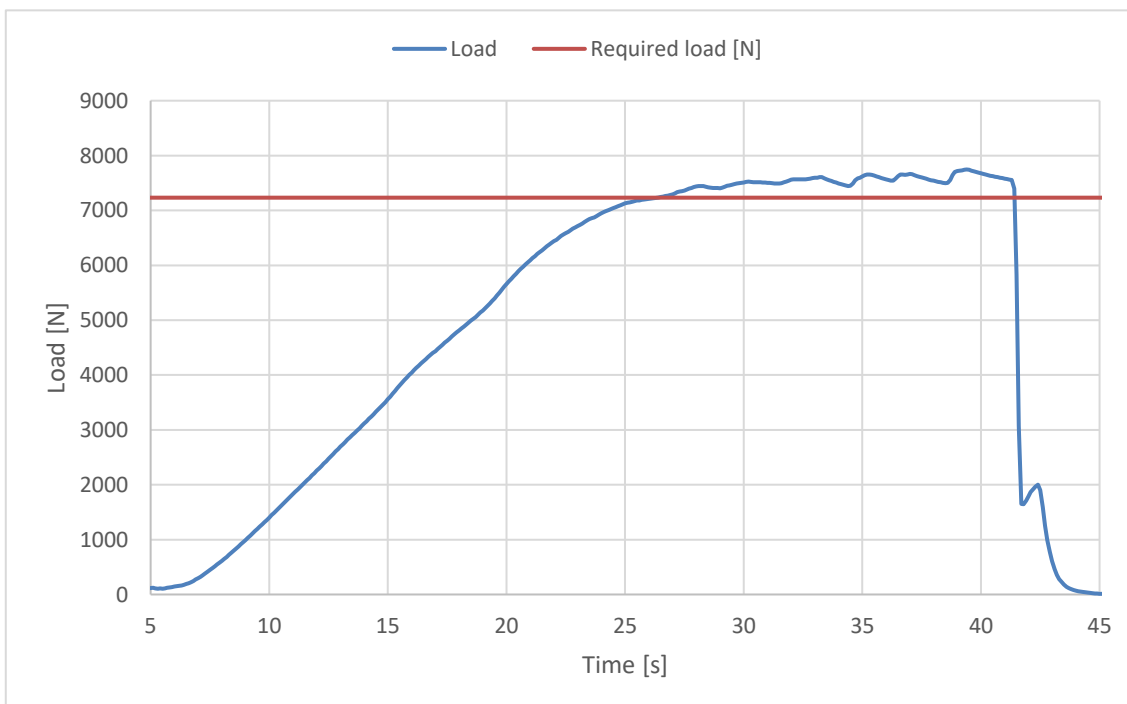
Test ID 02

Standard	EN 1651:1999
Reference	5.3.2.1
Test setup	Default flying position
Attachment points	Both main riser attachment (3,4)
Anchor points	Dummy (B1, B2)
Required load [g]	6
Required load [N]	7200
Minimum test duration [s]	10
Result	
Test duration [s]	15.1
Any signs of structural failure	No
Test results	POSITIVE

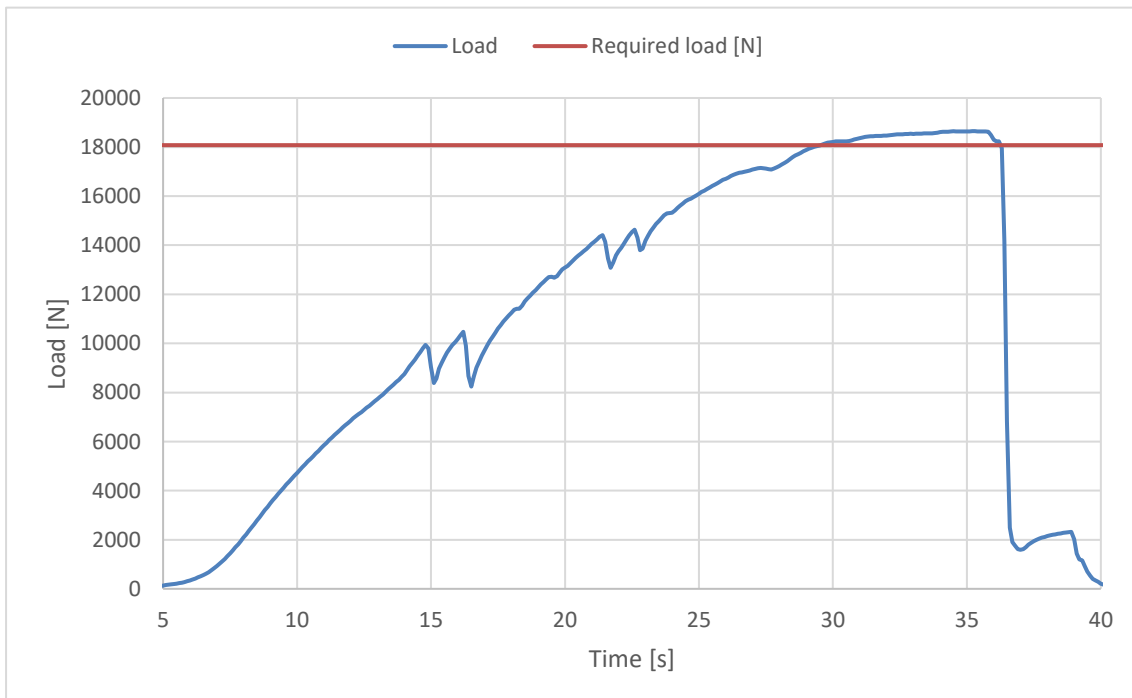
Test ID 03

Standard	EN 1651:1999
Reference	5.3.2.2
Test setup	Default flying position
Attachment points	Both main riser attachment (3,4)
Anchor points	Dummy (B1, B2)
Required load [g]	15
Required load [N]	18000
Minimum test duration [s]	5
Result	
Test duration [s]	6.7
Any signs of structural failure	No
Test results	POSITIVE

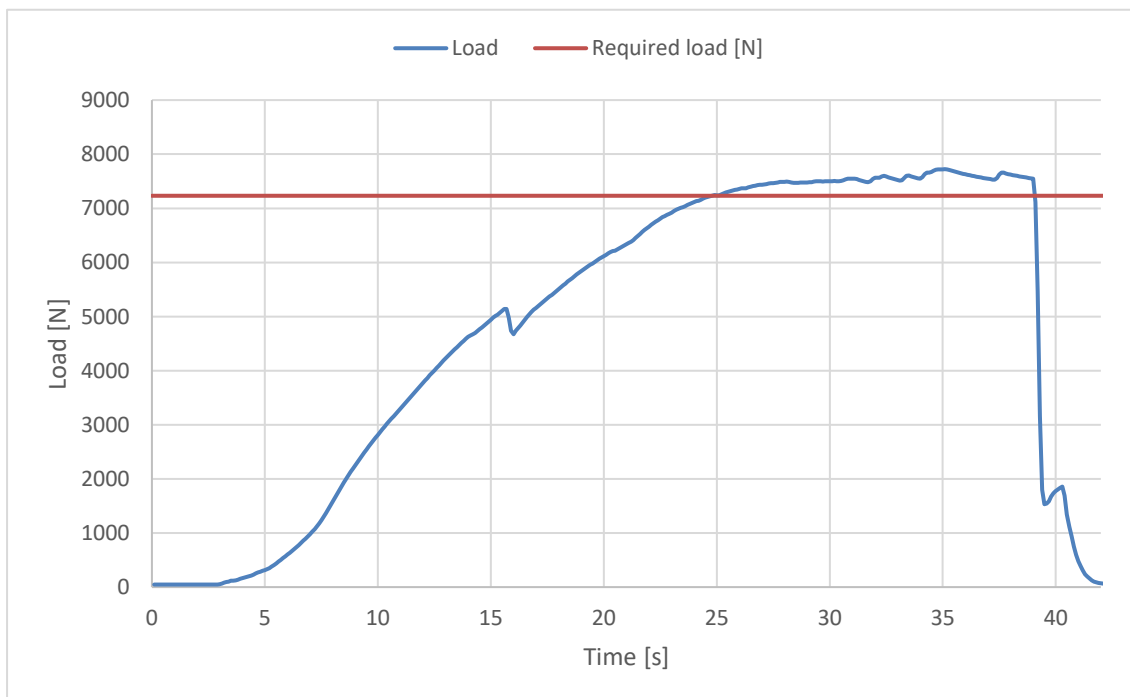
Test ID 04

Standard	EN 1651:1999
Reference	5.3.2.3
Test setup	Asymmetric, one riser
Attachment points	One main riser attachment (3)
Anchor points	Dummy (B1,B2)
Required load [g]	6
Required load [N]	7200
Minimum test duration [s]	10
Result	
Test duration [s]	14.3
Any signs of structural failure	No
Test results	POSITIVE

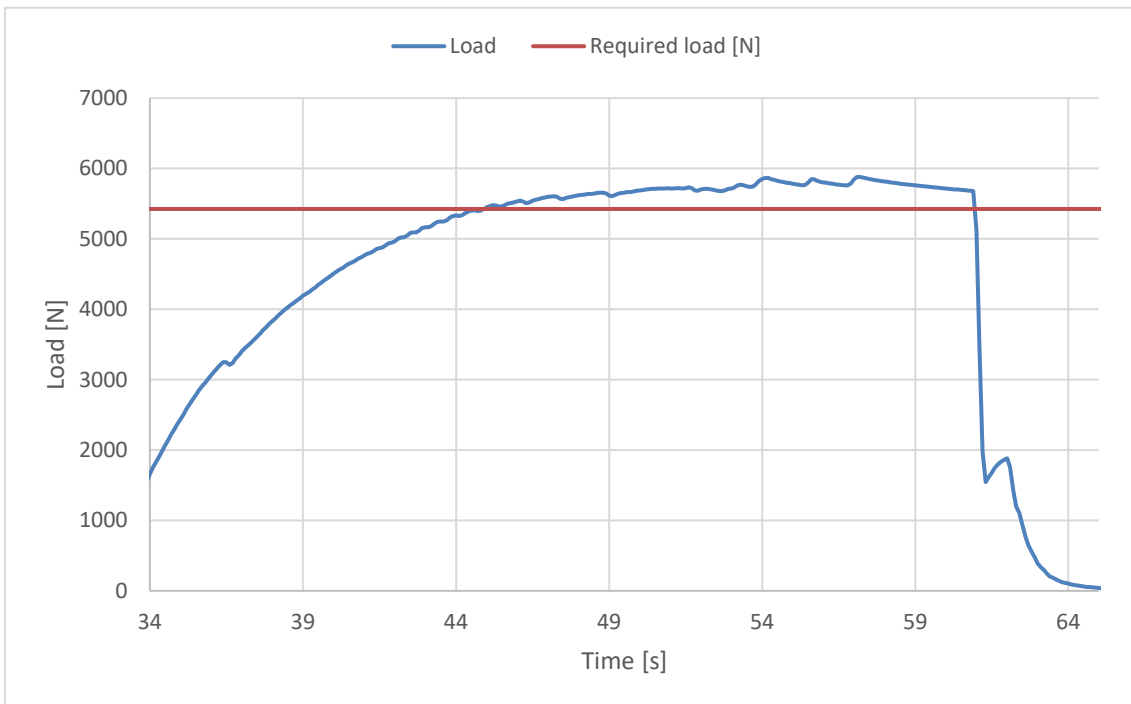
Test ID 07

Reference	5.3.2.6	
Test setup	Asymmetric, negative	
Attachment points	One main riser attachment (3 or 4) downwards	
Anchor points	Dummy (9)	
Required load [g]	4.5	
Required load [N]	5400	
Minimum test duration [s]	10	
Result		
Test duration [s]	16.1	
Any signs of structural failure	No	
Test results	POSITIVE

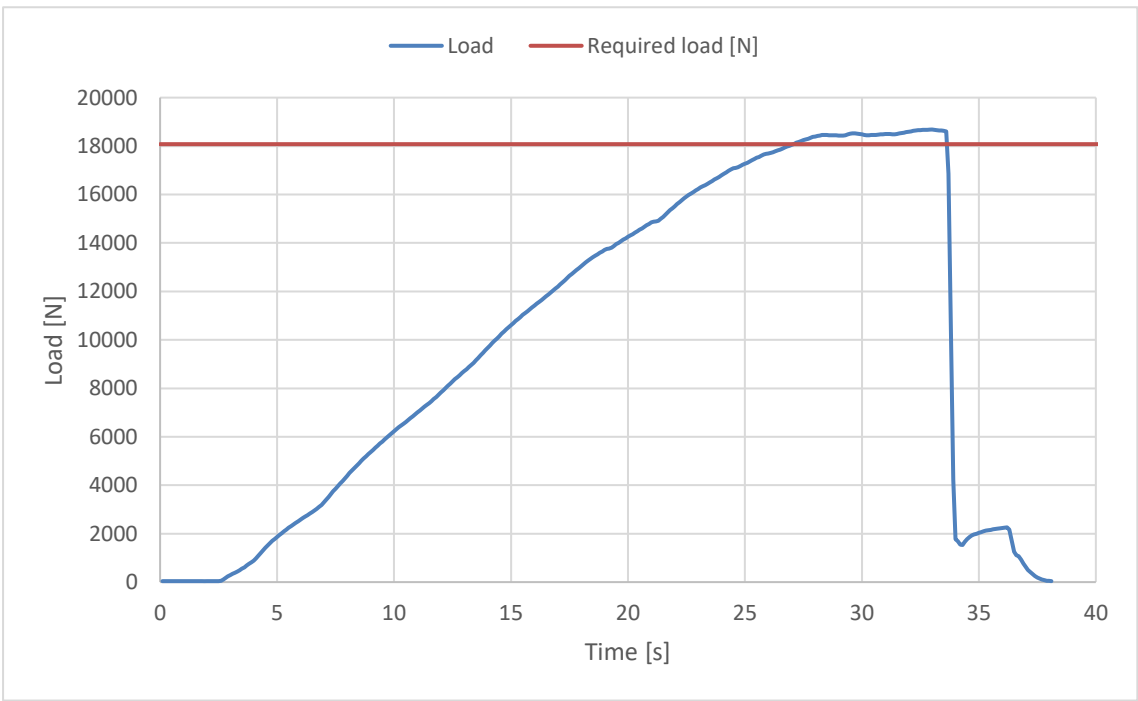
Test ID 13

Standard	EN 1651:1999
Reference	5.3.2.7
Test setup	Flying position before landing
Attachment points	Both main riser attachment (3,4)
Anchor points	Dummy (7,8)
Required load [g]	15
Required load [N]	18000
Minimum test duration [s]	5
Result	
Test duration [s]	6.6
Any signs of structural failure	No
Test results	POSITIVE

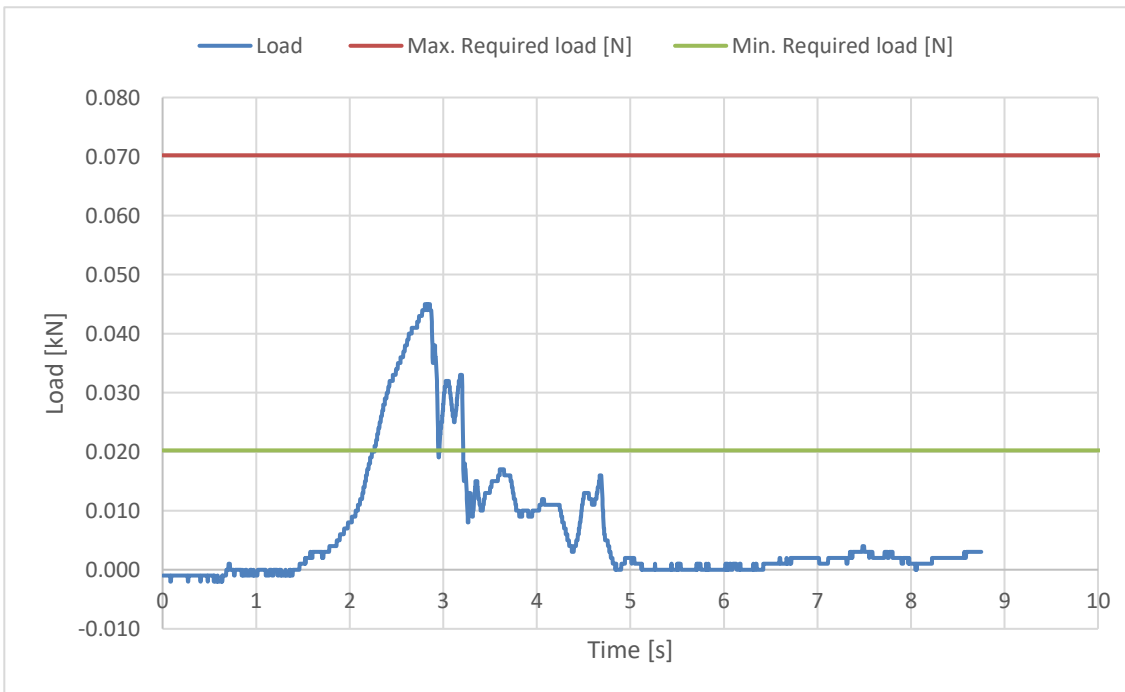
Test ID RRDT

Standard	NfL 2-565-20
Reference	6.1.5
Test setup	Default flying position
Attachment points	Sensor connect to handle, and pull in opening direction
	The test is to simulate the load required to open the emergency parachute(1st action).
Min. Required load [N]	20
Max. Required load [N]	70
Result	
Load for first action [N]	44.77
Test results	POSITIVE

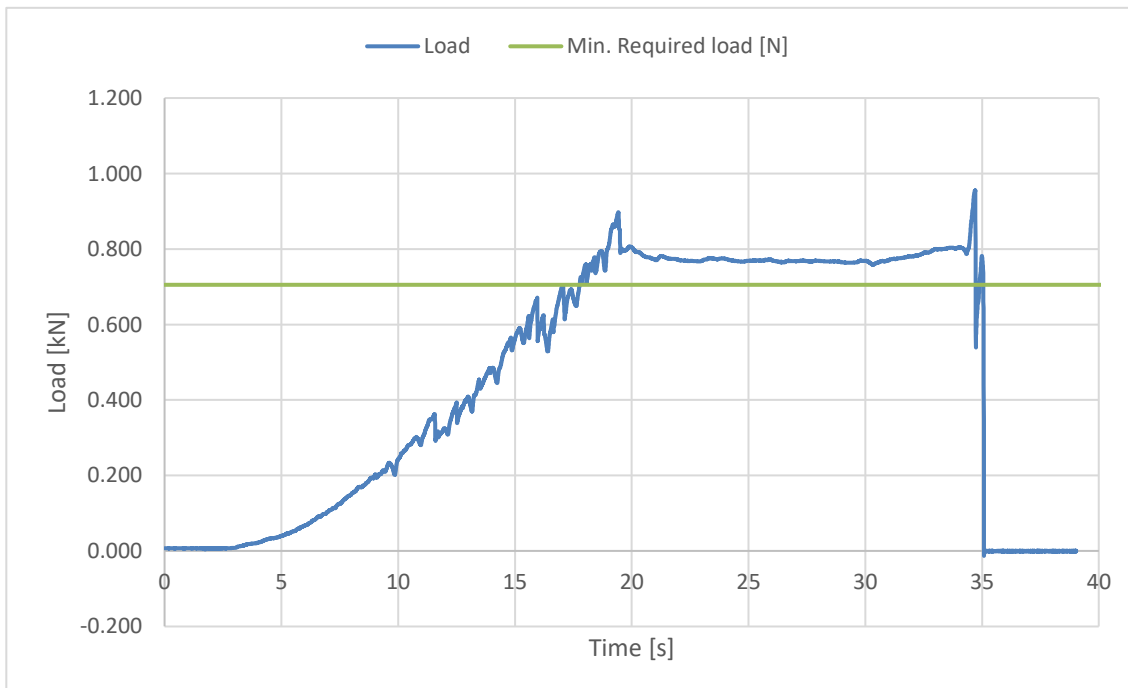
Test ID RRST

Standard	EN 12491
Reference in standard	5.3.2
Test setup	Two end points of handle
Attachment points	Sensor connect to end of handle, pull on the other side
	The handle must support min 700 N for 10 s, after measure breaking strength
Min. Required load [N]	700
Minimum test duration [s]	10
Result	
Test duration [s]:	16.9
Breaking strength [N]	951.09
Test results	POSITIVE
