Harness Structural test Report - NfL

Inspection certificate number: PH_411.2023

Name: **EVOLITE 2**
 Type: **ABS**
 Size: **M**
 Serial number: **2173MM0425RO**
 Impact pad type: ⁽¹⁾ **Foam**
 Clip-in weight [kg]: **120**
 Integrated container: **Yes**
 Date of test: **23.05.2023**

Summary of Structural test

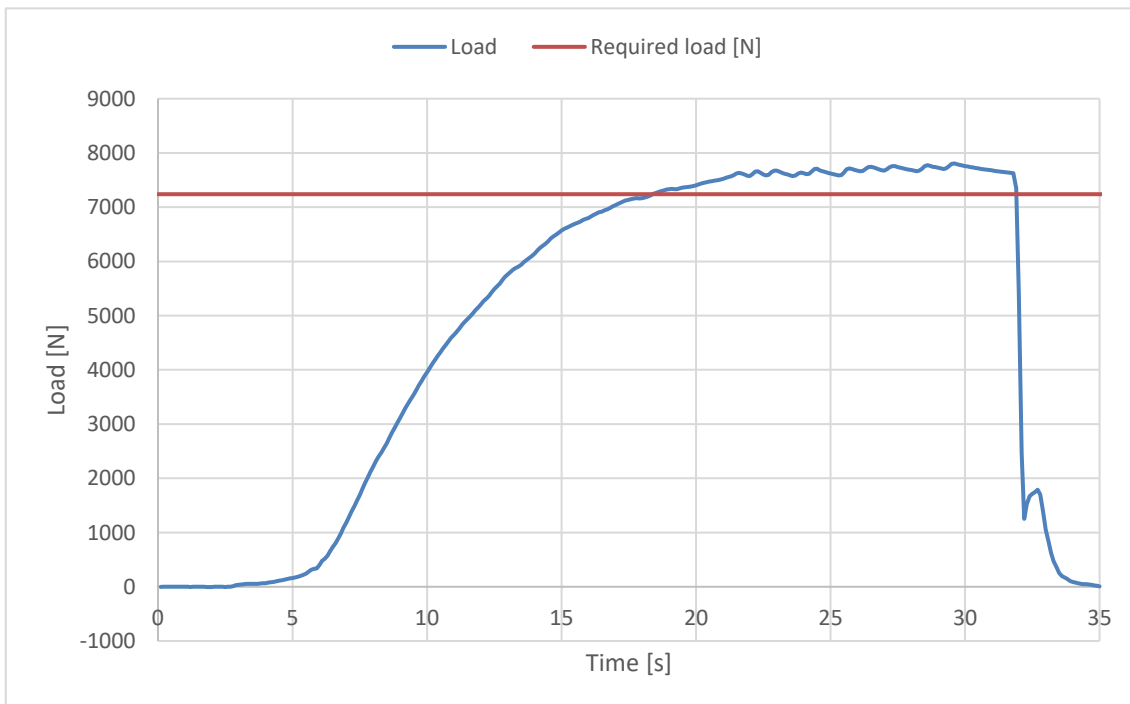
Test ID 02

Standard	EN 1651:1999
Reference	5.3.2.1
Test setup	Default flying position
Attachment points	Both main riser attachment (3,4)
Anchor points	Dummy (B1, B2)
Required load [g]	6
Required load [N]	7200
Minimum test duration [s]	10
Result	
Test duration [s]	13.6
Any signs of structural failure	No
Test results	POSITIVE

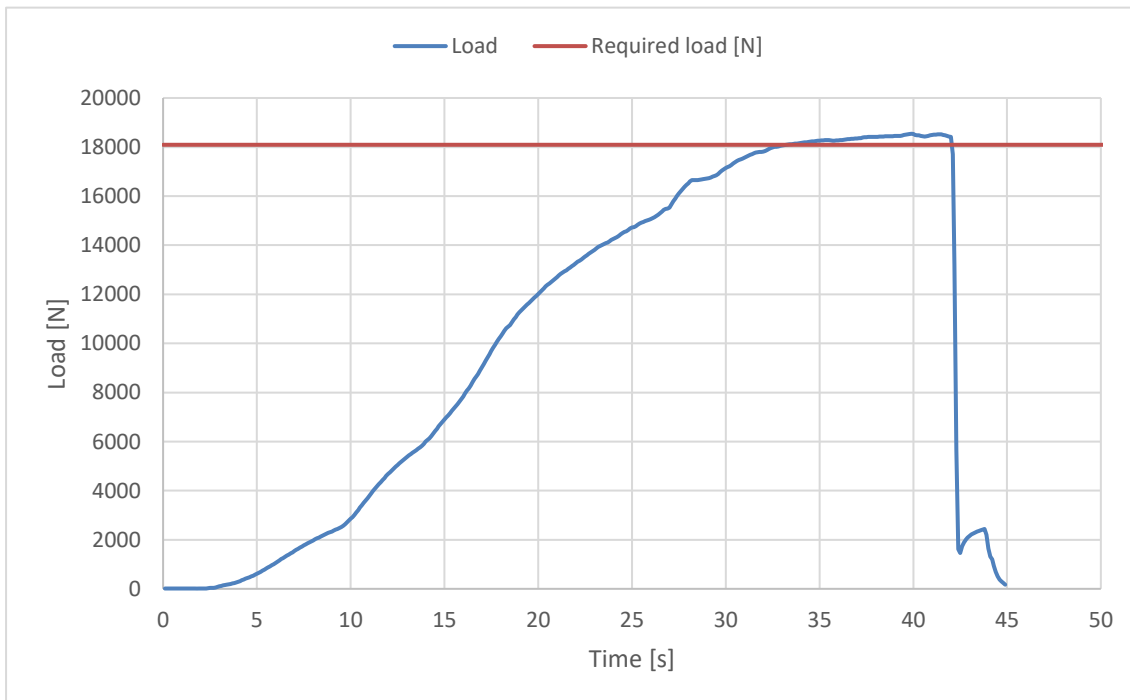
Test ID 03

Standard **EN 1651:1999**
 Reference **5.3.2.2**
 Test setup **Default flying position**
 Attachment points **Both main riser attachment (3,4)**
 Anchor points **Dummy (B1, B2)**

Required load [g] **15**
 Required load [N] **18000**
 Minimum test duration [s] **5**

Test duration [s] **8.8**
 Any signs of structural failure **No**
 Test results **POSITIVE**

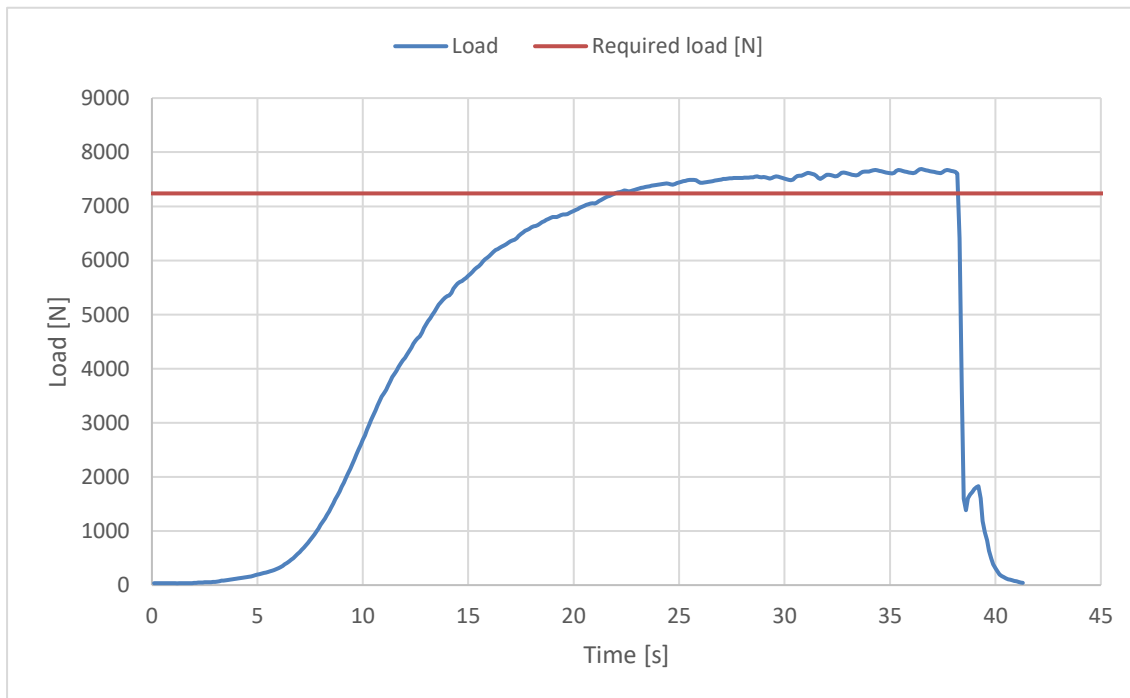
Test ID 04

Standard **EN 1651:1999**
 Reference **5.3.2.3**
 Test setup **Asymmetric, one riser**
 Attachment points **One main riser attachment (3)**
 Anchor points **Dummy (B1,B2)**

Required load [g] **6**
 Required load [N] **7200**
 Minimum test duration [s] **10**

Test duration [s] **16.3**
 Any signs of structural failure **No**
 Test results **POSITIVE**

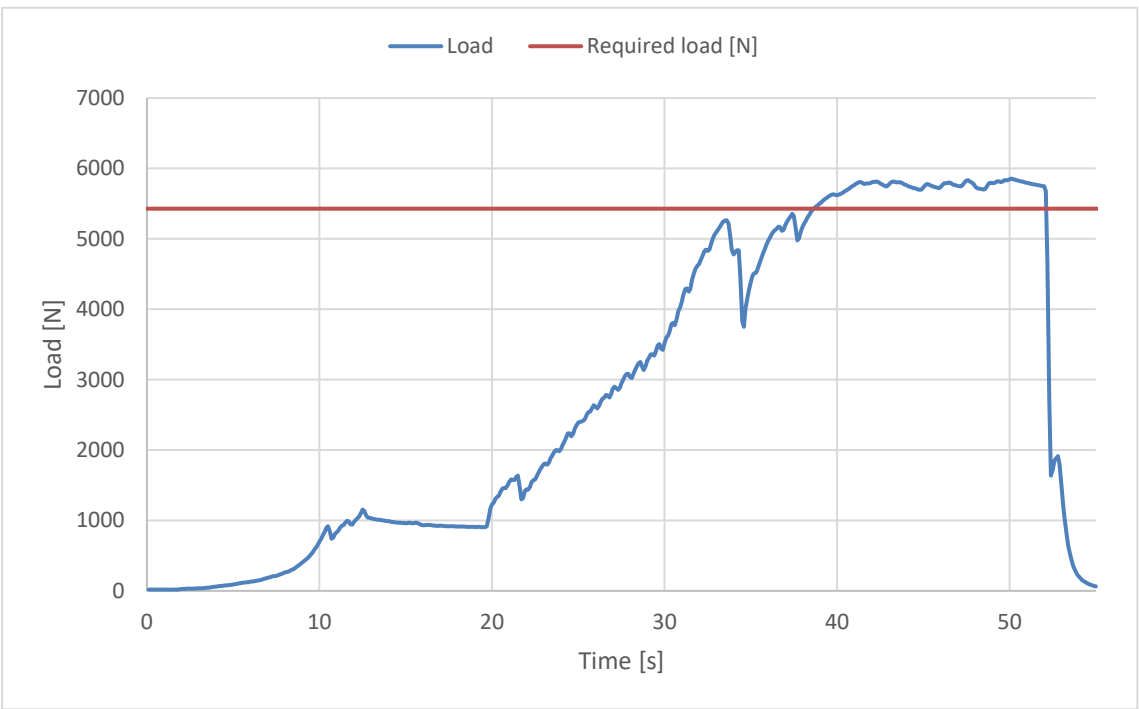
Test ID 07

Reference	5.3.2.6	
Test setup	Asymmetric, negative	
Attachment points	One main riser attachment (3 or 4) downwards	
Anchor points	Dummy (9)	
Required load [g]	4.5	
Required load [N]	5400	
Minimum test duration [s]	10	
Result		
Test duration [s]	13.5	
Any signs of structural failure	No	
Test results	POSITIVE

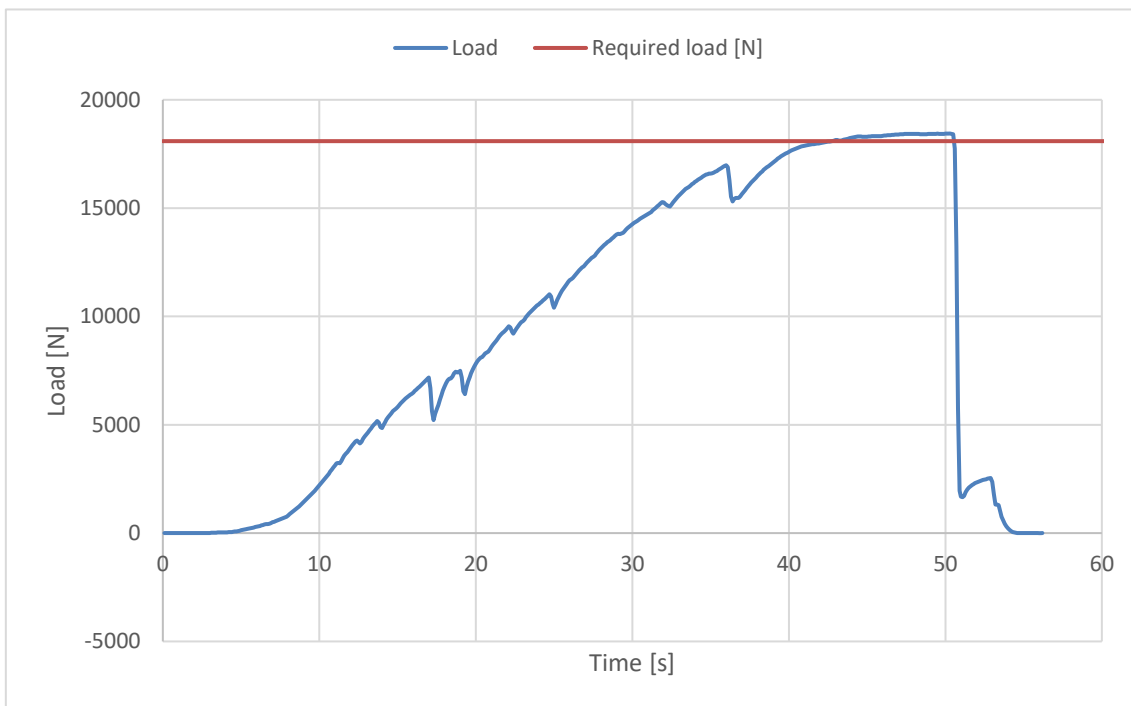
Test ID 09

Standard **EN 1651:1999**
 Reference **5.3.2.4**
 Test setup **Rescue attachments**
 Attachment points **Rescue riser attachment (1,2)**
 Anchor points **Dummy (B1,B2)**

Required load [g] **15**
 Required load [N] **18000**
 Minimum test duration [s] **5**

Test duration [s] **7.8**
 Any signs of structural failure **No**
 Test results **POSITIVE**

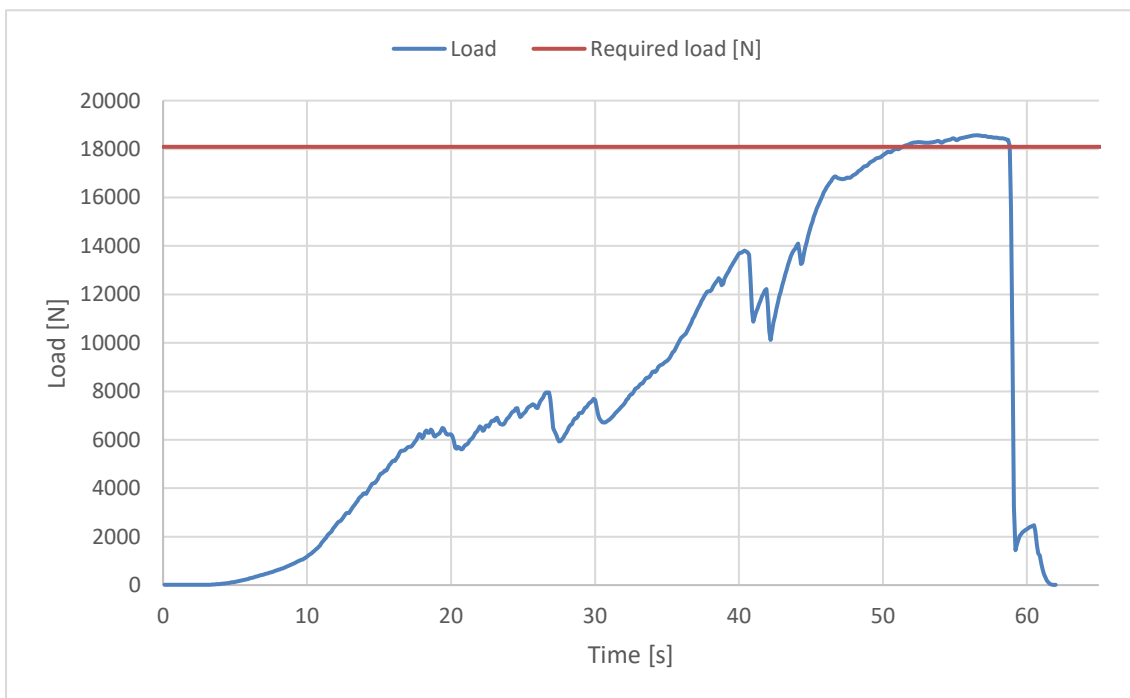
Test ID 13

Standard	EN 1651:1999
Reference	5.3.2.7
Test setup	Flying position before landing
Attachment points	Both main riser attachment (3,4)
Anchor points	Dummy (7,8)
Required load [g]	15
Required load [N]	18000
Minimum test duration [s]	5
Result	
Test duration [s]	7.5
Any signs of structural failure	No
Test results	POSITIVE

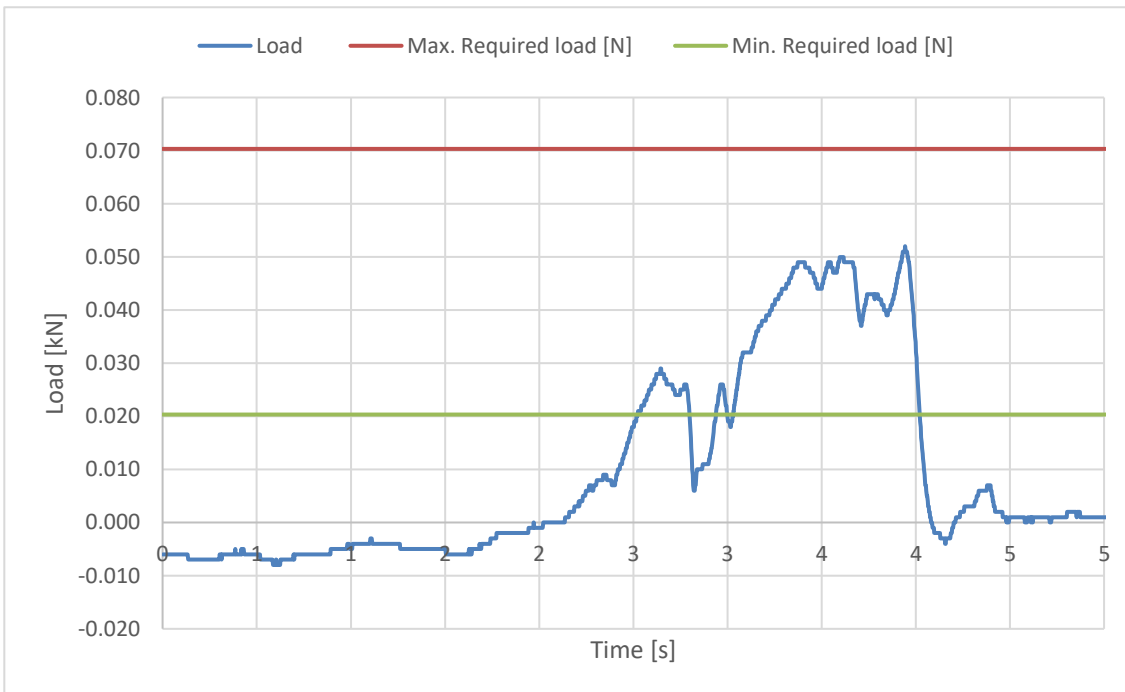
Test ID RRDT

Standard **NfL 2-565-20**
 Reference **6.1.5**
 Test setup **Default flying position**
 Attachment points **Sensor connect to handle, and pull in opening direction**
 The test is to simulate the load required to open the emergency parachute(1st action).

Min. Required load [N] **20**
 Max. Required load [N] **70**

Load for first action [N] **51.65**
 Test results **POSITIVE**

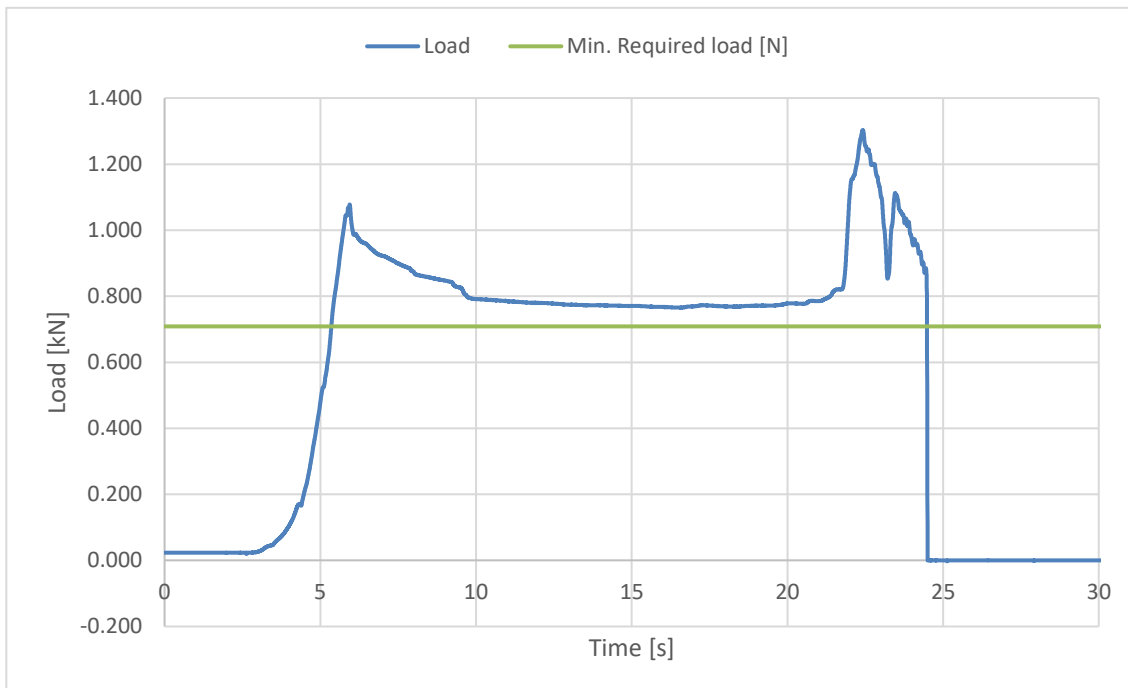
Test ID RRST

Standard	EN 12491
Reference in standard	5.3.2
Test setup	Two end points of handle
Attachment points	Sensor connect to end of handle, pull on the other side
	The handle must support min 700 N for 10 s, after measure breaking strength
Min. Required load [N]	700
Minimum test duration [s]	10
Result	
Test duration [s]:	19.1
Breaking strength [N]	1294.34
Test results	POSITIVE
