Harness Structural test Report - LTF

Inspection certificate number: **PH_297.2020**

Name:	**Access 2**
Type:	**ABS**
Size:	**M**
Serial number:	**2170MMO121ROAB2**
Impact pad type: (1)	**Foam**
Clip-in weight [kg]:	**120**
Date of test:	**10.02.2020**

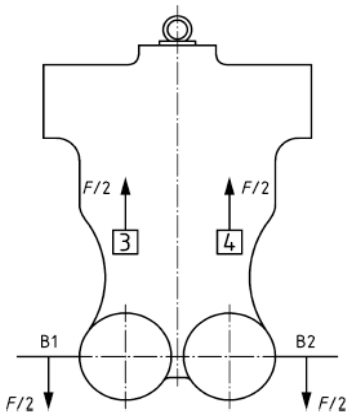
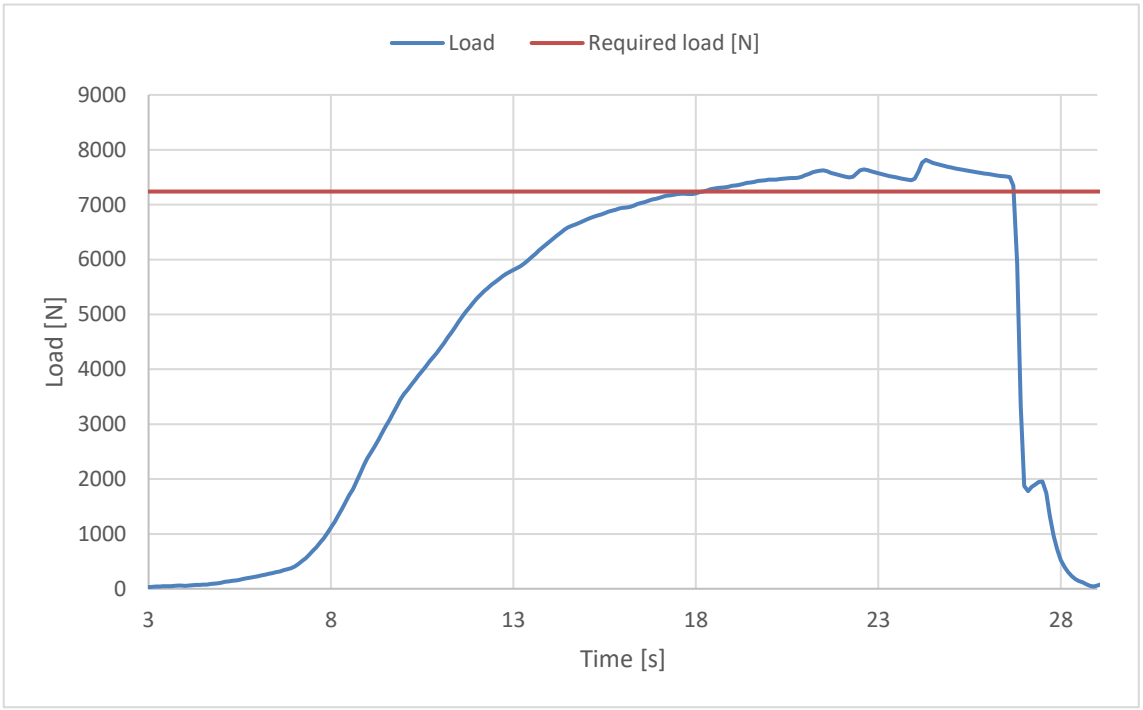
Harness Structural test **Test ID 02**

Test duration [s]	**8.6**
Any signs of structural failure	**No**
Test results	**POSITIVE**

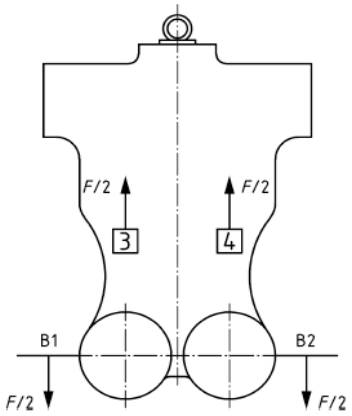
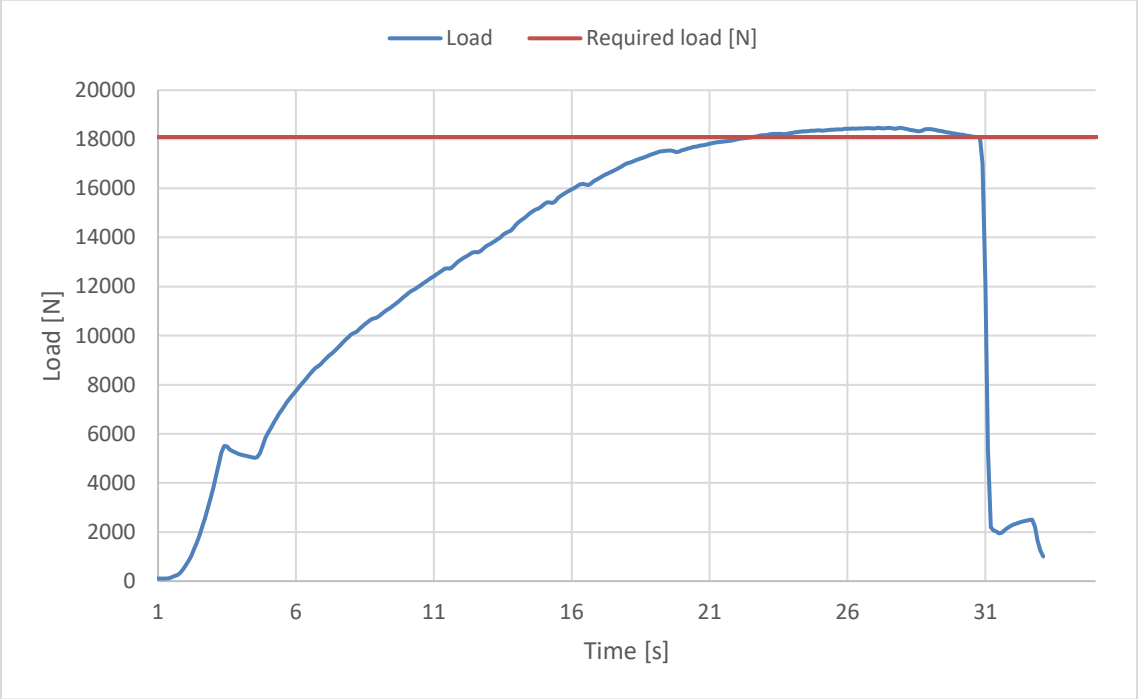
Harness Structural test **Test ID 03**

Standard	**EN 1651:1999**
Reference in standard	**5.3.2.2**
Test setup	**Default flying position**
Attachment points	**Both main riser attachment (3,4)**
Anchor points	**Dummy (B1, B2)**
Required load [g]	**15**
Required load [N]	**18000**
Minimum test duration [s]	**5**
Result	
Test duration [s]	**8.1**
Any signs of structural failure	**No**
Test results	**POSITIVE**

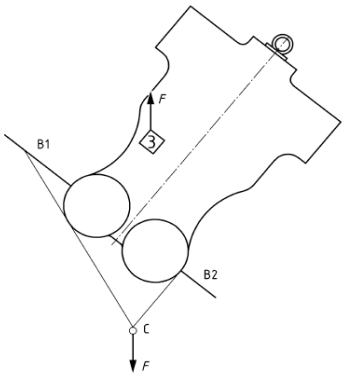
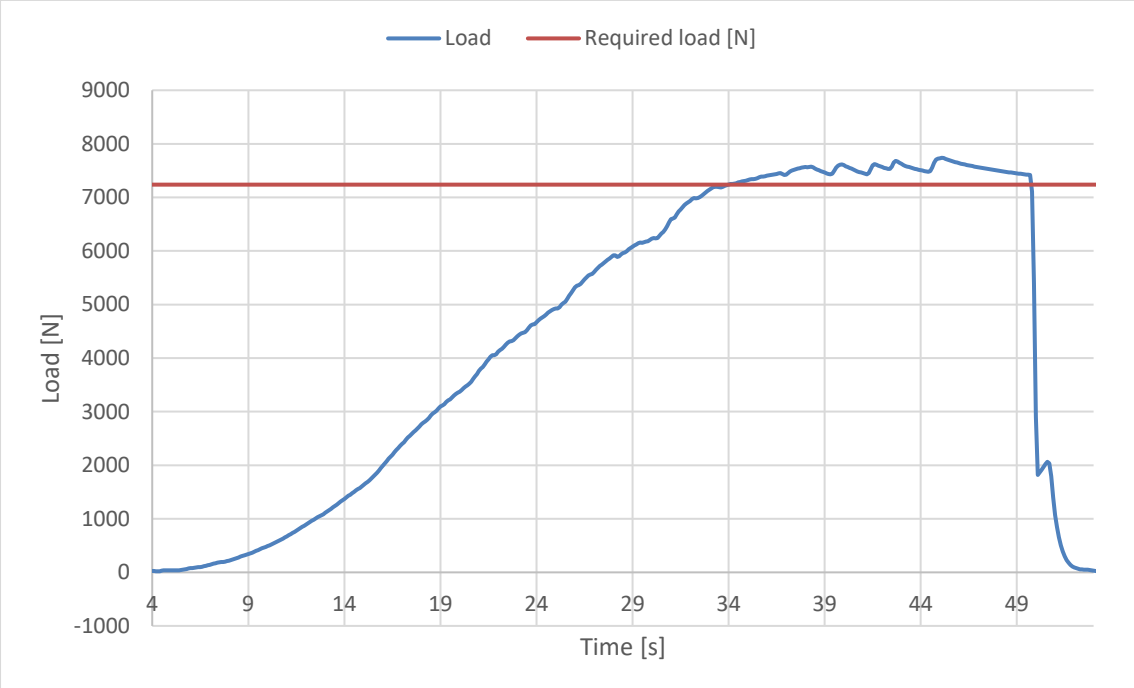
Harness Structural test **Test ID 04**

Standard	**EN 1651:1999**
Reference in standard	**5.3.2.3**
Test setup	**Asymmetric, one riser**
Attachment points	**One main riser attachment (3)**
Anchor points	**Dummy (B1,B2)**
Required load [g]	**6**
Required load [N]	**7200**
Minimum test duration [s]	**10**
Result	
Test duration [s]	**15.8**
Any signs of structural failure	**No**
Test results	**POSITIVE**

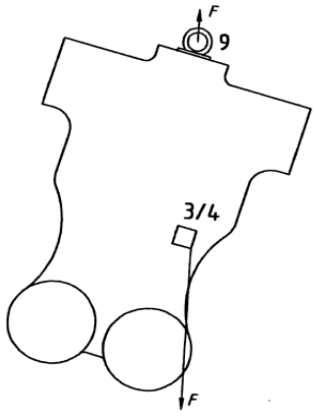
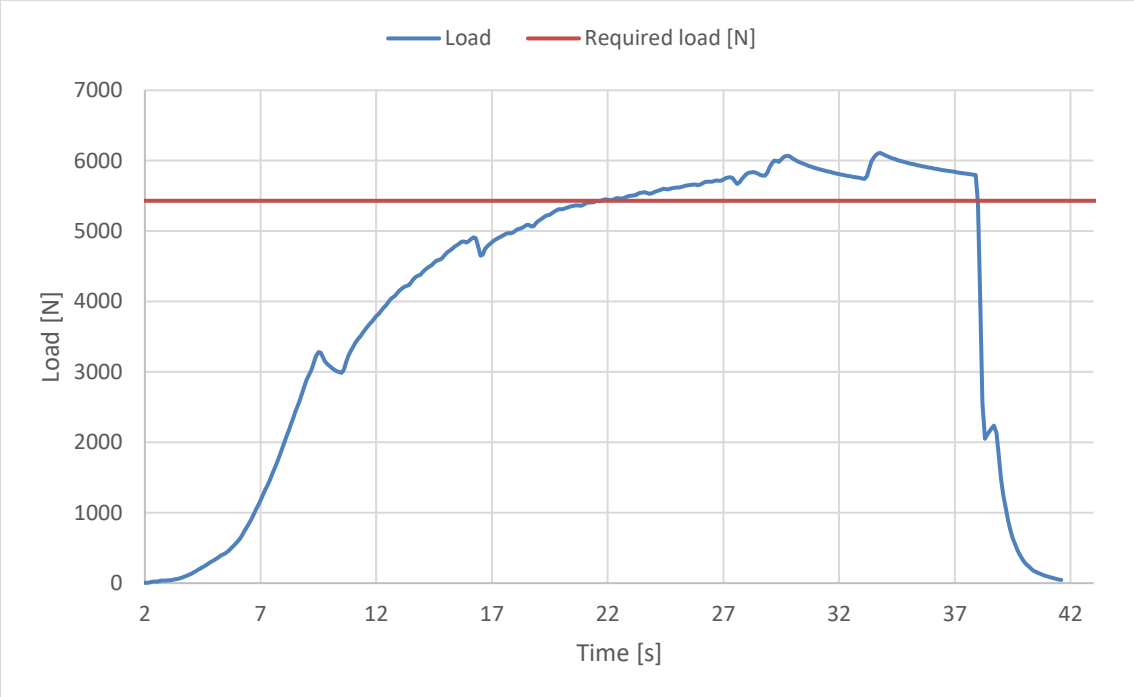
Harness Structural test **Test ID 07**

Test duration [s]	**16.2**
Any signs of structural failure	**No**
Test results	**POSITIVE**

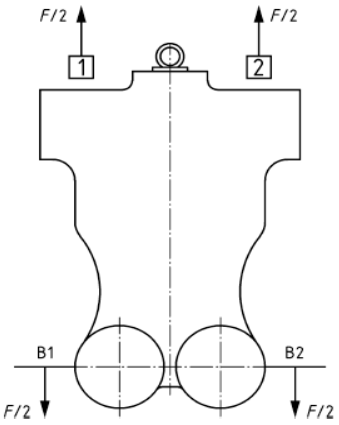
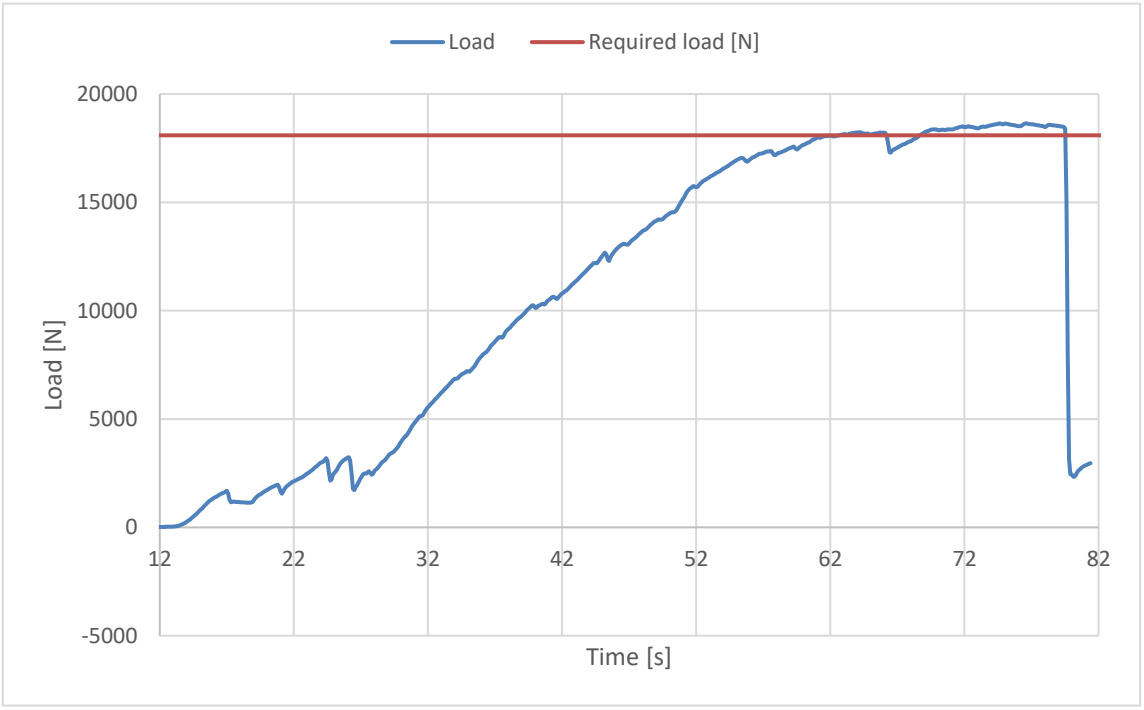
Harness Structural test **Test ID 09**

Standard	**EN 1651:1999**
Reference in standard	**5.3.2.4**
Test setup	**Rescue attachments**
Attachment points	**Rescue riser attachment (1,2)**
Anchor points	**Dummy (B1,B2)**
Required load [g]	**15**
Required load [N]	**18000**
Minimum test duration [s]	**5**
Result	
Test duration [s]	**10.9**
Any signs of structural failure	**No**
Test results	**POSITIVE**

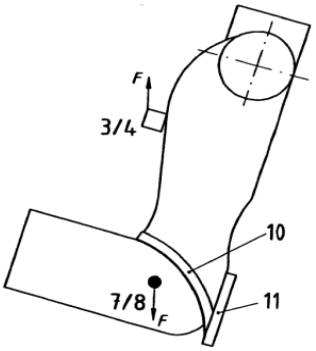
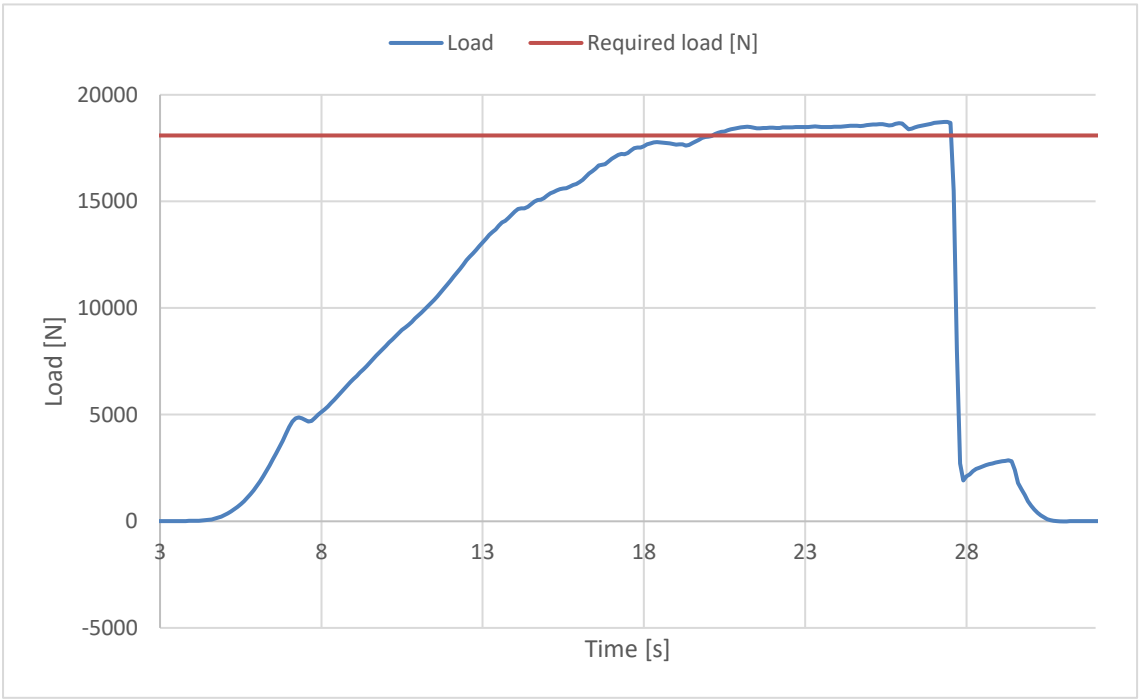
Harness Structural test **Test ID 13**

Standard	**EN 1651:1999**
Reference in standard	**5.3.2.7**
Test setup	**Flying position before landing**
Attachment points	**Both main riser attachment (3,4)**
Anchor points	**Dummy (7,8)**
Required load [g]	**15**
Required load [N]	**18000**
Minimum test duration [s]	**5**
Result	
Test duration [s]	**7.4**
Any signs of structural failure	**No**
Test results	**POSITIVE**

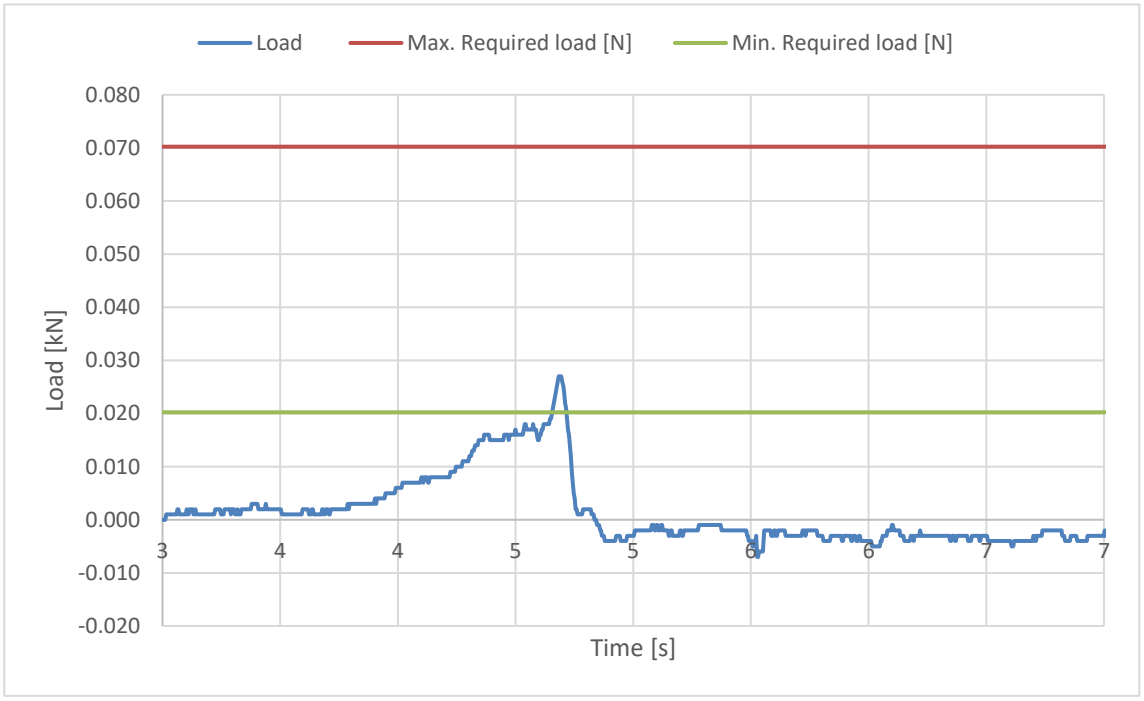
Rescue Deployment Test		**Test ID RRDT**
Standard	**LTF NfL II 91/09**	
Reference in standard	**6.1.5**	
Test setup	**Default flying position**	
Attachment points	**Sensor connect to handle, and pull in opening direction**	
	The test is to simulate the load required to open the emergency parachute(1st action).	
Min. Required load [N]	**20**	
Max. Required load [N]	**70**	
Result		
Load for first action [N]	**26.77**	
Test results	**POSITIVE**

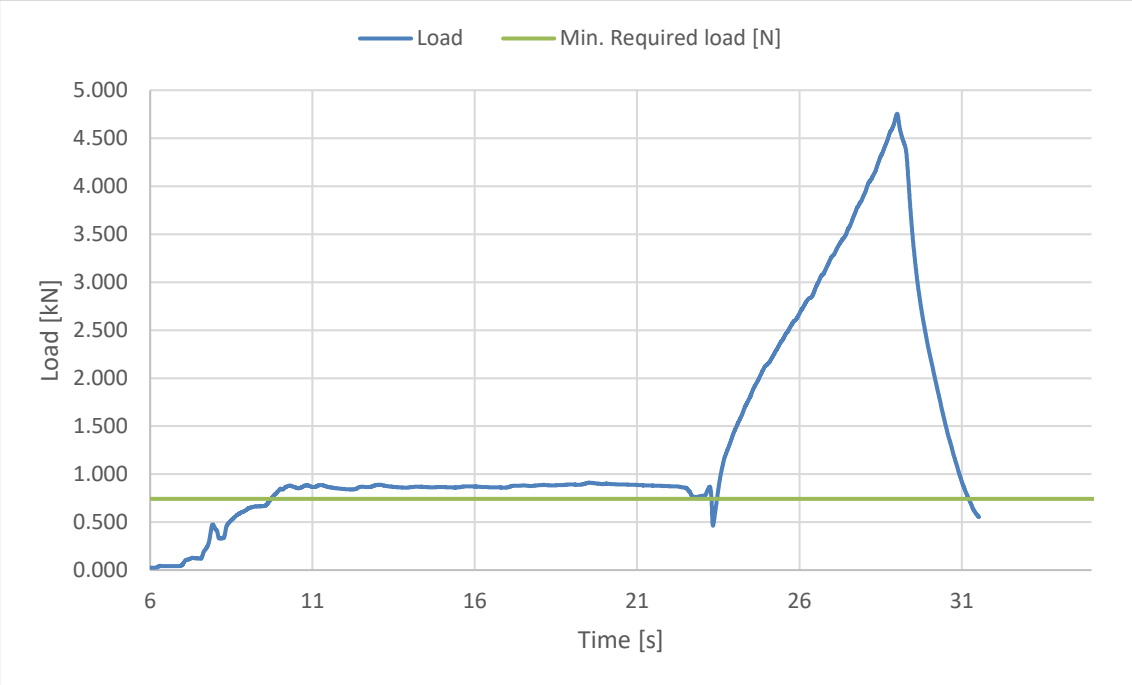
Rescue Deployment Handle strength test		**Test ID RRST**
Standard	**EN12491:2015**	
Reference in standard	**5.3.2**	
Test setup	**Two end points of handle**	
Attachment points	**Sensor connect to end of handle, pull on the other side**	
	The handle must support min 700 N for 10 s, after measure breaking strength	
Min. Required load [N]	**700**	
Minimum test duration [s]	**10**	
Result		
Test duration [s]:	**13.5**	
Breaking strength [N]	**4715.75**	
Test results	**POSITIVE**
