Harness Structural test Report - EN / NfL

Inspection certificate number: **PH_520.2026**

Name:	**Genie Race 6**
Size:	**M**
Serial number:	**WR3600**
Impact pad: (1)	**Yes**
Clip-in weight [kg]:	**110**
Date of test:	**30.07.2026**

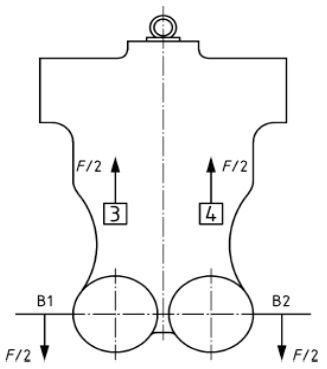
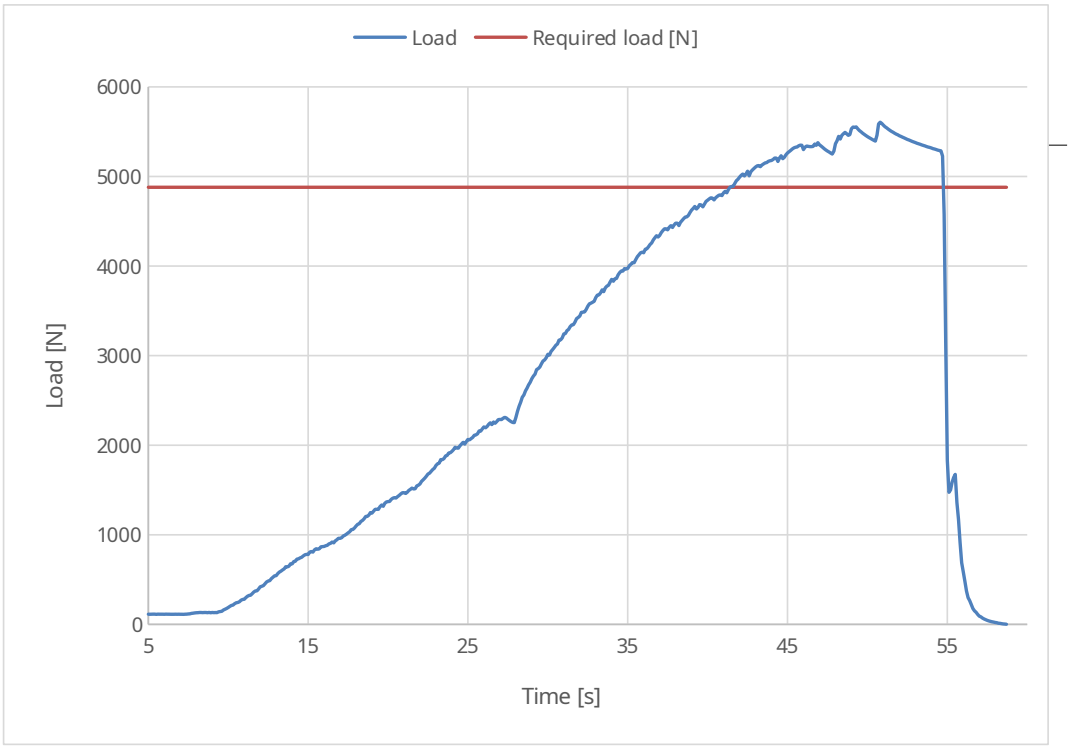
Harness Structural test **Test ID 01**

Test duration [s]	**13.4**
Any signs of structural failure	**No**
Slippery test OK	**Yes**
Test results	**POSITIVE**

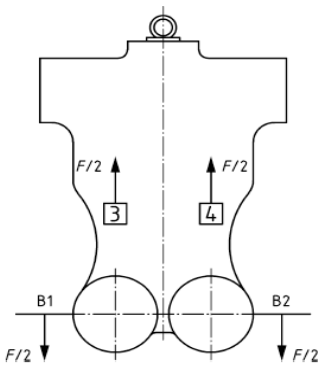
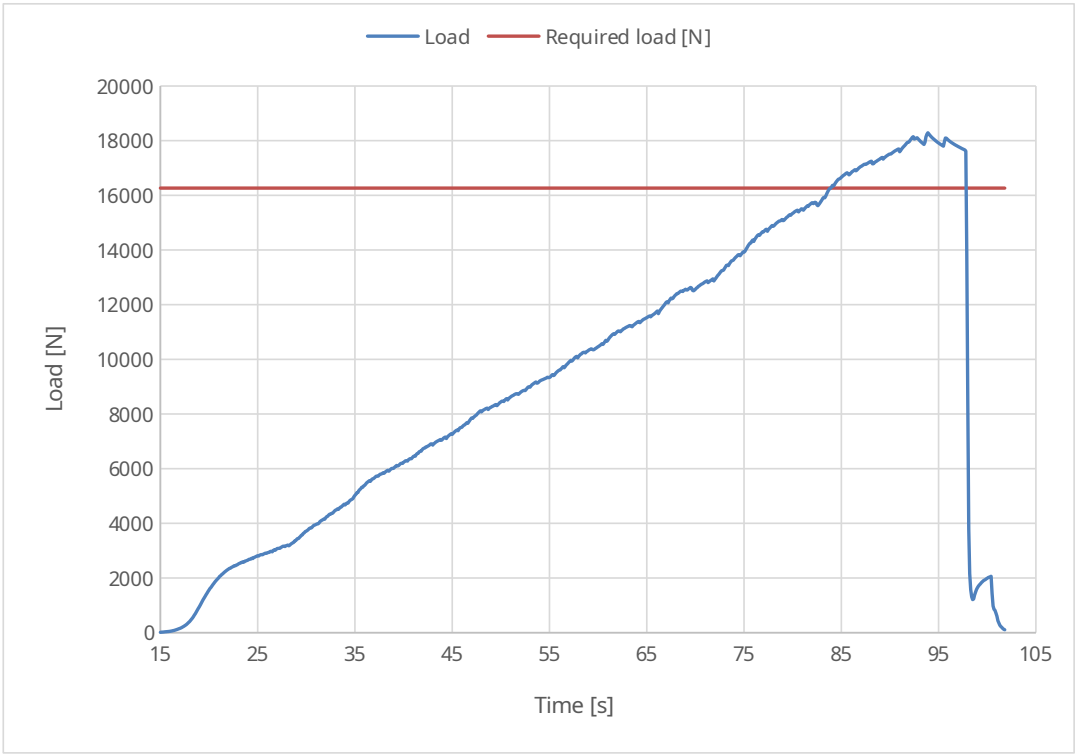
Harness Structural test **Test ID 03**

Standard	**EN 1651 / NfL 2024-2-785**
Reference in standard	**5.5.1.1b**
Test setup	**Positive symmetric load**
Attachment points	**Both main riser attachment (3,4)**
Anchor points	**Dummy (B1, B2)**
Required load [g]	**15**
Required load [N]	**16186.5**
Minimum test duration [s]	**5**
Result	
Test duration [s]	**13.9**
Any signs of structural failure	**No**
Slippery test OK	**Yes**
Test results	**POSITIVE**

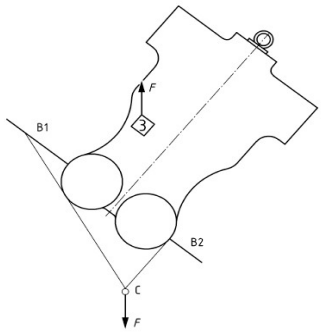
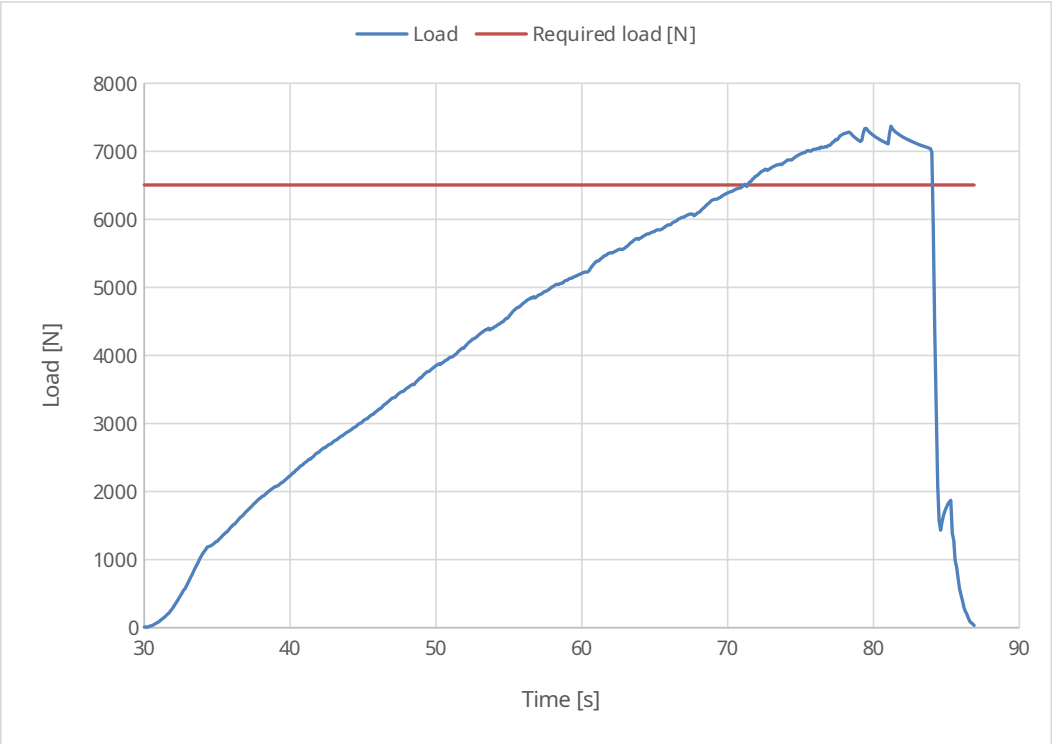
Harness Structural test **Test ID 05**

Test duration [s]	**12.7**
Any signs of structural failure	**No**
Test results	**POSITIVE**

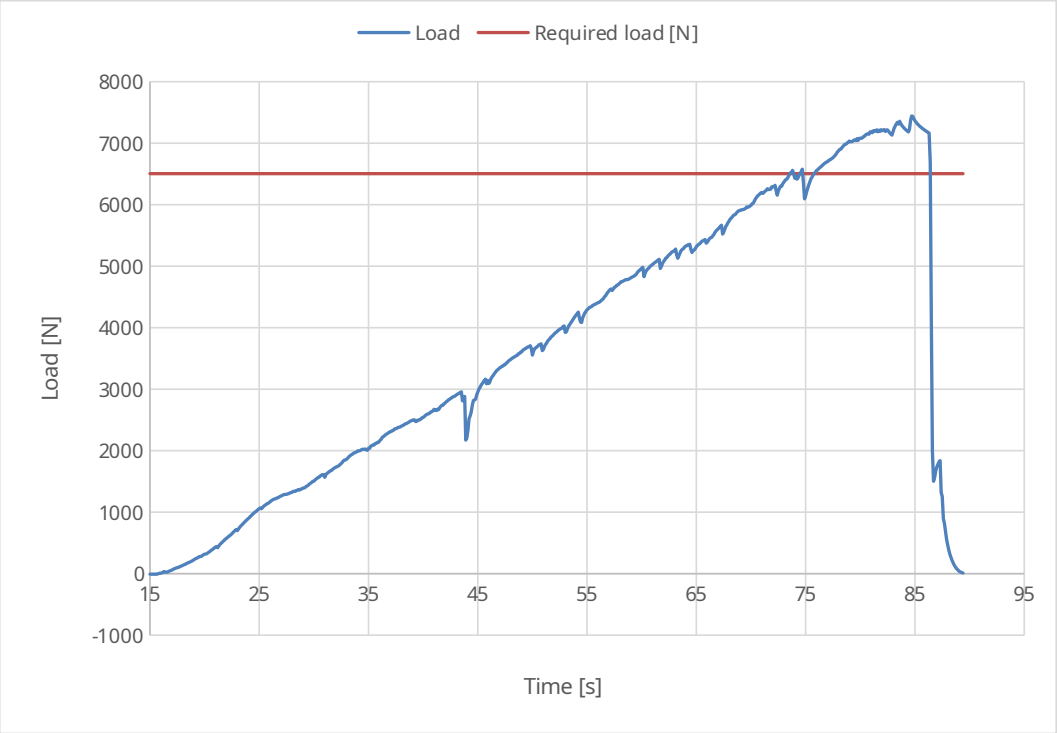
Harness Structural test **Test ID 06**

Test duration [s]	**10.7**
Any signs of structural failure	**No**
Test results	**POSITIVE**

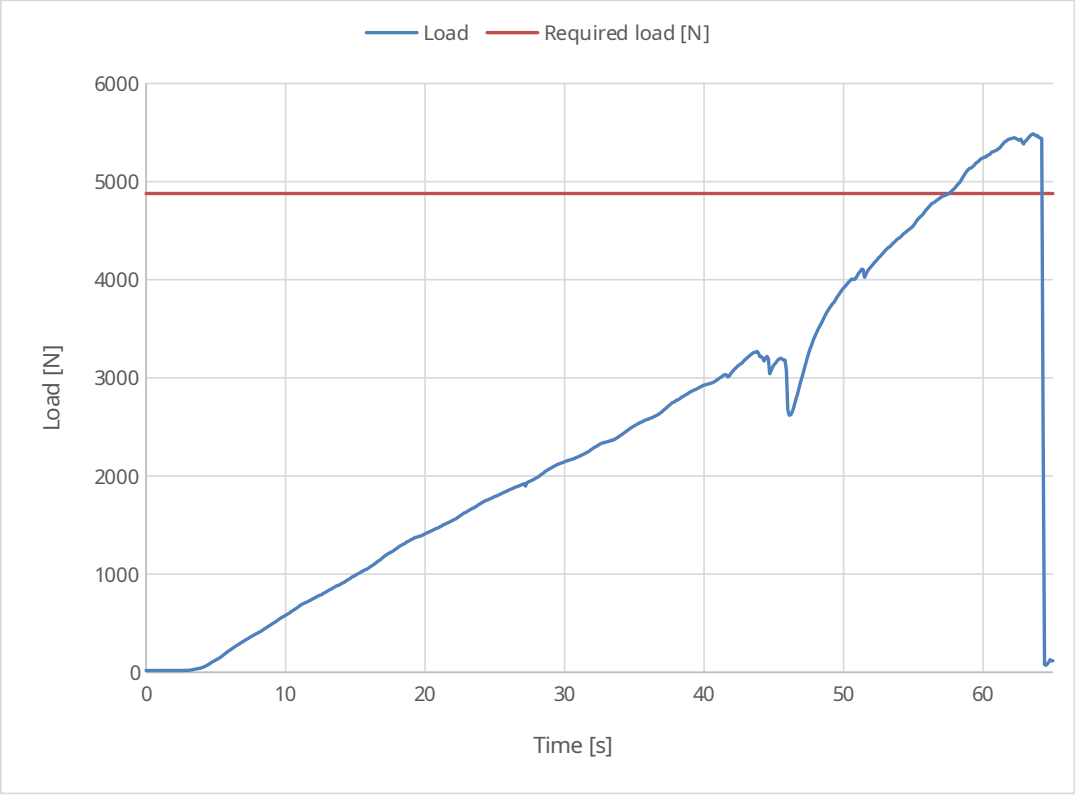
Harness Structural test **Test ID 08**

Test duration [s]	**6.7**
Any signs of structural failure	**No**
Test results	**POSITIVE**

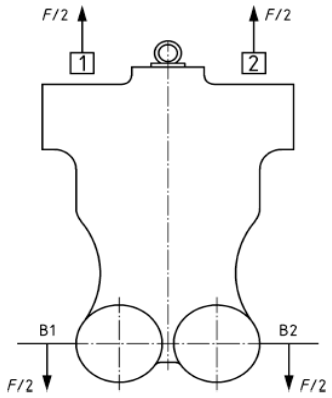
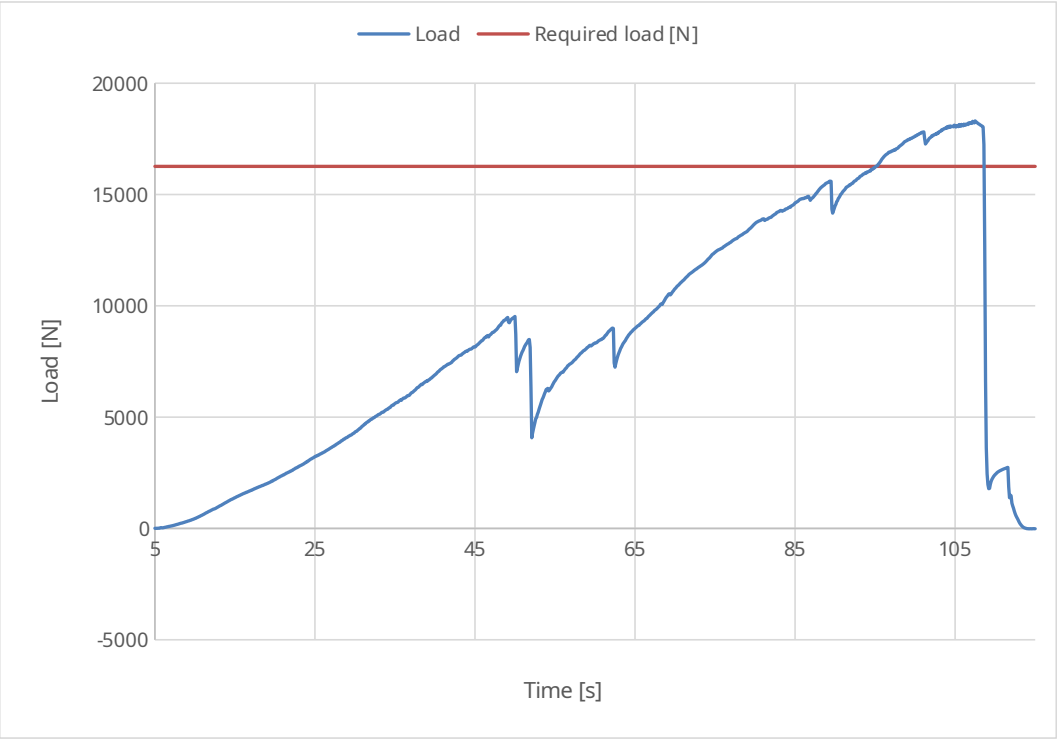
Harness Structural test **Test ID 09**

Standard	**EN 1651 / NfL 2024-2-785**
Reference in standard	**5.5.1.3**
Test setup	**Positive symmetric load rescue points**
Attachment points	**Both main riser attachment (1,2)**
Anchor points	**Dummy (B1,B2)**
Required load [g]	**15**
Required load [N]	**16186.5**
Minimum test duration [s]	**5**
Result	
Test duration [s]	**13.6**
Any signs of structural failure	**No**
Slippery test OK	**Yes**
Test results	**POSITIVE**

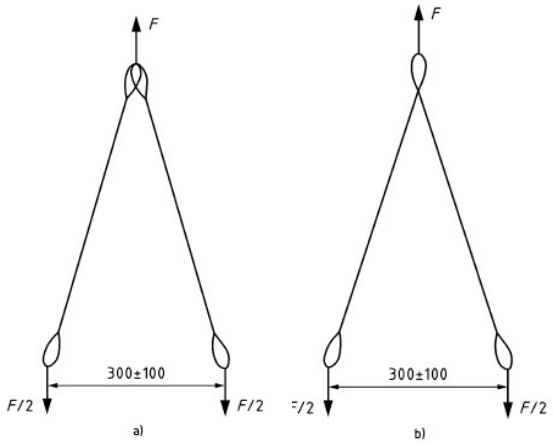
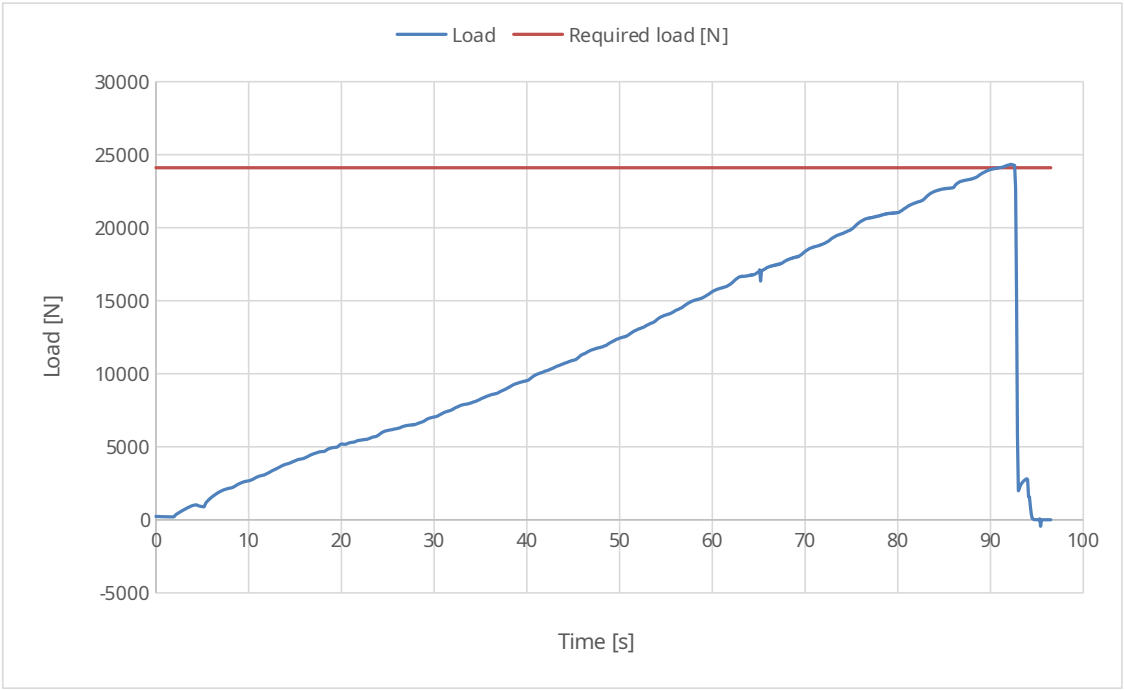
Harness Structural test **Test ID 11**

Test duration [s]	**1.7**
Any signs of structural failure	**No**
Test results	**POSITIVE**

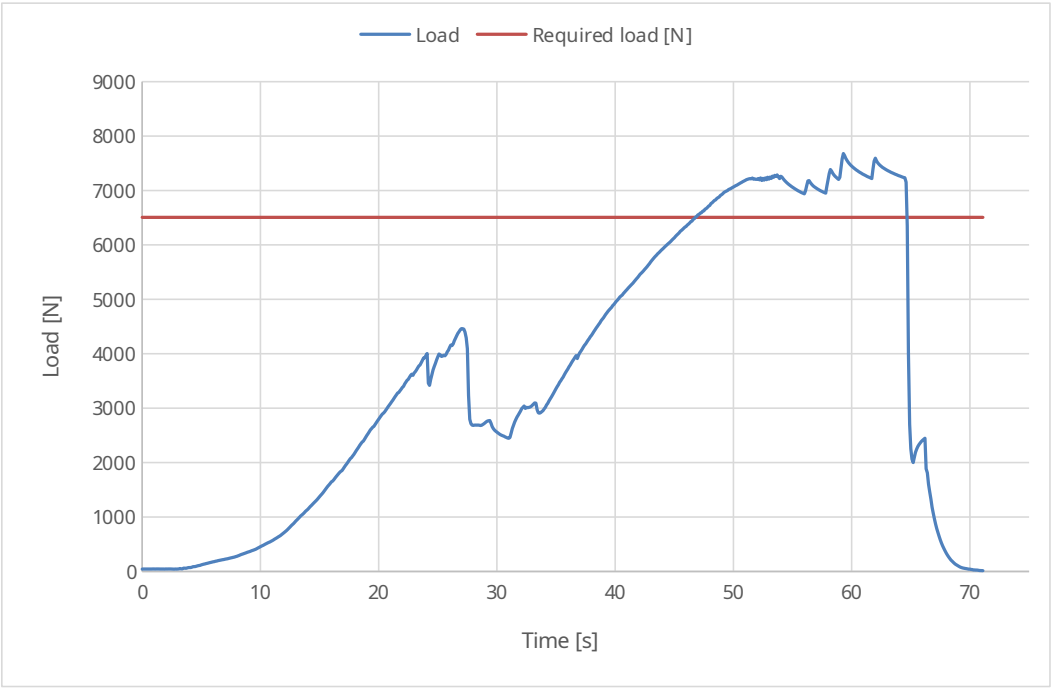
Harness Structural test **Test ID 12**

Test duration [s]	**17.9**
Any signs of structural failure	**No**
Slippery test OK	**Yes**
Test results	**POSITIVE**

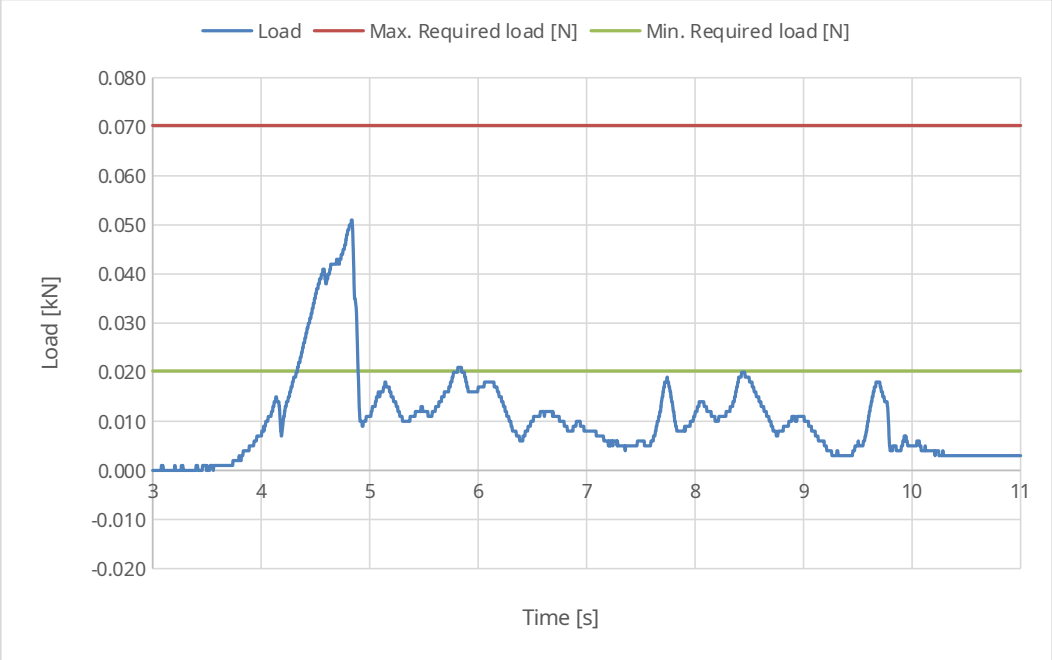
Rescue Deployment Test **Test ID RDT**

Load for first action [N]	**51.26**
Test results	**POSITIVE**

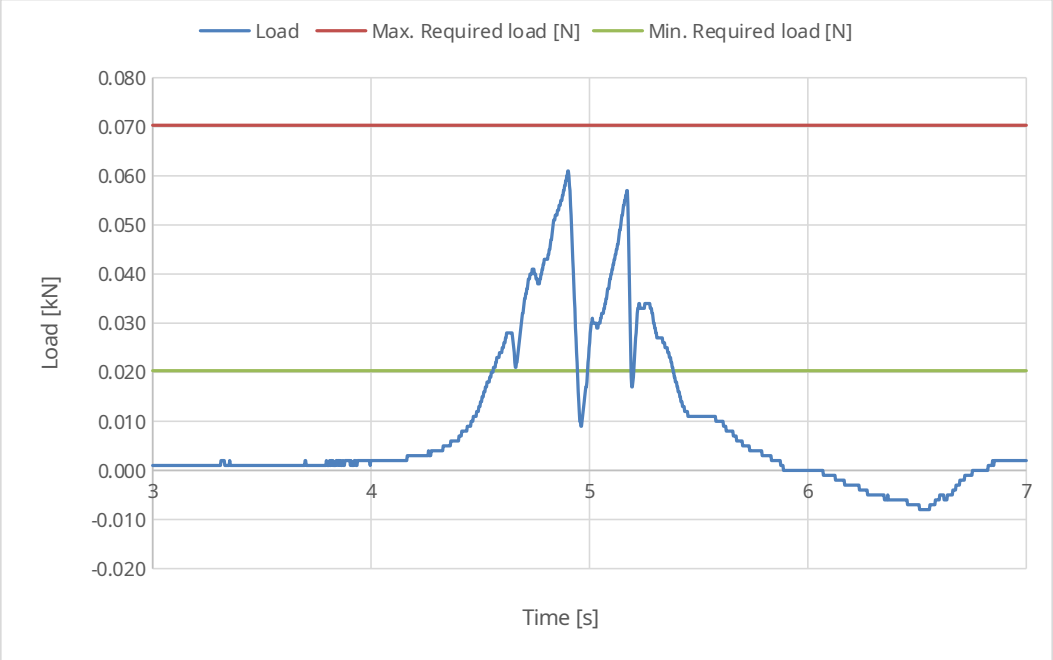
Rescue Deployment Test **Test ID RDT**

Load for first action [N]	**61.31**
Test results	**POSITIVE**

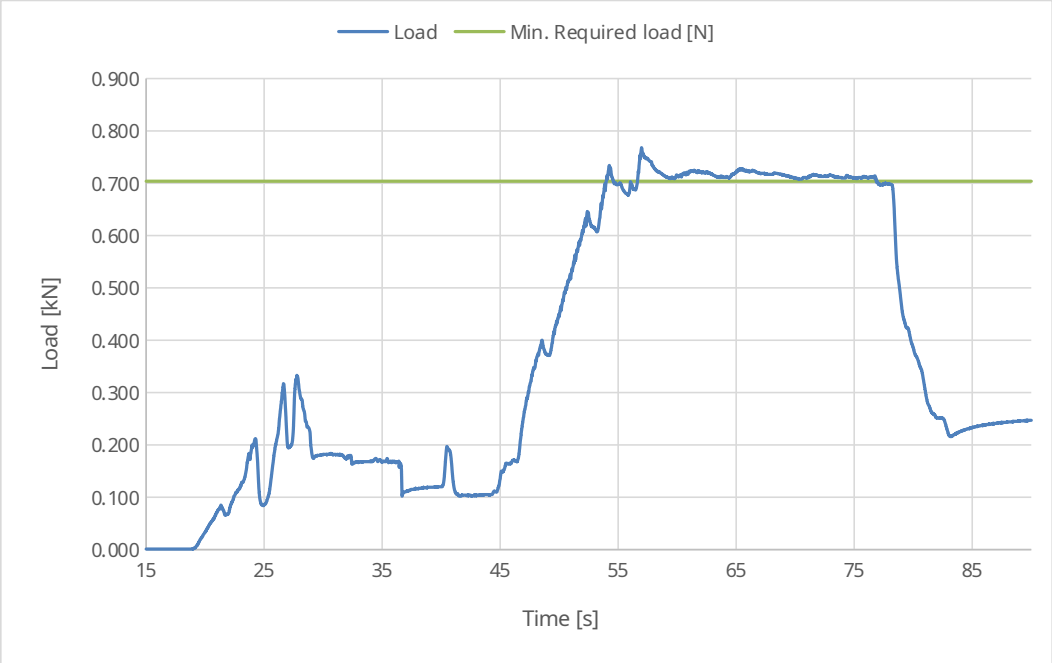
Rescue Deployment Handle strength test **Test ID RST**

Test duration [s]:	**20.2**
Breaking strength [N]	**764.05**
Test results	**POSITIVE**
