Harness Structural test Report - EN

Inspection certificate number: **PH_404.2023**

Name:	**VIBE**
Type:	**ABS**
Size:	**L**
Serial number:	**12_S**
Impact pad type: (1)	**Foam**
Clip-in weight [kg]:	**100**
Date of test:	**02.05.2023**

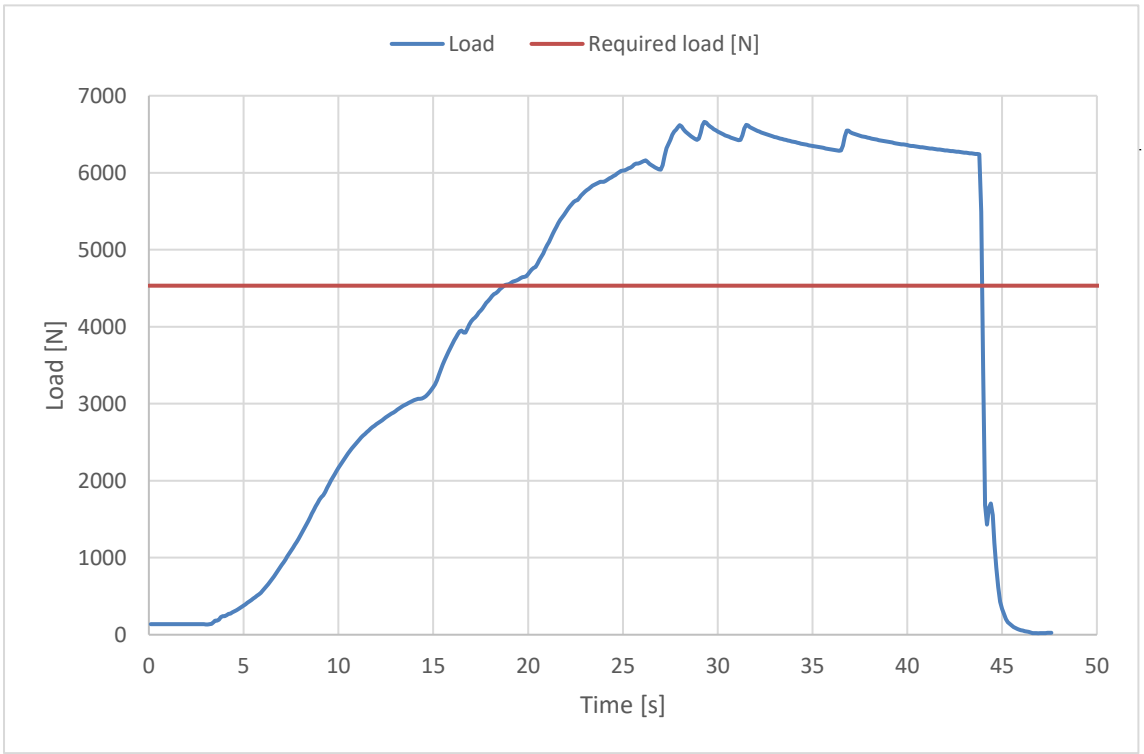
Harness Structural test **Test ID 01**

Standard	**EN 1651**
Reference in standard	**5.5.1.1**
Test setup	**Positive symmetric load (Slippage)**
Attachment points	**Both main riser attachment (3,4)**
Anchor points	**Dummy (B1, B2)**
Required load [g]	**4.5**
Required load [N]	**4500**
Minimum test duration [s]	**5**
Result	
Test duration [s]	**25.2**
Any signs of structural failure	**No**
Slippery test OK	**Yes**
Test results	**POSITIVE**

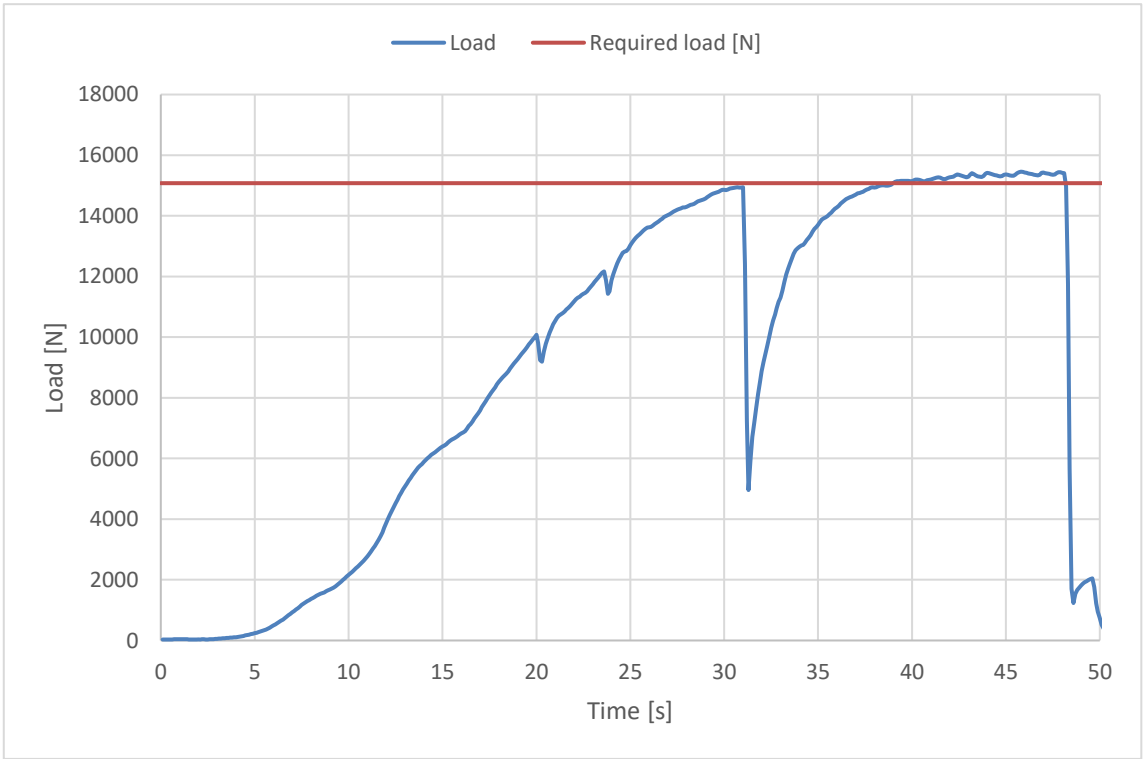
Harness Structural test **Test ID 03**

Standard	**EN 1651**
Reference in standard	**5.5.1.1b**
Test setup	**Positive symmetric load**
Attachment points	**Both main riser attachment (3,4)**
Anchor points	**Dummy (B1, B2)**
Required load [g]	**15**
Required load [N]	**15000**
Minimum test duration [s]	**5**
Result	
Test duration [s]	**9.2**
Any signs of structural failure	**No**
Slippery test OK	**Yes**
Test results	**POSITIVE**

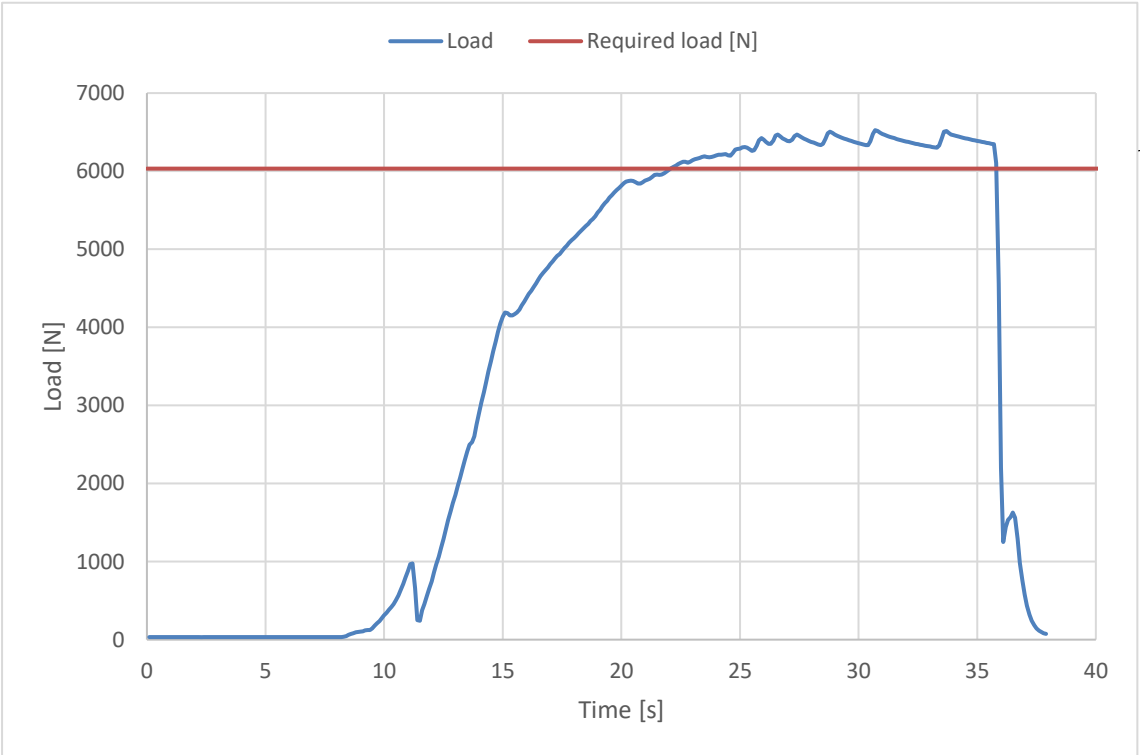
Harness Structural test **Test ID 05**

Standard	**EN 1651**
Reference in standard	**5.5.1.2**
Test setup	**Positive asymmetric load**
Attachment points	**One riser attachment (3 or 4)**
Anchor points	**Dummy (C)**
Required load [g]	**6**
Required load [N]	**6000**
Minimum test duration [s]	**5**
Result	
Test duration [s]	**13.8**
Any signs of structural failure	**No**
Test results	**POSITIVE**

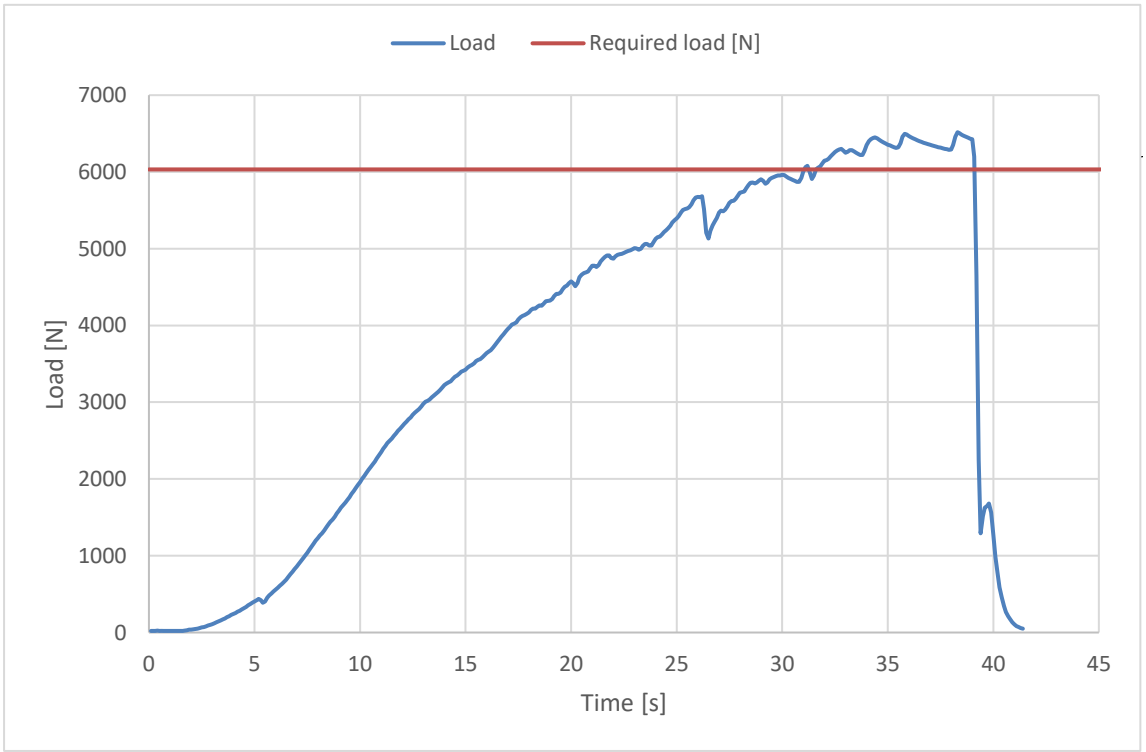
Harness Structural test **Test ID 06**

Standard	**EN 1651**
Reference in standard	**5.5.1.6**
Test setup	**Negative symmetric load**
Attachment points	**Both main riser attachment (3,4)**
Anchor points	**Dummy (A)**
Required load [g]	**6**
Required load [N]	**6000**
Minimum test duration [s]	**5**
Result	
Test duration [s]	**7.5**
Any signs of structural failure	**No**
Test results	**POSITIVE**

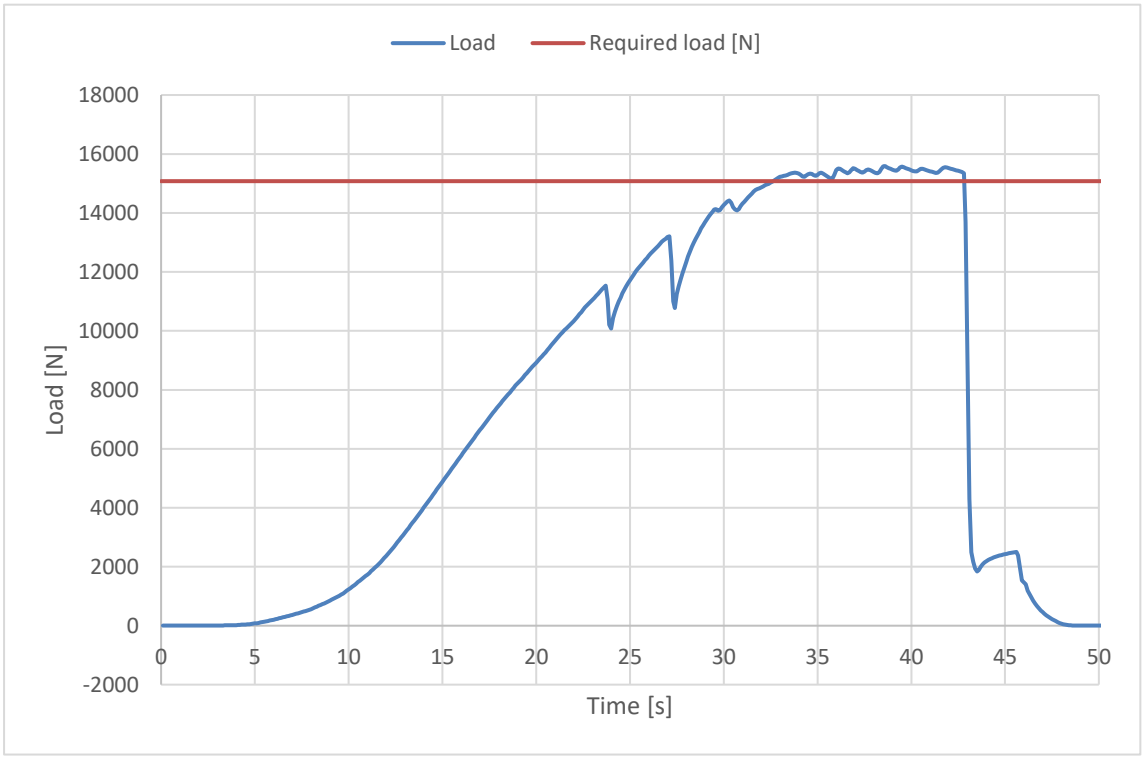
Harness Structural test **Test ID 09**

Standard	**EN 1651**
Reference in standard	**5.5.1.3**
Test setup	**Positive symmetric load rescue points**
Attachment points	**Both main riser attachment (1,2)**
Anchor points	**Dummy (B1,B2)**
Required load [g]	**15**
Required load [N]	**15000**
Minimum test duration [s]	**5**
Result	
Test duration [s]	**10.2**
Any signs of structural failure	**No**
Slippery test OK	**Yes**
Test results	**POSITIVE**

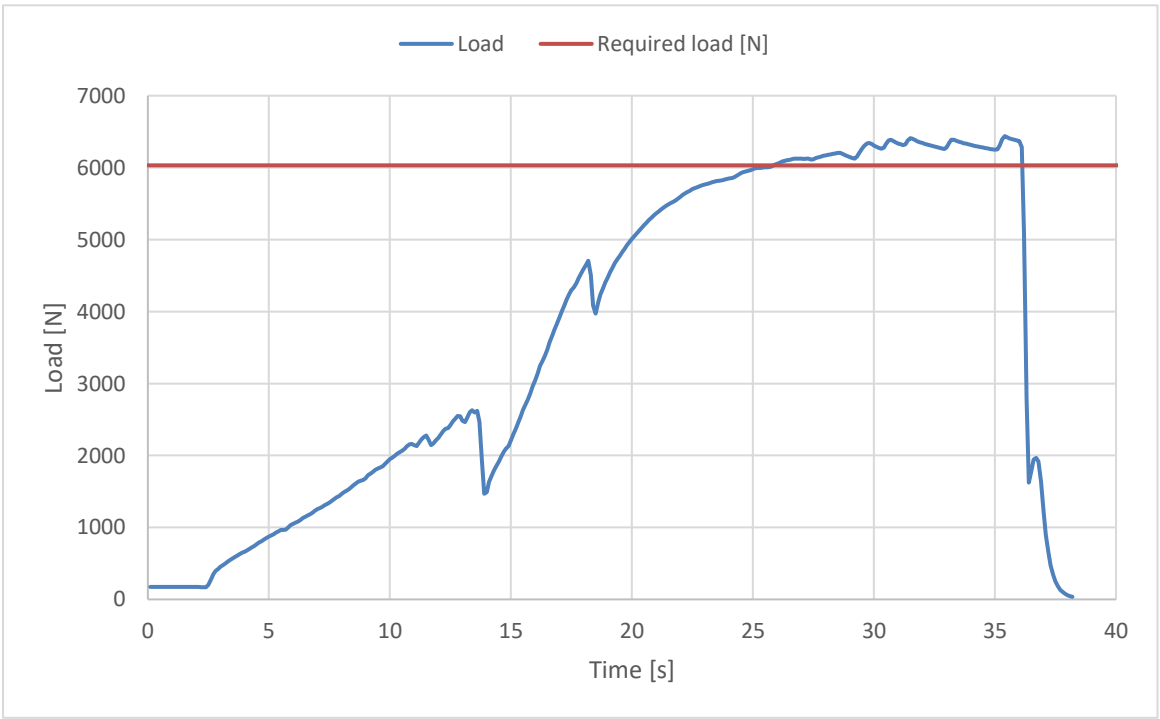
Harness Structural test **Test ID 12**

Standard	**EN 1651**
Reference in standard	**5.5.1.7**
Test setup	**Upright (landing) position load**
Attachment points	**Both main riser attachment (3, 4)**
Anchor points	**Both legstrap of harness (no dummy)**
Required load [g]	**6**
Required load [N]	**6000**
Minimum test duration [s]	**5**
Harness type	**type b**
Result	
Test duration [s]	**10.3**
Any signs of structural failure	**No**
Slippery test OK	**Yes**
Test results	**POSITIVE**

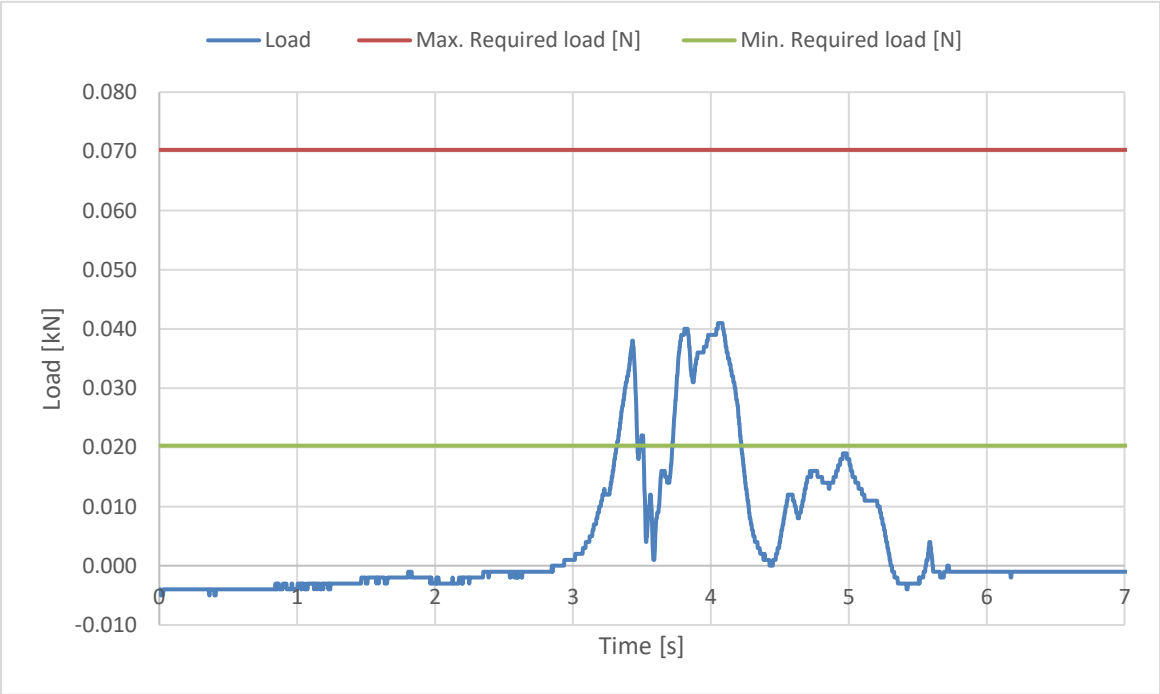
Rescue Deployment Test		**Test ID RRDT**
Standard	**EN 1651**	
Reference in standard	**5.5.1.11**	
Test setup	**Default flying position**	
Attachment points	**Sensor connect to handle, and pull in opening direction**	
	The test is to simulate the load required to open the emergency parachute(1st action).	
Min. Required load [N]	**20**	
Max. Required load [N]	**70**	
Result		
Load for first action [N]	**41.27**	
Test results	**POSITIVE**

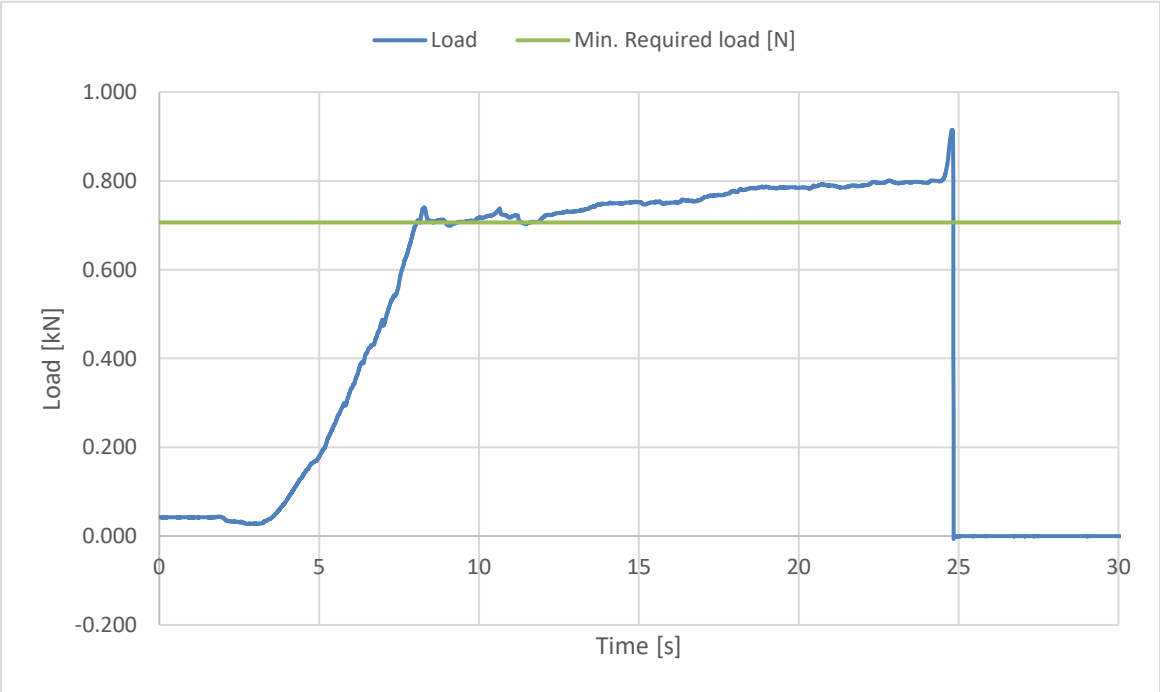
Rescue Deployment Handle strength test **Test ID RRST**

Standard	**EN 12491**
Reference in standard	**5.3.2**
Test setup	**Two end points of handle**
Attachment points	**Sensor connect to end of handle, pull on the other side**
	The handle must support min 700 N for 10 s, after measure breaking strength
Min. Required load [N]	**700**
Minimum test duration [s]	**10**

Test duration [s]:	**13.2**
Breaking strength [N]	**908.92**
Test results	**POSITIVE**
