PH PARAGLIDER HARNESSSES

INSPECTION CERTIFICATE

Inspection certificate number: **PH 110.2014**

HARNES STRUCTURAL STRENGHT TEST

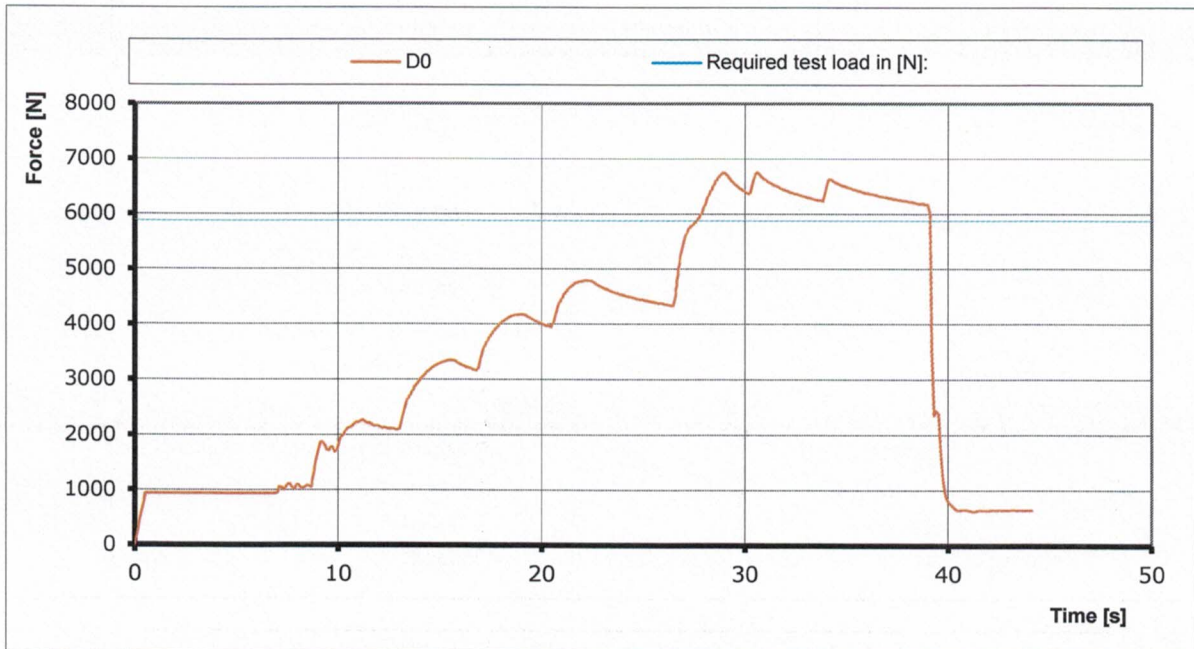
Test standard §: **5.3.2.1**
 Test setup: **Default flying position**

Anchoring: Attachment points: **Both main riser attachments (3, 4)**
 Dummy: **Default, hip fixed (7, 8)**
 Required load in force [g] : **6**
 Model max load [kg]: **100**
 Required test load in [N]: **5886**
 Min. duration test load [s]: **10**

Duration of maintained min. load [s]: **11.42** [C°] **24.6**
 Any signs of structural failure after this test: **no failure** RH [%] **66**
 Test result: **POSITIVE** [hPa] **1016.9**
 Graph: **D0**

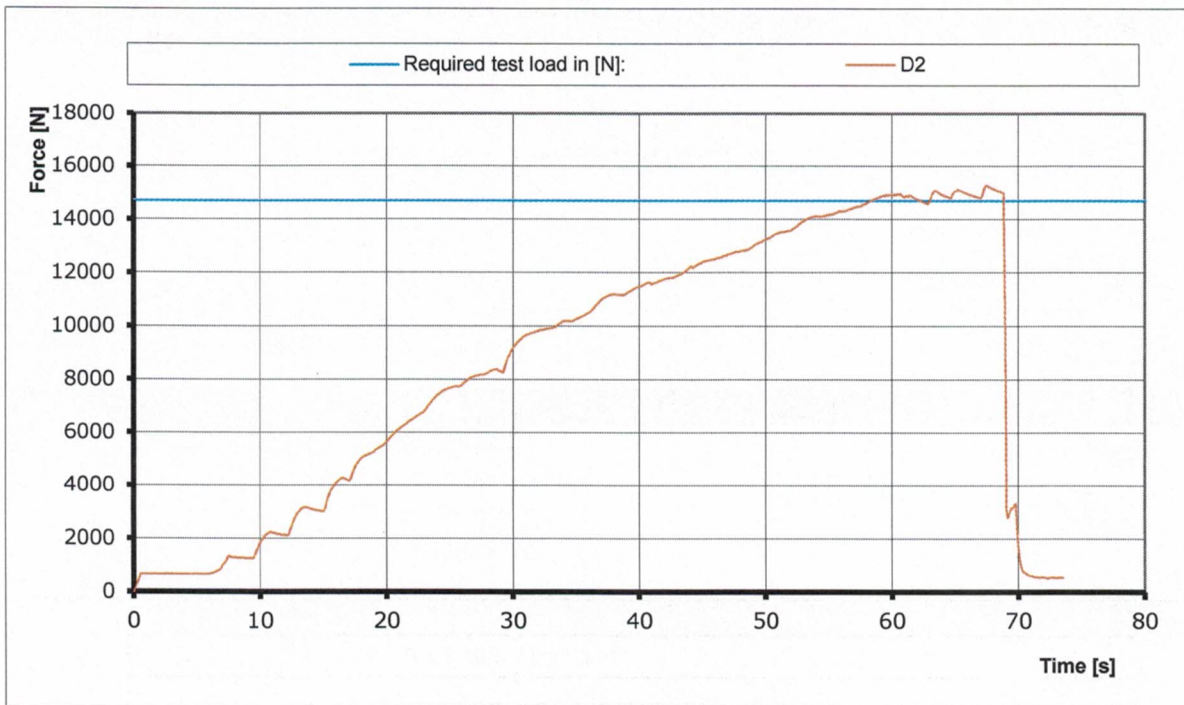
Test standard §: **5.3.2.2**
 Test setup: **Default flying position**

Anchoring: Attachment points: **Both main riser attachments (3, 4)**

Required load in force [g] : **15**
 Model max load [kg]: **100**
 Required test load in [N]: **14715**
 Min. duration [s]: **5**

Duration of maintained min. load [s]: **5.78** [C°] **24.6**
 Any signs of structural failure after this test: **no failure** RH [%] **66**
 Test result: **POSITIVE** [hPa] **1016.9**
 Graph: **D2**

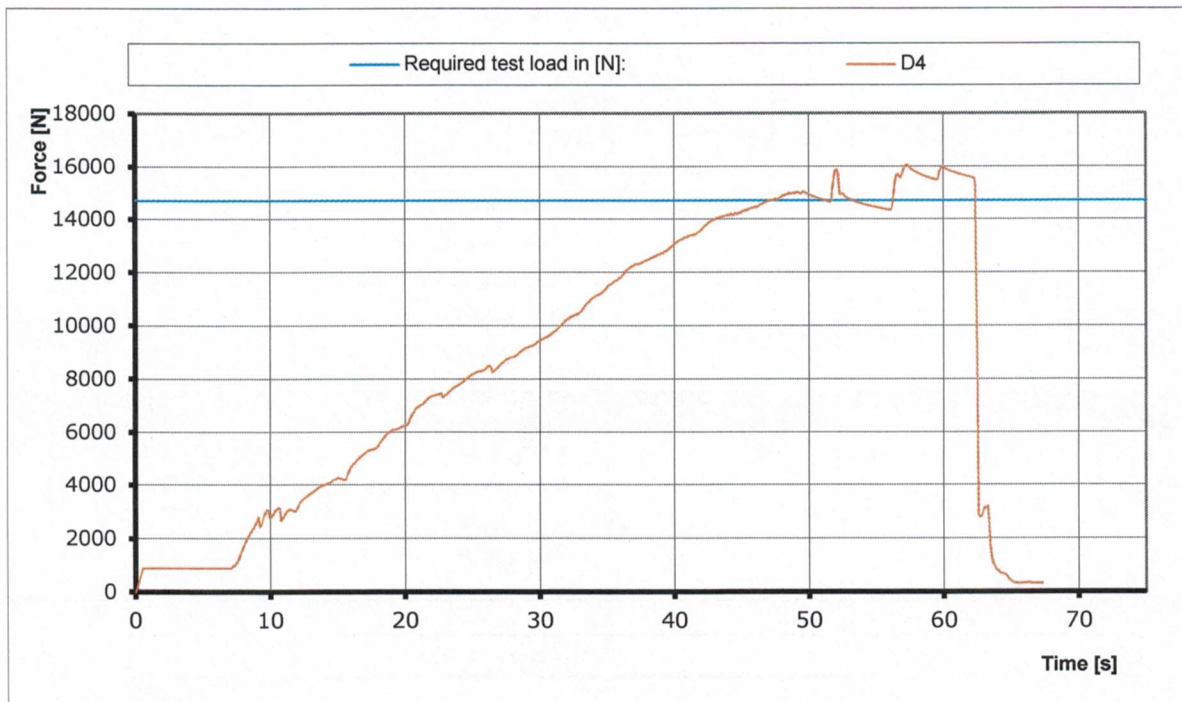
Test standard §: **EN 5.3.2.7**

Flying position before landing: **seat board (11) in landing position, leg straps (10) closed.**

Attachment points: **Both of the main riser attachments attached (3 and 4);**

Required test load in [N]: **14715**

Duration of maintained min. load [s]: **6.11** [C°] **24.6**
 Any signs of structural failure after this test: **no failure** RH [%] **66**
 Test result: **POSITIVE** [hPa] **1016.9**
 Graph: **D4**

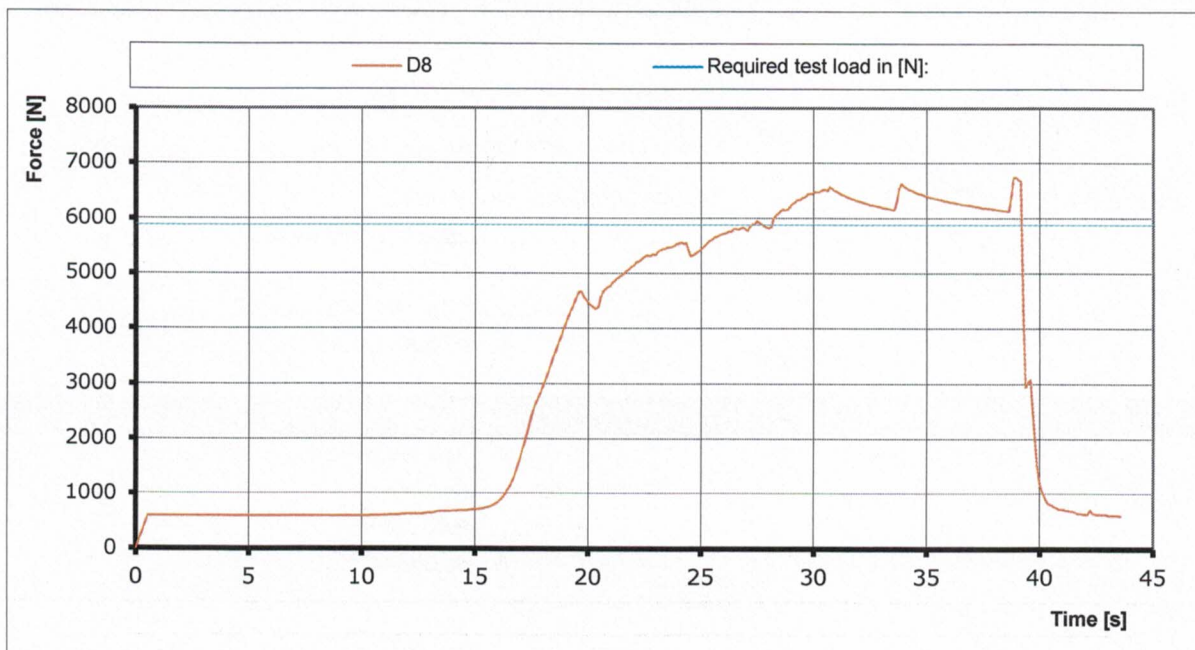
Graph: **D8**

Test standard §: **5.3.2.3**

Test setup: **Only one riser attached**

Attachment points: **One main riser attachments (3)**

Required test load in [N]: **5886**

Duration of maintained min. load [s]: **11.02**

Any signs of structural failure after this test: **no failure**

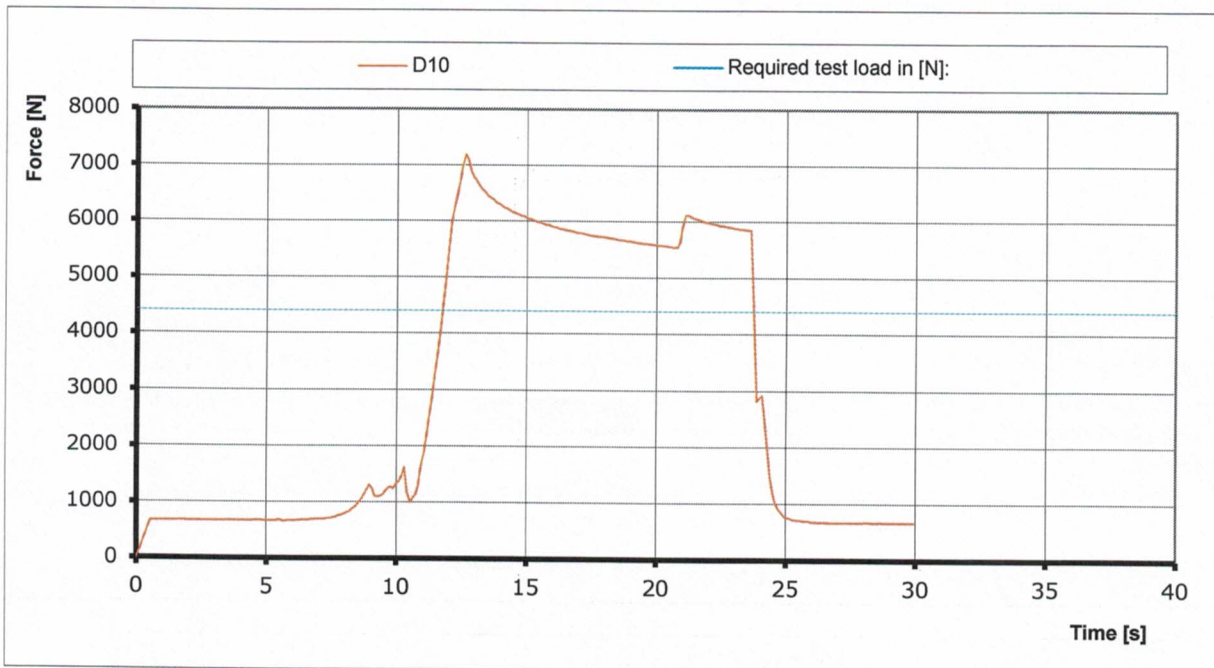
Test standard §: **5.3.2.6**

Test setup: **Normal flying position in NEGATIF**

Attachment points: **ONE of the main riser attachments attached downwards(3 or 4);**
 Dummy: **Dummy anchored at the head position (9)**
 Required load in force [g]: **4.5**
 Model max load [kg]: **100**
 Required test load in [N]: **4415**
 Min. duration [s]: **10**

Duration of maintained min. load [s]: **11.97** [C°] **24.6**
 Any signs of structural failure after this test: **no failure** RH [%] **66**
 Test result: **POSITIVE** [hPa] **1016.9**
 Graph: **D10**
