PH PARAGLIDER HARNESSSES

INSPECTION CERTIFICATE

Inspection certificate number: **PH_172.2016**

Name: **Zoom** Size: **M**
 Type: **ABS** Pilot max load [kg]: **100**
 Impact pad type: **n/a** Weight [kg]: **2.4**
 Serial number: **10424** Reception date: **29.06.2016**
 Volume reserve parachute container [cm3] Max: **n/a**
 Min: **n/a**

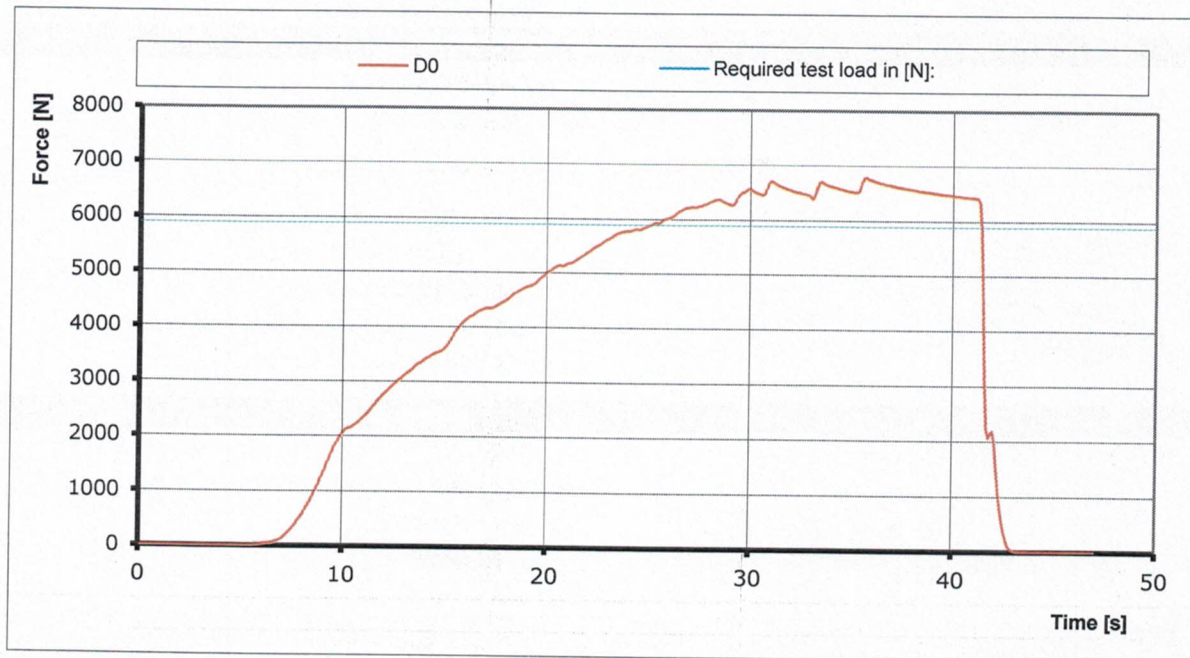
Test standard §: **5.3.2.1**
 Test setup: **Default flying position**

Attachment points: **Both main riser attachments (3, 4)**

Dummy: **Default, hip fixed (7, 8)**

Required load in force [g] : **6**
 Model max load [kg]: **100**
 Required test load in [N]: **5886**
 Min. duration test load [s]: **10**

Duration of maintained min. load [s]: **16.12** [C°] **25.4**
 Any signs of structural failure after this test: **no failure** RH [%] **55**
 Test result: **POSITIVE** [hPa] **1017.7**
 Graph: **D0**

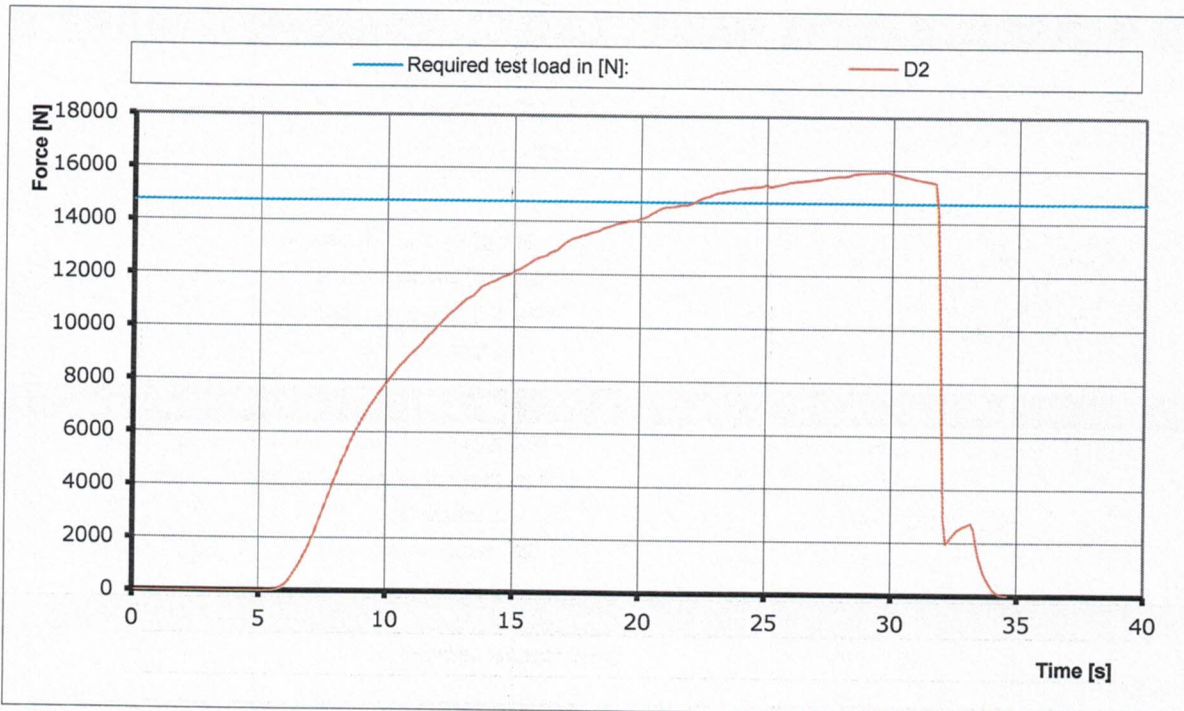
Test standard §: **5.3.2.2**

Test setup: **Default flying position**

Attachment points: **Both main riser attachments (3, 4)**

Required test load in [N]: **14715**

Duration of maintained min. load [s]: **9.51** [C°] **25.4**
 Any signs of structural failure after this test: **no failure** RH [%] **55**
 Test result: **POSITIVE** [hPa] **1017.7**
 Graph: **D2**

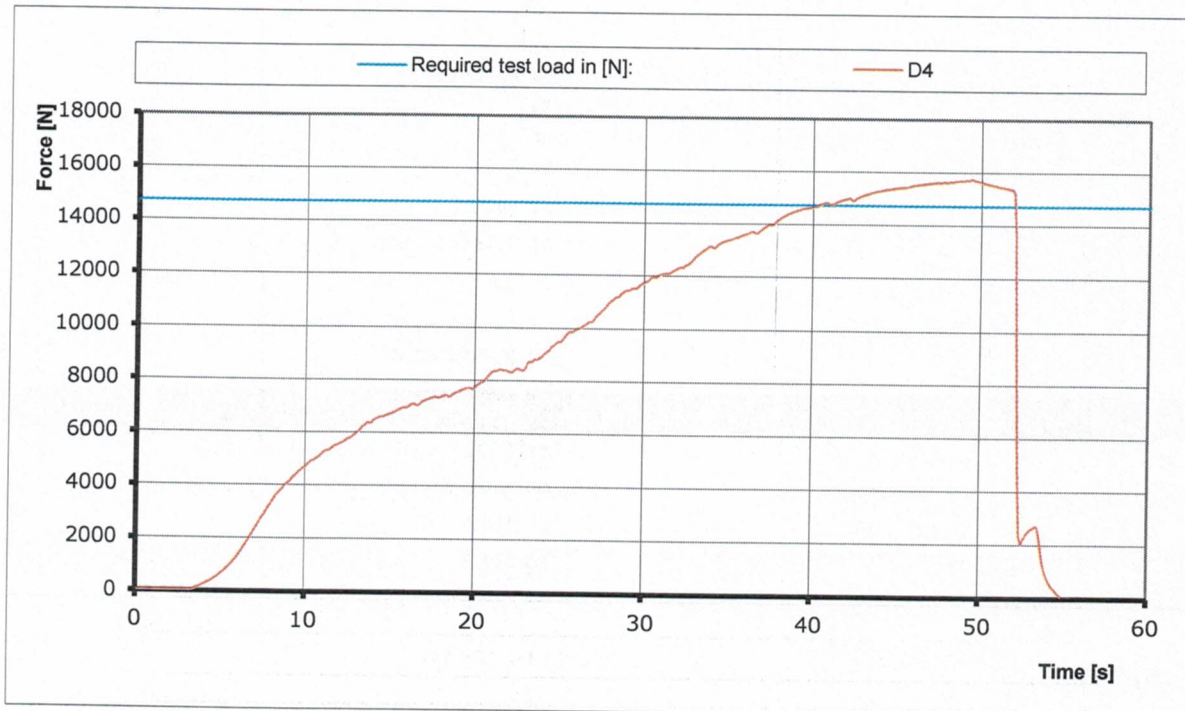
Test standard §: **EN 5.3.2.7**

Flying position before landing: **seat**
 Test setup: **board (11) in landing position, leg straps (10) closed.**
 Attachment points: **Both of the main riser attachments attached (3 and 4);**
 Dummy: **Default, hip fixed (7, 8)**

Required load in force [g] : **15**
 Model max load [kg]: **100**
 Required test load in [N]: **14715**
 Min. duration [s]: **5**

Duration of maintained min. load [s]: **11.35** [C°] **25.4**
 Any signs of structural failure after this test: **no failure** RH [%] **55**
 Test result: **POSITIVE** [hPa] **1017.7**
 Graph: **D4**

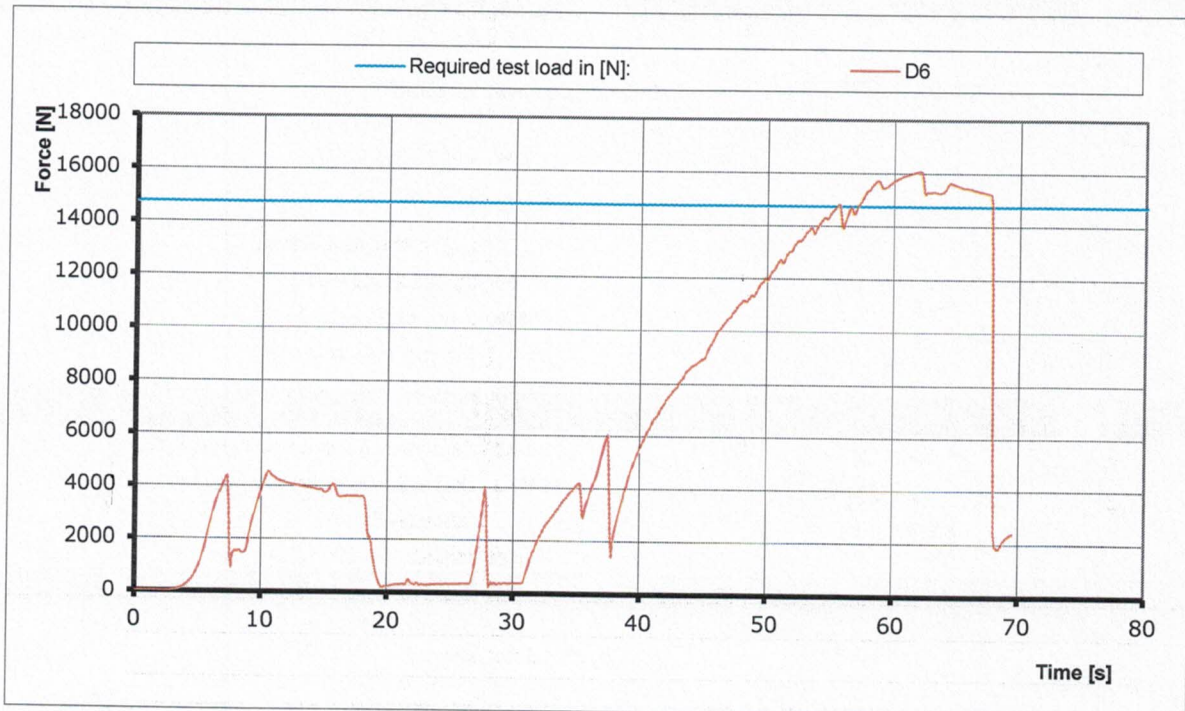
Test standard §: **5.3.2.4**

Test setup: **Rescue attachments**

Attachment points: **Rescue riser attachments (1,2)**

Required load in force [g] : **15**
 Model max load [kg]: **100**
 Required test load in [N]: **14715**
 Min. duration [s]: **5**

Duration of maintained min. load [s]: **10.61** [C°] **25.4**
 Any signs of structural failure after this test: **no failure** RH [%] **55**
 Test result: **POSITIVE** [hPa] **1017.7**
 Graph: **D6**

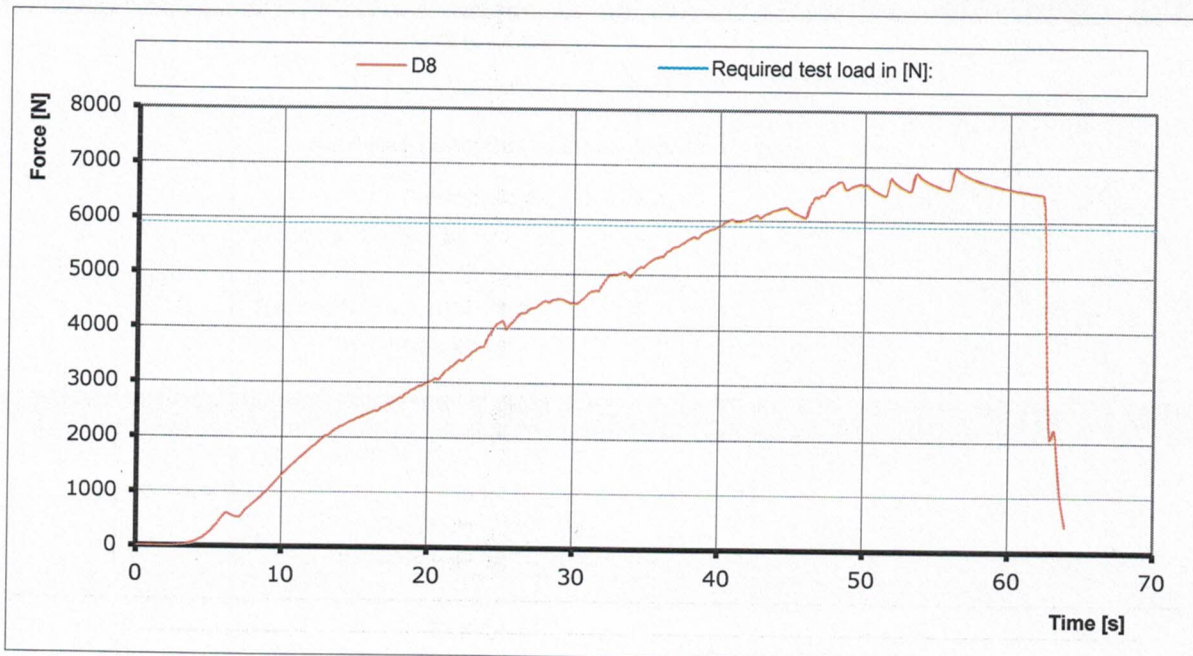
Test standard §: **5.3.2.3**

Test setup: **Only one riser attached**

Attachment points: **One main riser attachments (3)**

Required load in force [g] : **6**
 Model max load [kg]: **100**
 Required test load in [N]: **5886**
 Min. duration [s]: **10**

Duration of maintained min. load [s]: **22.23** [C°] **25.4**
 Any signs of structural failure after this test: **no failure** RH [%] **55**
 Test result: **POSITIVE** [hPa] **1017.7**
 Graph: **D8**

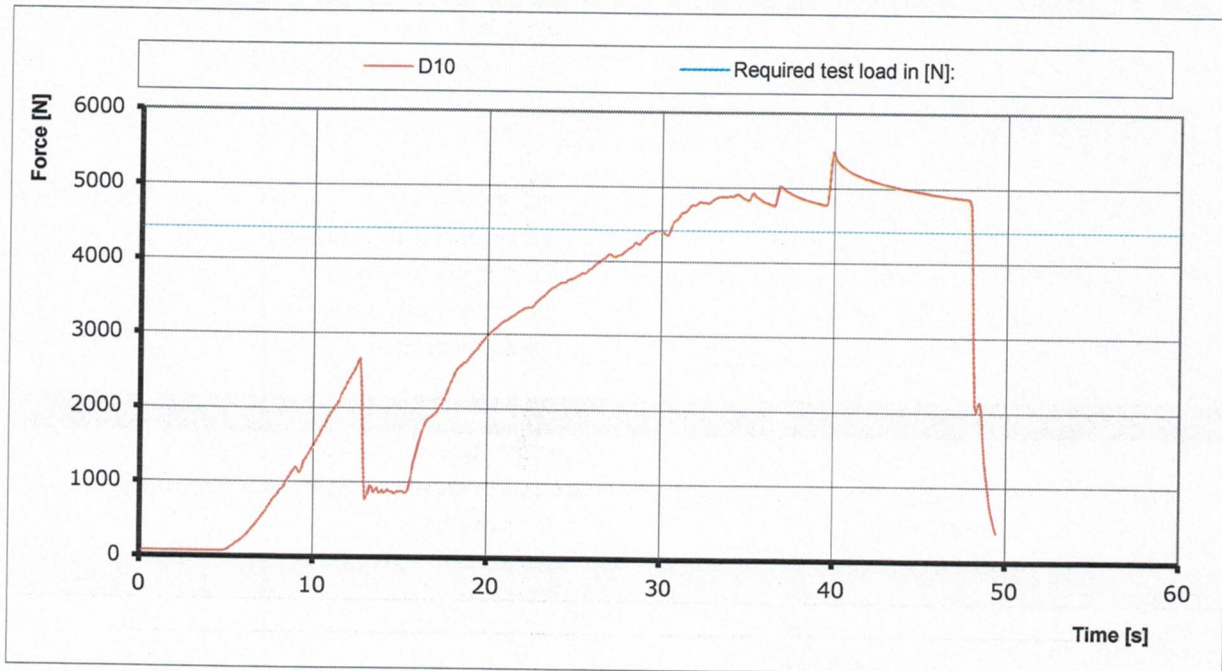
Test standard §: **5.3.2.6**

Test setup: **Normal flying position in NEGATIF**

Attachment points: **ONE of the main riser attachments attached downwards(3 or 4);**

Dummy: **Dummy anchored at the head position (9)**

Required test load in [N]: **4415**

Duration of maintained min. load [s]: **17.40** [C°] **25.4**
 Any signs of structural failure after this test: **no failure** RH [%] **55**
 Test result: **POSITIVE** [hPa] **1017.7**
 Graph: **D10**
