## Harness Structural test Report - NfL

Inspection certificate number: **PH\_438.2024**

Name: **VisstaXC**  
 Type: **ABS**  
 Size: **L**  
 Serial number: **BFLOWLV351**  
 Impact pad type: <sup>(1)</sup> **Foam**  
 Clip-in weight [kg]: **120**  
 Integrated container: **Yes**  
 Date of test: **04.01.2024**

**NfL 2-565-20, EN12491:2015 and EN1651:1999**

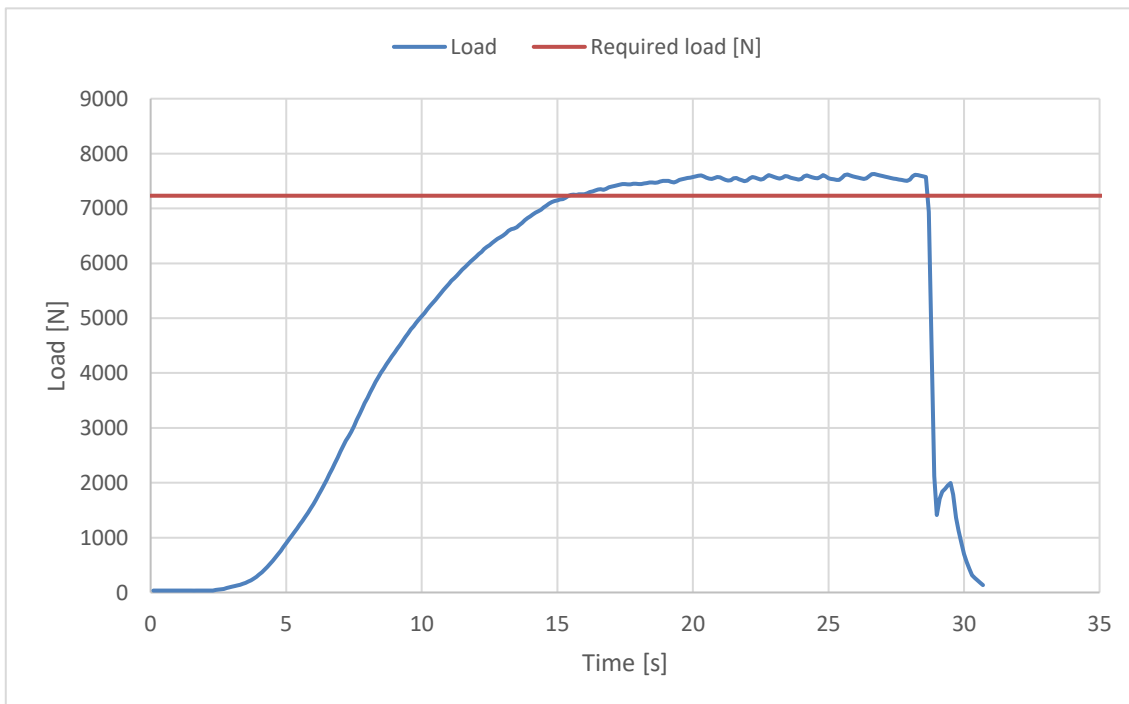
**Test ID 02**

Standard	<b>EN 1651:1999</b>
Reference	<b>5.3.2.1</b>
Test setup	<b>Default flying position</b>
Attachment points	<b>Both main riser attachment (3,4)</b>
Anchor points	<b>Dummy (B1, B2)</b>
Required load [g]	<b>6</b>
Required load [N]	<b>7200</b>
Minimum test duration [s]	<b>10</b>
<b>Result</b>	
Test duration [s]	<b>13.2</b>
Any signs of structural failure	<b>No</b>
Test results	<b>POSITIVE</b>

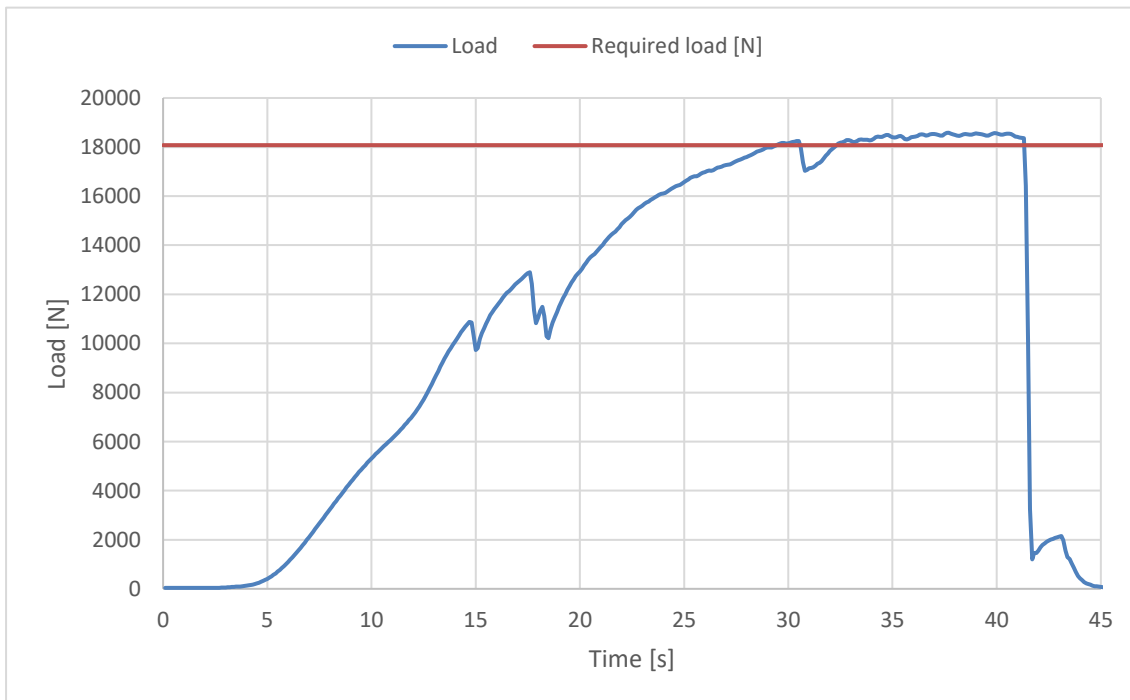
**Test ID 03**

Standard **EN 1651:1999**  
 Reference **5.3.2.2**  
 Test setup **Default flying position**  
 Attachment points **Both main riser attachment (3,4)**  
 Anchor points **Dummy (B1, B2)**

Required load [g] **15**  
 Required load [N] **18000**  
 Minimum test duration [s] **5**

Test duration [s] **9**  
 Any signs of structural failure **No**  
 Test results **POSITIVE**

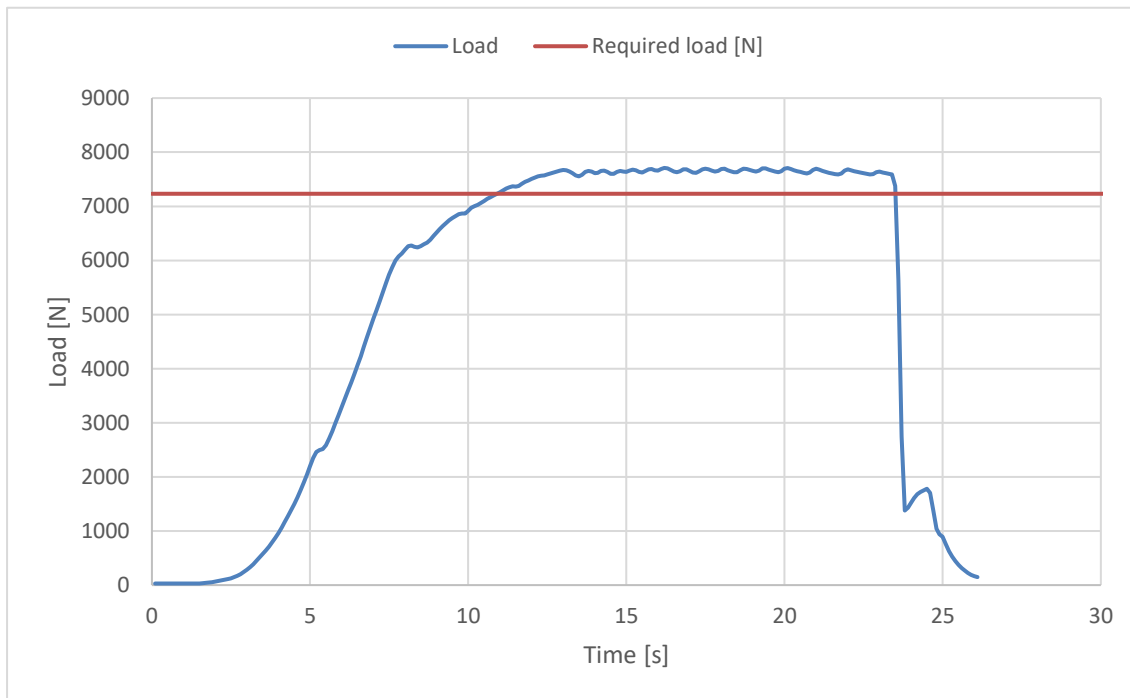
**Test ID 04**

Standard	<b>EN 1651:1999</b>
Reference	<b>5.3.2.3</b>
Test setup	<b>Asymmetric, one riser</b>
Attachment points	<b>One main riser attachment (3)</b>
Anchor points	<b>Dummy (B1,B2)</b>
Required load [g]	<b>6</b>
Required load [N]	<b>7200</b>
Minimum test duration [s]	<b>10</b>
<b>Result</b>	
Test duration [s]	<b>12.6</b>
Any signs of structural failure	<b>No</b>
Test results	<b>POSITIVE</b>

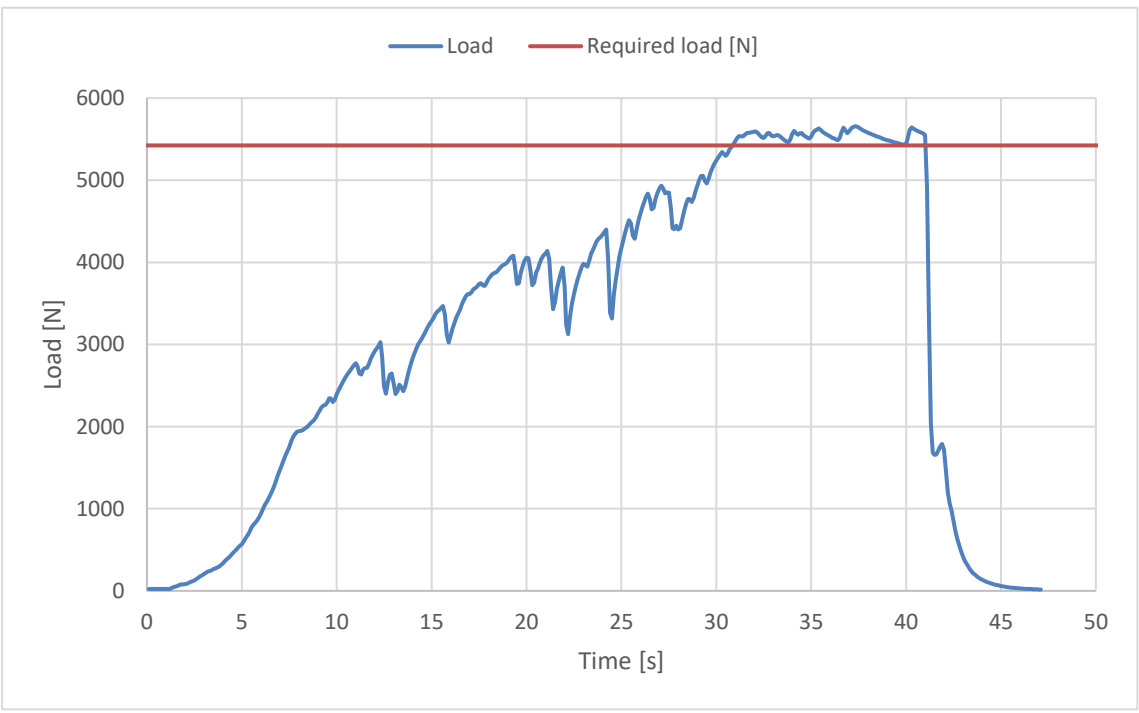
**Test ID 07**

Reference	<b>5.3.2.6</b>	
Test setup	<b>Asymmetric, negative</b>	
Attachment points	<b>One main riser attachment (3 or 4) downwards</b>	
Anchor points	<b>Dummy (9)</b>	
Required load [g]	<b>4.5</b>	
Required load [N]	<b>5400</b>	
Minimum test duration [s]	<b>10</b>	
<b>Result</b>		
Test duration [s]	<b>10.2</b>	
Any signs of structural failure	<b>No</b>	
Test results	<b>POSITIVE</b>

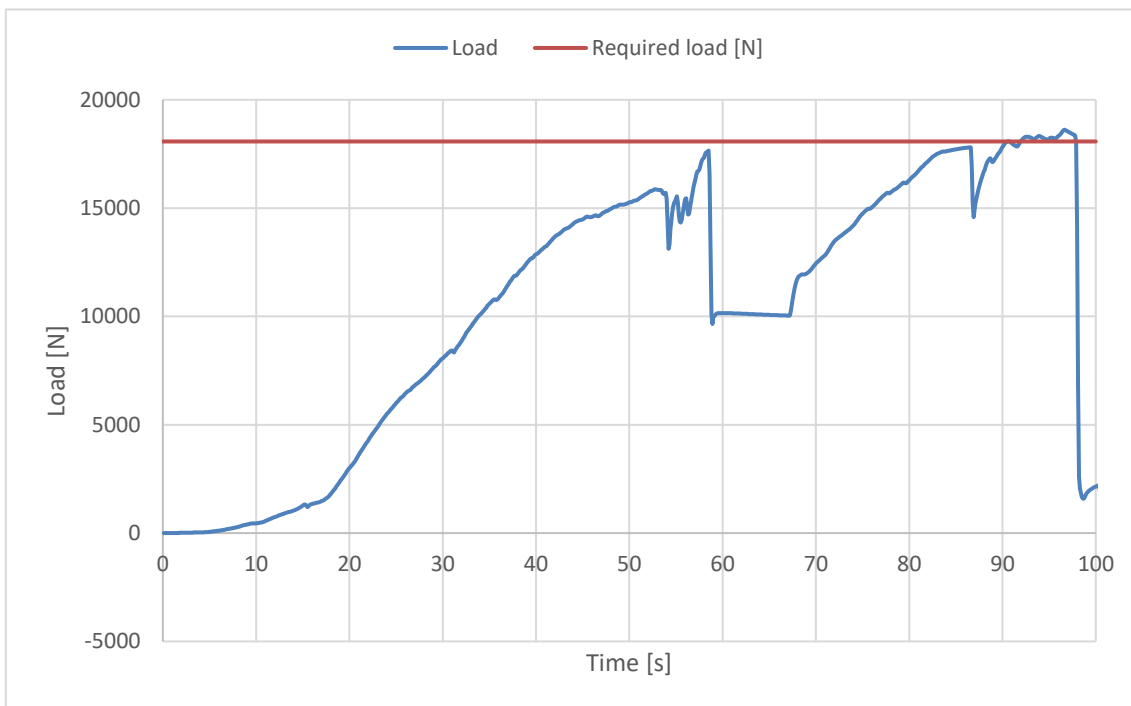
**Test ID 09**

Standard	<b>EN 1651:1999</b>
Reference	<b>5.3.2.4</b>
Test setup	<b>Rescue attachments</b>
Attachment points	<b>Rescue riser attachment (1,2)</b>
Anchor points	<b>Dummy (B1,B2)</b>
Required load [g]	<b>15</b>
Required load [N]	<b>18000</b>
Minimum test duration [s]	<b>5</b>
<b>Result</b>	
Test duration [s]	<b>5.9</b>
Any signs of structural failure	<b>No</b>
Test results	<b>POSITIVE</b>

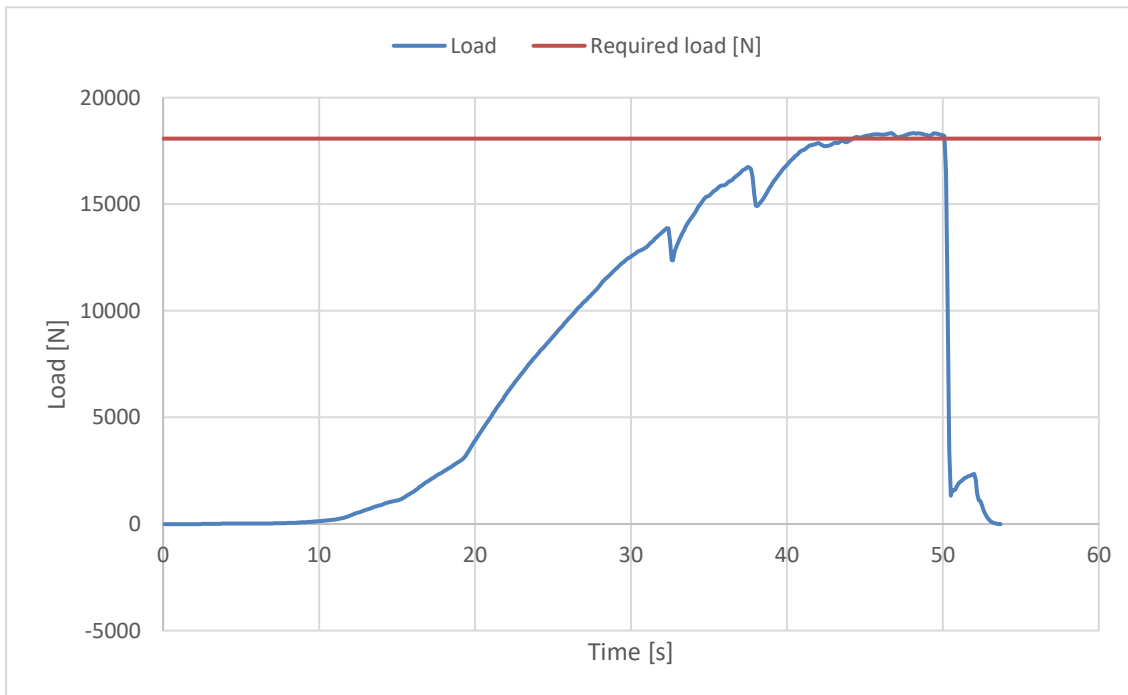
**Test ID 13**

Standard	<b>EN 1651:1999</b>
Reference	<b>5.3.2.7</b>
Test setup	<b>Flying position before landing</b>
Attachment points	<b>Both main riser attachment (3,4)</b>
Anchor points	<b>Dummy (7,8)</b>
Required load [g]	<b>15</b>
Required load [N]	<b>18000</b>
Minimum test duration [s]	<b>5</b>
<b>Result</b>	
Test duration [s]	<b>5.9</b>
Any signs of structural failure	<b>No</b>
Test results	<b>POSITIVE</b>

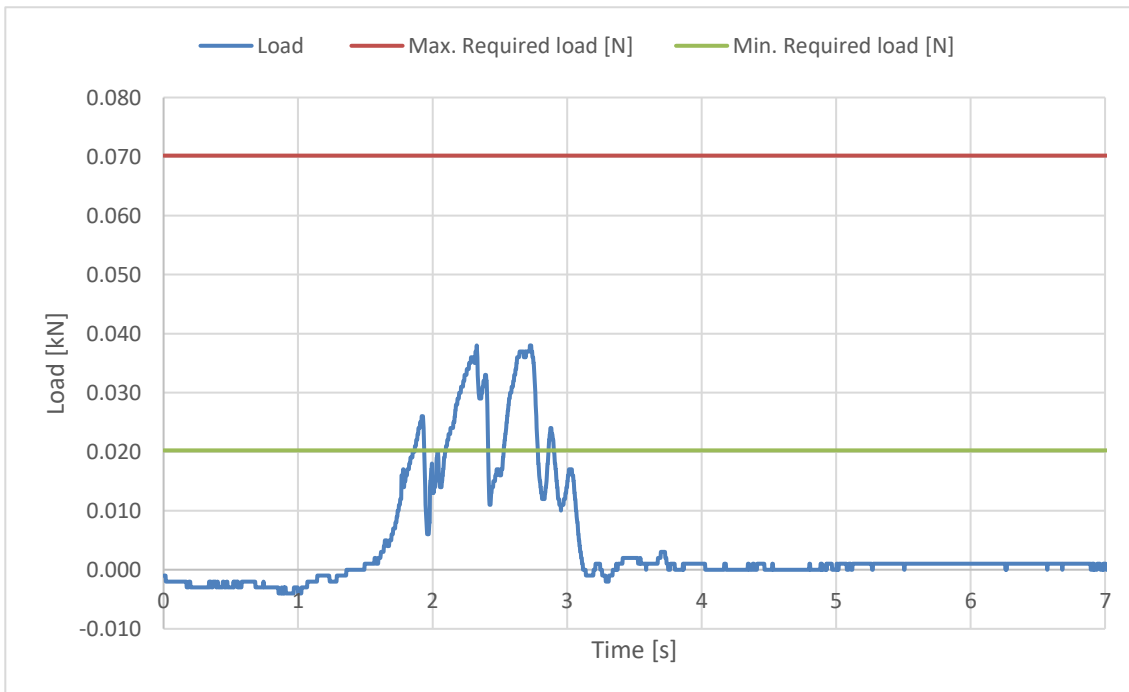
**Test ID RRDT**

Standard **NfL 2-565-20**  
 Reference **6.1.5**  
 Test setup **Default flying position**  
 Attachment points **Sensor connect to handle, and pull in opening direction**  
 The test is to simulate the load required to open the emergency parachute(1st action).

Min. Required load [N] **20**  
 Max. Required load [N] **70**

Load for first action [N] **37.80**  
 Test results **POSITIVE**

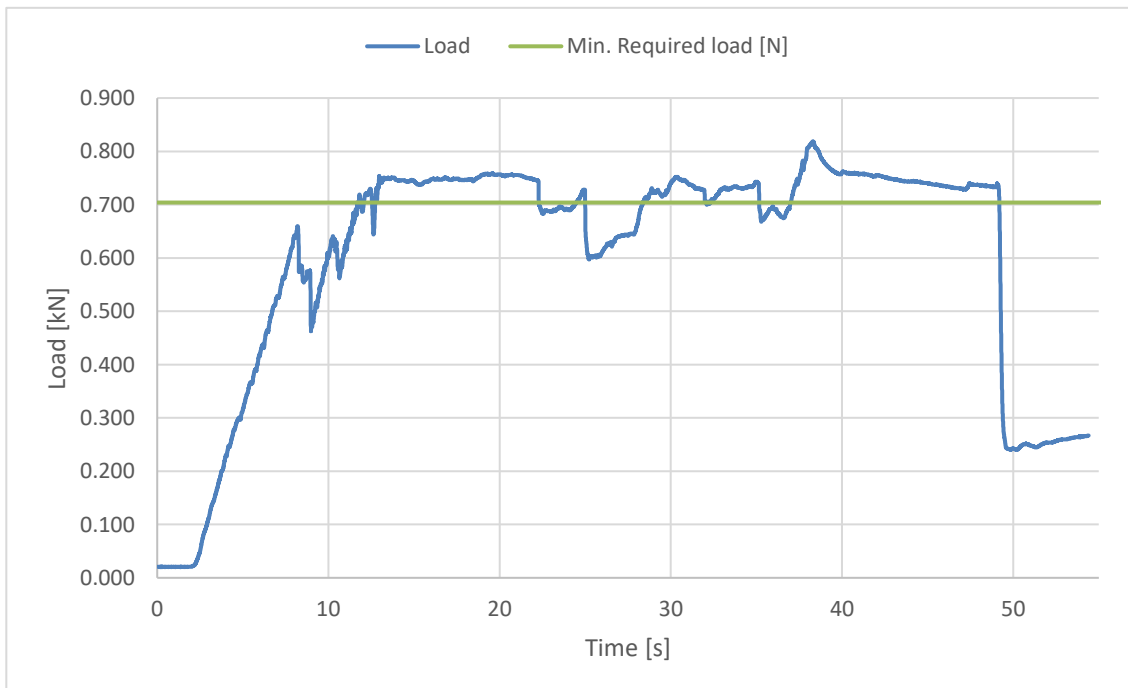
**Test ID RRST**

Standard	<b>EN 12491</b>
Reference in standard	<b>5.3.2</b>
Test setup	<b>Two end points of handle</b>
Attachment points	<b>Sensor connect to end of handle, pull on the other side</b>
	The handle must support min 700 N for 10 s, after measure breaking strength
Min. Required load [N]	<b>700</b>
Minimum test duration [s]	<b>10</b>
<b>Result</b>	
Test duration [s]:	<b>12.2</b>
Breaking strength [N]	<b>814.79</b>
Test results	<b>POSITIVE</b>
