# Harness Structural test Report - EN

Inspection certificate number: **PH\_395.2023**

Name: **F\*Race 2 race version**  
 Type: **ABS**  
 Size: **M**  
 Serial number: **V1**  
 Impact pad type: <sup>(1)</sup> **Inflatable**  
 Clip-in weight [kg]: **100**

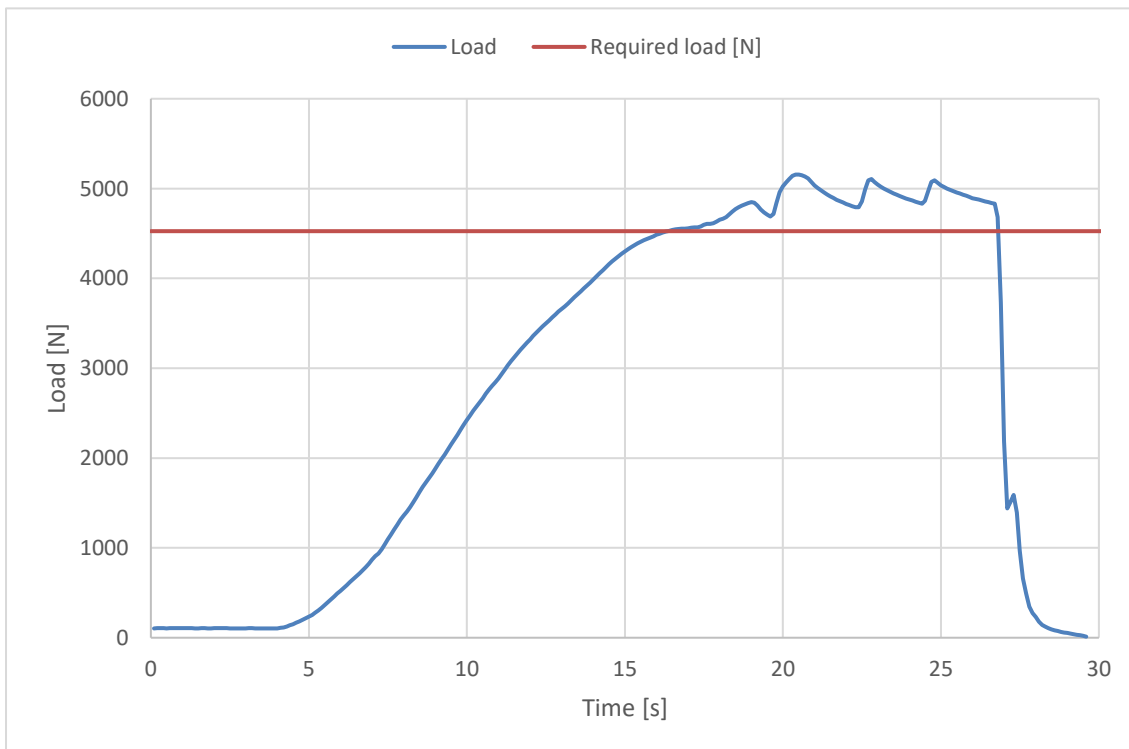
Test ID 01

Standard **EN 1651**  
Reference in standard **5.5.1.1**  
Test setup **Positive symmetric load (Slippage)**  
Attachment points **Both main riser attachment (3,4)**  
Anchor points **Dummy (B1, B2)**

Required load [g] **4.5**  
Required load [N] **4500**  
Minimum test duration [s] **5**

Test duration [s] **10.5**  
Any signs of structural failure **No**  
Slippery test OK **Yes**  
Test results **POSITIVE**

| Test id | - EN 1651 | Setup | Req. Load [g] | Req. Load [N] | Min. duration [s] | Result |
|---|---|---|---|---|---|---|
| 01 <sup>(3)</sup> | ✓ 5.5.1.1 | Positive symmetric load (Slippage) | 4.5 | 4500 | 5 | POSITIVE |

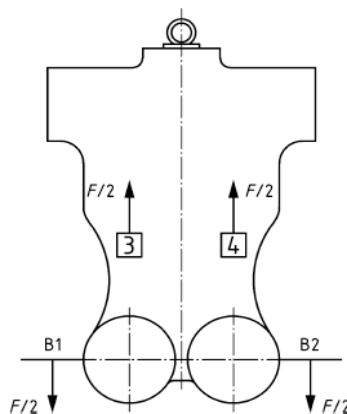
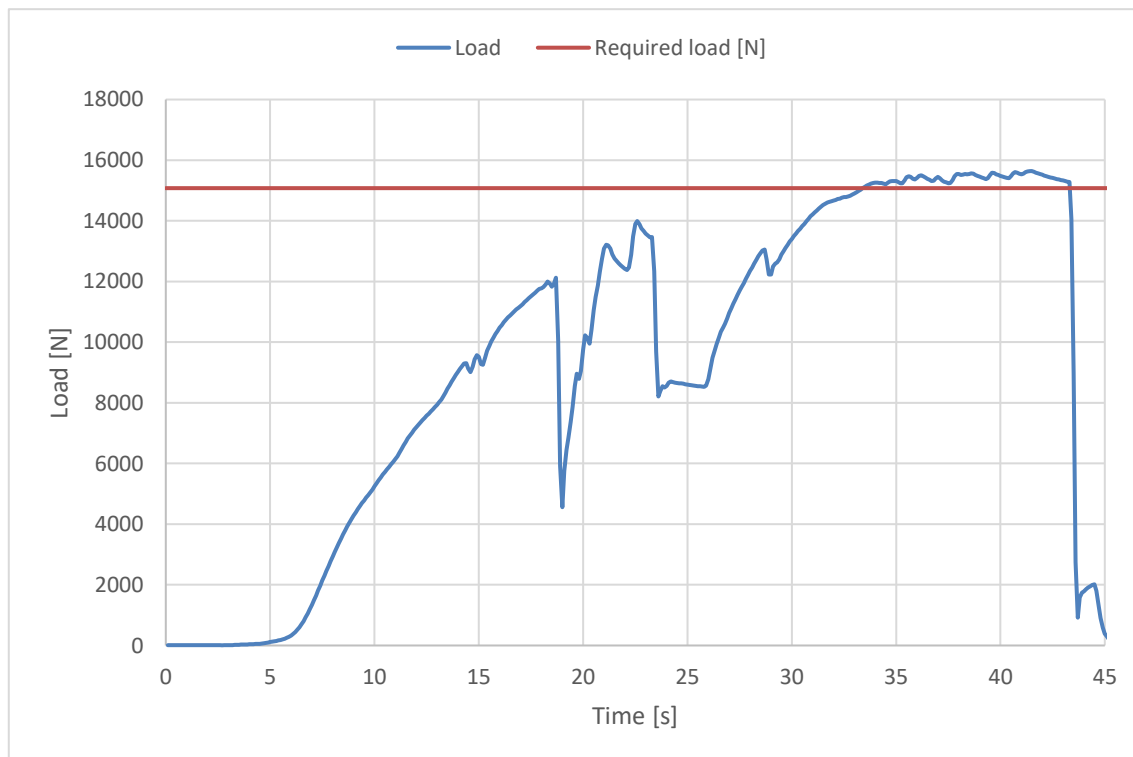
Test ID 03

Standard **EN 1651**  
Reference in standard **5.5.1.1b**  
Test setup **Positive symmetric load**  
Attachment points **Both main riser attachment (3,4)**  
Anchor points **Dummy (B1, B2)**

Required load [g] **15**  
Required load [N] **15000**  
Minimum test duration [s] **5**

Test duration [s] **10**  
Any signs of structural failure **No**  
Slippery test OK **Yes**  
Test results **POSITIVE**

| Test id | - EN 1651 | Setup | Req. Load [g] | Req. Load [N] | Min. duration [s] | Result |
|---|---|---|---|---|---|---|
| 03 <sup>(3)</sup> | ✓ 5.5.1.1b | Positive symmetric load | 15 | 15000 | 5 | POSITIVE |

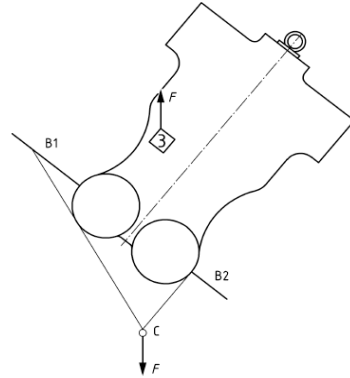
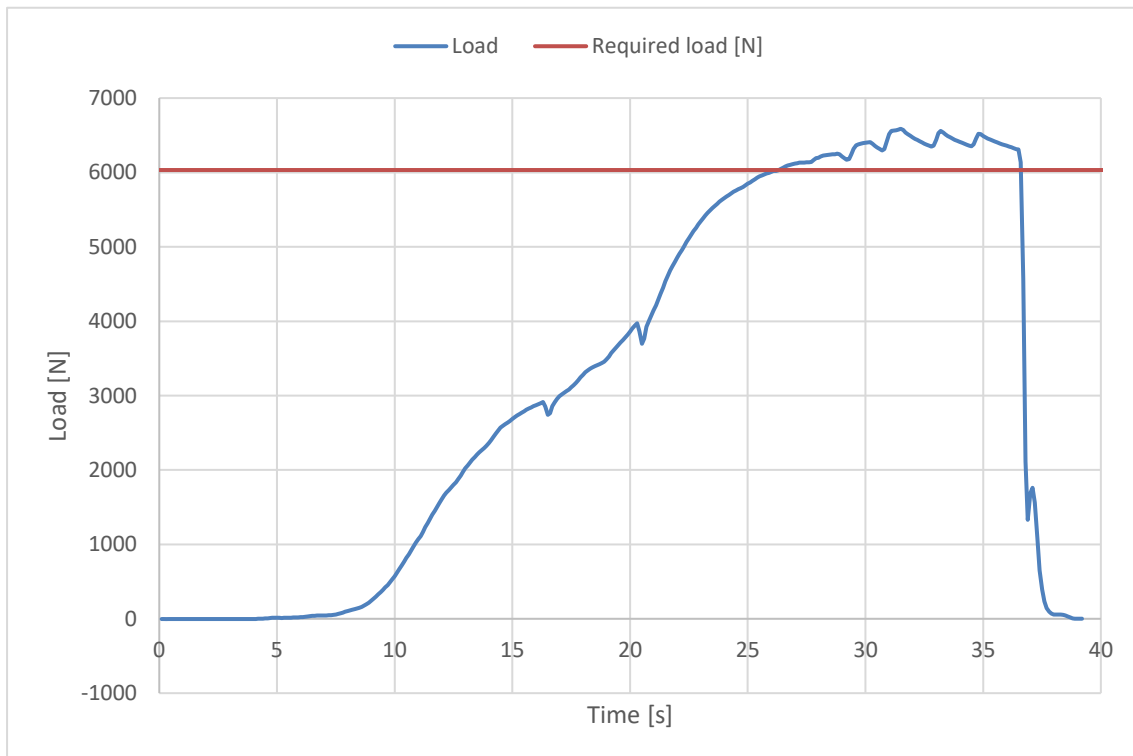
Test ID 05

Reference in standard **5.5.1.2**

Test setup **Positive asymmetric load**

Attachment points **One riser attachment (3 or 4)**

Anchor points **Dummy (C)**

Required load [N] **6000**

Test duration [s] **10.3**

Any signs of structural failure **No**

Test results **POSITIVE**

| Test id | - EN 1651 | Setup | Req. Load [g] | Req. Load [N] | Min. duration [s] | Result |
|---|---|---|---|---|---|---|
| 05 | ✓ 5.5.1.2 | Positive asymmetric load | 6 | 6000 | 5 | POSITIVE |

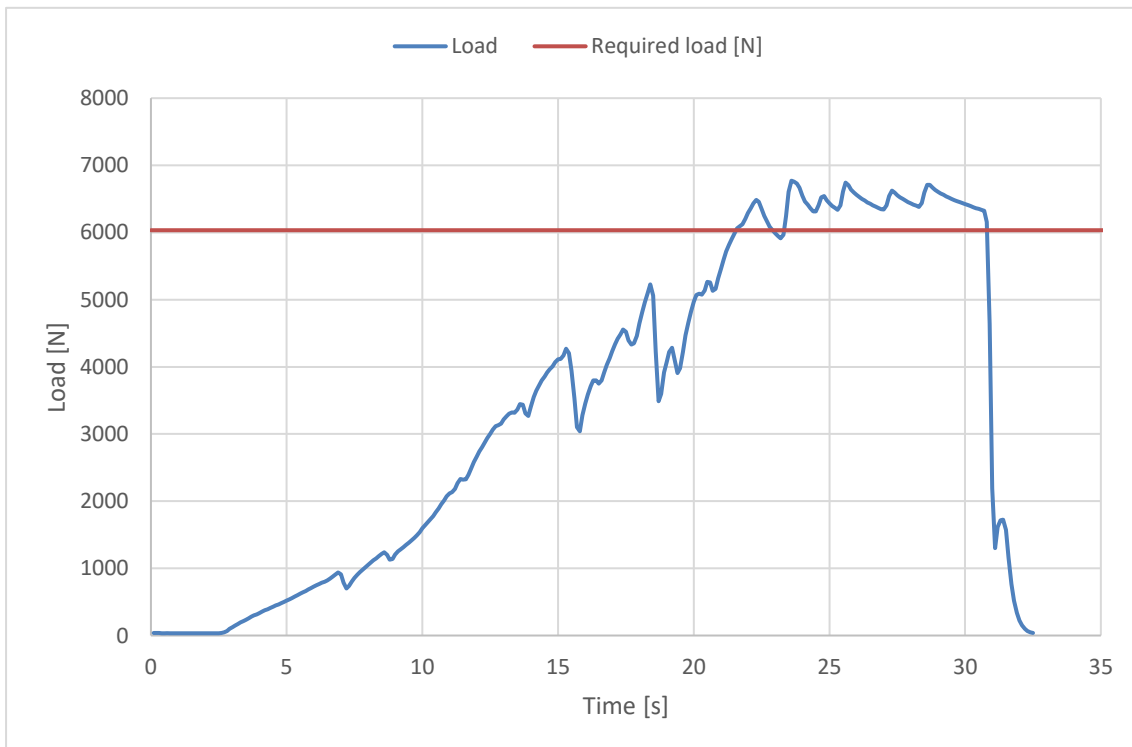
Test ID 06

Standard **EN 1651**  
Reference in standard **5.5.1.6**  
Test setup **Negative symmetric load**  
Attachment points **Both main riser attachment (3,4)**  
Anchor points **Dummy (A)**

Required load [g] **6**  
Required load [N] **6000**  
Minimum test duration [s] **5**

Test duration [s] **7.5**  
Any signs of structural failure **No**  
Test results **POSITIVE**

| Test id | - EN 1651 | Setup | Req. Load [g] | Req. Load [N] | Min. duration [s] | Result |
|---|---|---|---|---|---|---|
| 06 | ✓ 5.5.1.6 | Negative symmetric load | 6 | 6000 | 5 | POSITIVE |

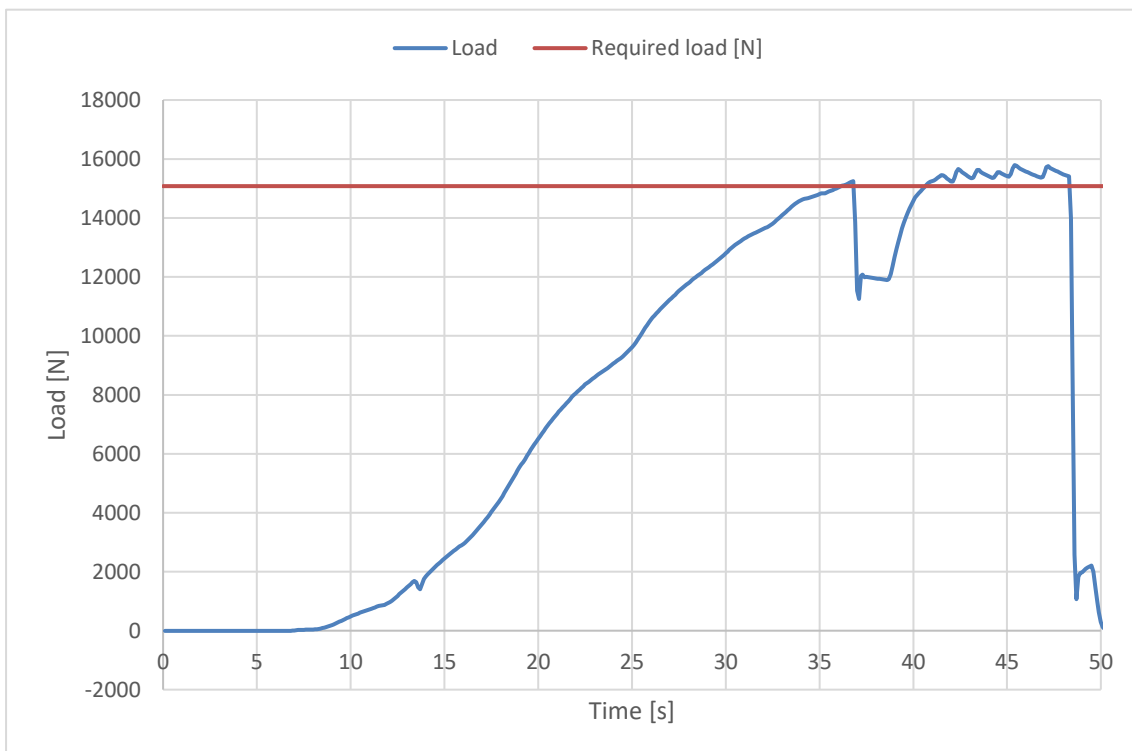
Test ID 09

Standard **EN 1651**  
Reference in standard **5.5.1.3**  
Test setup **Positive symmetric load rescue points**  
Attachment points **Both main riser attachment (1,2)**  
Anchor points **Dummy (B1,B2)**

Required load [g] **15**  
Required load [N] **15000**  
Minimum test duration [s] **5**

Test duration [s] **7.7**  
Any signs of structural failure **No**  
Slippery test OK **Yes**  
Test results **POSITIVE**

| Test id | - EN 1651 | Setup | Req. Load [g] | Req. Load [N] | Min. duration [s] | Result |
|---|---|---|---|---|---|---|
| 09 <sup>(3)(4)</sup> | ✓ 5.5.1.3 | Positive symmetric load rescue points | 15 | 15000 | 5 | POSITIVE |

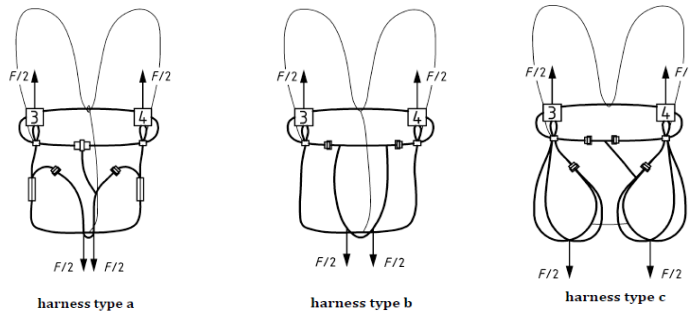
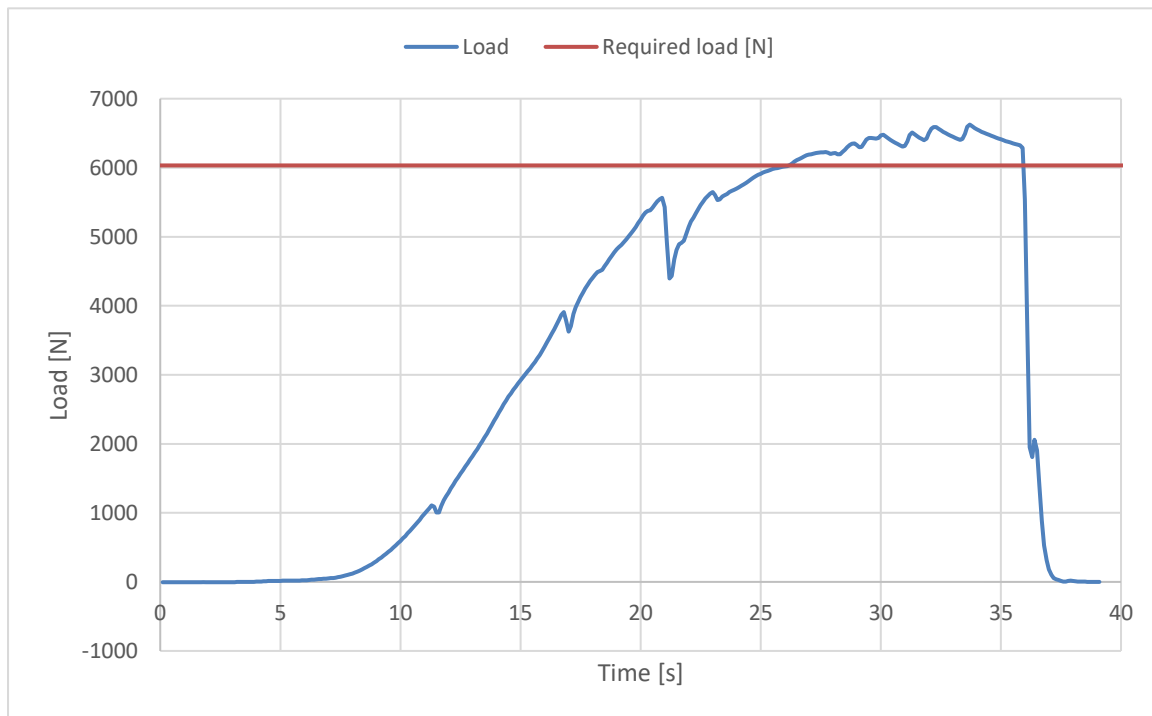
Test ID 12

Standard **EN 1651**  
Reference in standard **5.5.1.7**  
Test setup **Upright (landing) position load**  
Attachment points **Both main riser attachment (3, 4)**  
Anchor points **Both legstrap of harness (no dummy)**

Required load [g] **6**  
Required load [N] **6000**  
Minimum test duration [s] **5**  
Harness type **type b**

Test duration [s] **9.8**  
Any signs of structural failure **No**  
Slippery test OK **Yes**  
Test results **POSITIVE**

| Test id | - EN 1651 | Setup | Req. Load [g] | Req. Load [N] | Min. duration [s] | Result |
|---|---|---|---|---|---|---|
| 12 <sup>(3)</sup> | ✓ 5.5.1.7 | Upright (landing) position load | 6 | 6000 | 5 | POSITIVE |

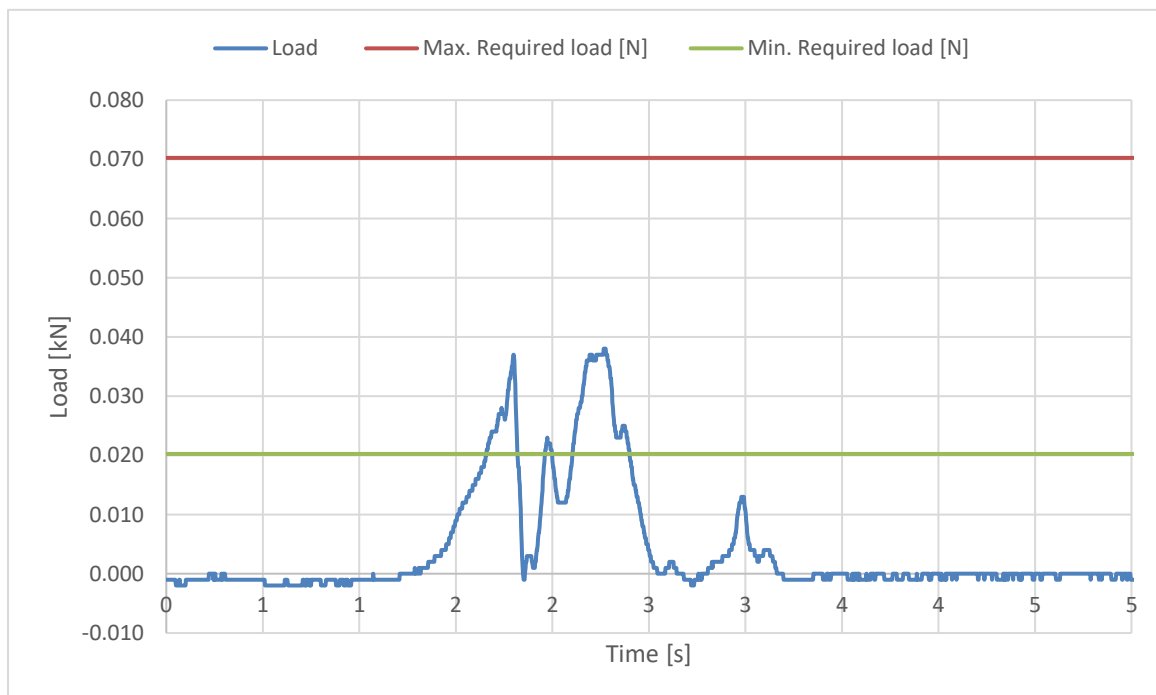
Test ID RRDT

| Attachment points | <b>Sensor connect to handle, and pull in opening direction</b> |
| The test is to simulate the load required to open the emergency parachute(1st action). | |
| Load for first action [N] | <b>38.25</b> |
| Test results | <b>POSITIVE</b> |

| Test id | - EN 1651 | Setup | Min load [N] | Max. load [N] | Measured [N] | Result |
|---|---|---|---|---|---|---|
| RRDT | ✓ 5.5.1.11 | Default flying position | 20 | 70 | 38.25 | POSITIVE |

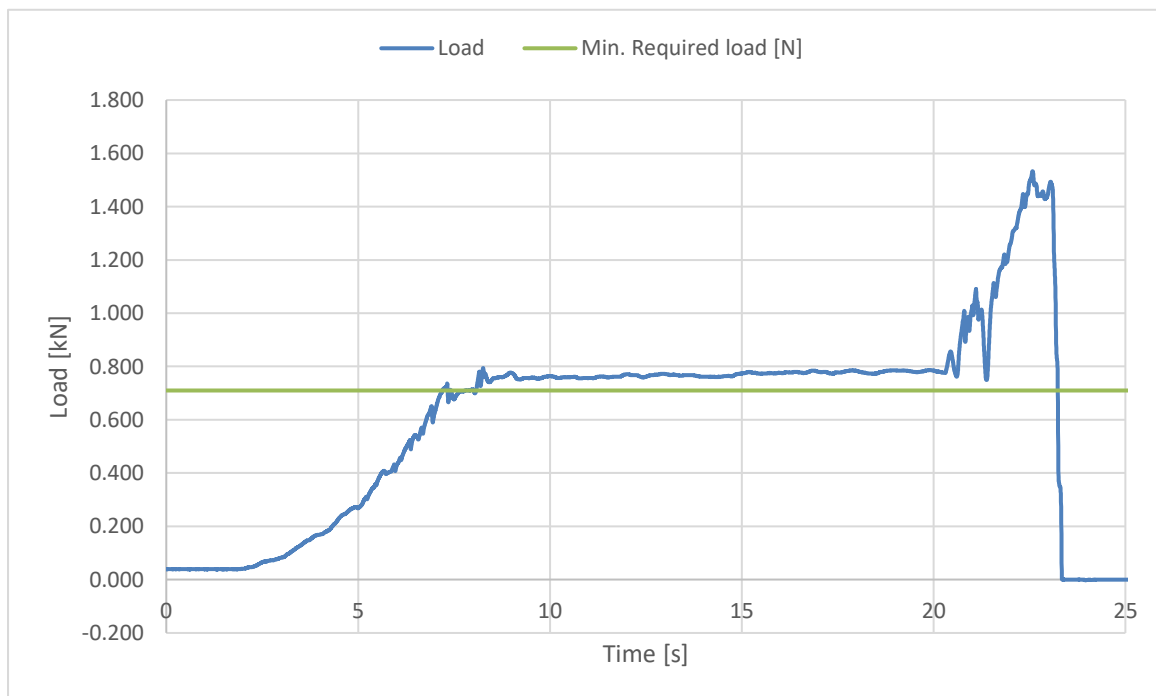
Test ID RRST

Standard **EN 12491**  
Reference in standard **5.3.2**  
Test setup **Two end points of handle**  
Attachment points **Sensor connect to end of handle, pull on the other side**  
The handle must support min 700 N for 10 s, after measure breaking strength

Min. Required load [N] **700**  
Minimum test duration [s] **10**

Test duration [s]: **15.2**  
Breaking strength [N] **1522.82**  
Test results **POSITIVE**

| Test id | - EN 12491 | Setup | Req. Load [N] | Min. duration [s] | Breaking strength [N] | Result |
|---|---|---|---|---|---|---|
| RRST | ✓ 5.3.2 | Two end points of handle | 700 | 10 | 1522.82 | POSITIVE |
