Harness Structural test Report - NfL

Inspection certificate number: **PH_386.2023**

Name: **BFcocon V2**
 Type: **ABS**
 Size: **L**
 Serial number: **985.52**
 Impact pad type: ⁽¹⁾ **Inflatable**
 Clip-in weight [kg]: **120**
 Integrated container: **Yes**
 Date of test: **24.01.2024**

Summary of Structural test

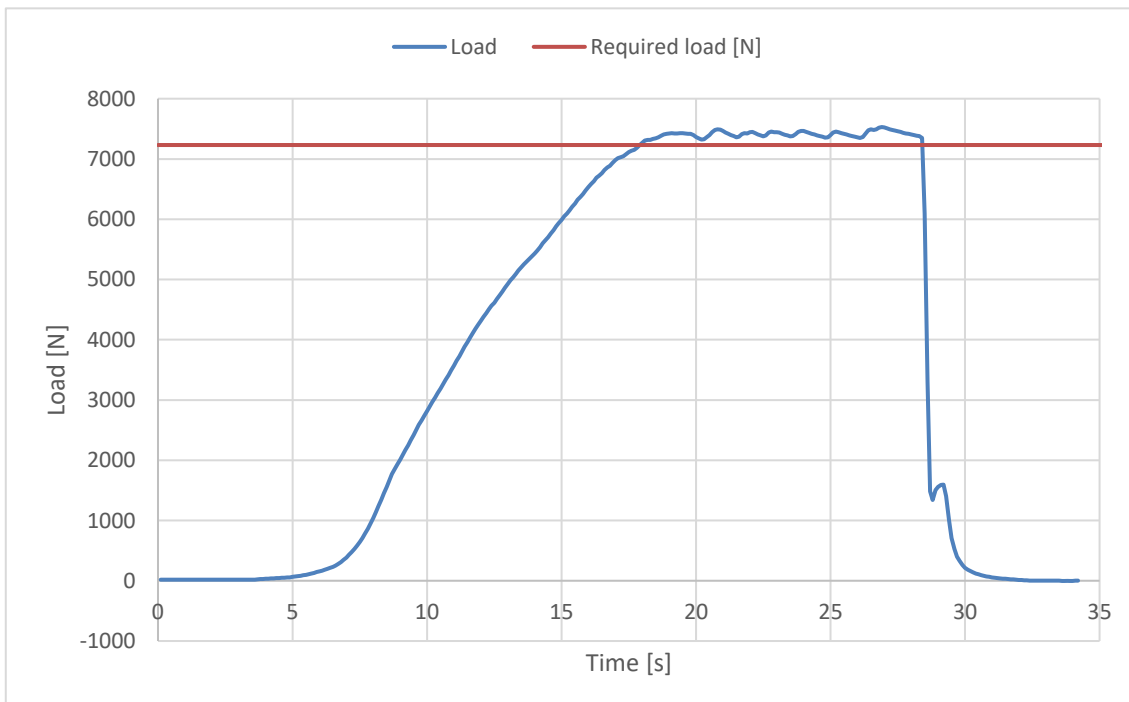
Test ID 02

Reference	5.3.2.1	
Test setup	Default flying position	
Attachment points	Both main riser attachment (3,4)	
Anchor points	Dummy (B1, B2)	
Required load [g]	6	
Required load [N]	7200	
Minimum test duration [s]	10	
Result		
Test duration [s]	10.5	
Any signs of structural failure	No	
Test results	POSITIVE

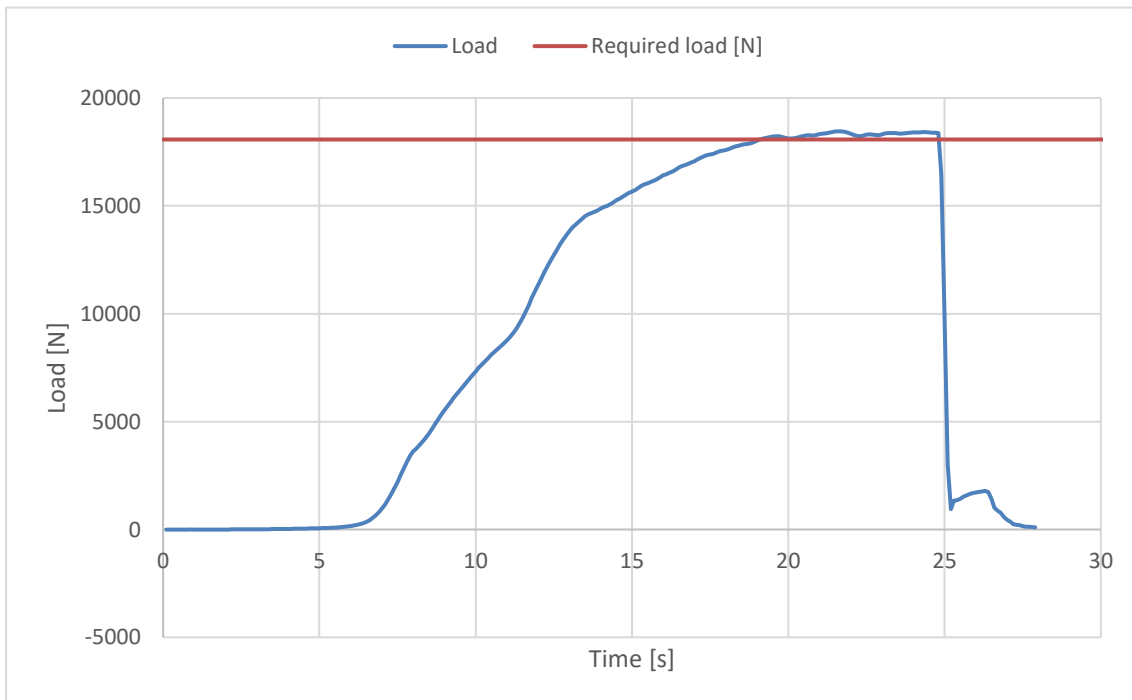
Test ID 03

Reference	5.3.2.2	
Test setup	Default flying position	
Attachment points	Both main riser attachment (3,4)	
Anchor points	Dummy (B1, B2)	
Required load [g]	15	
Required load [N]	18000	
Minimum test duration [s]	5	
Result		
Test duration [s]	5.7	
Any signs of structural failure	No	
Test results	POSITIVE

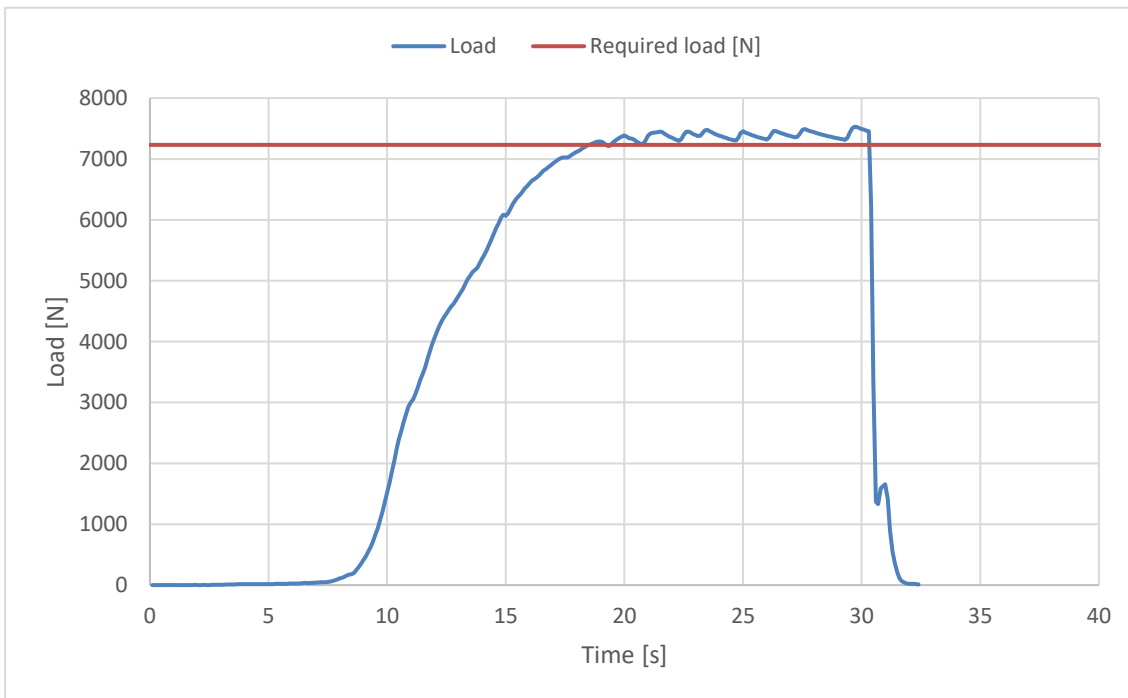
Test ID 04

Standard **EN 1651:1999**
 Reference **5.3.2.3**
 Test setup **Asymmetric, one riser**
 Attachment points **One main riser attachment (3)**
 Anchor points **Dummy (B1,B2)**

Required load [g] **6**
 Required load [N] **7200**
 Minimum test duration [s] **10**

Test duration [s] **10.9**
 Any signs of structural failure **No**
 Test results **POSITIVE**

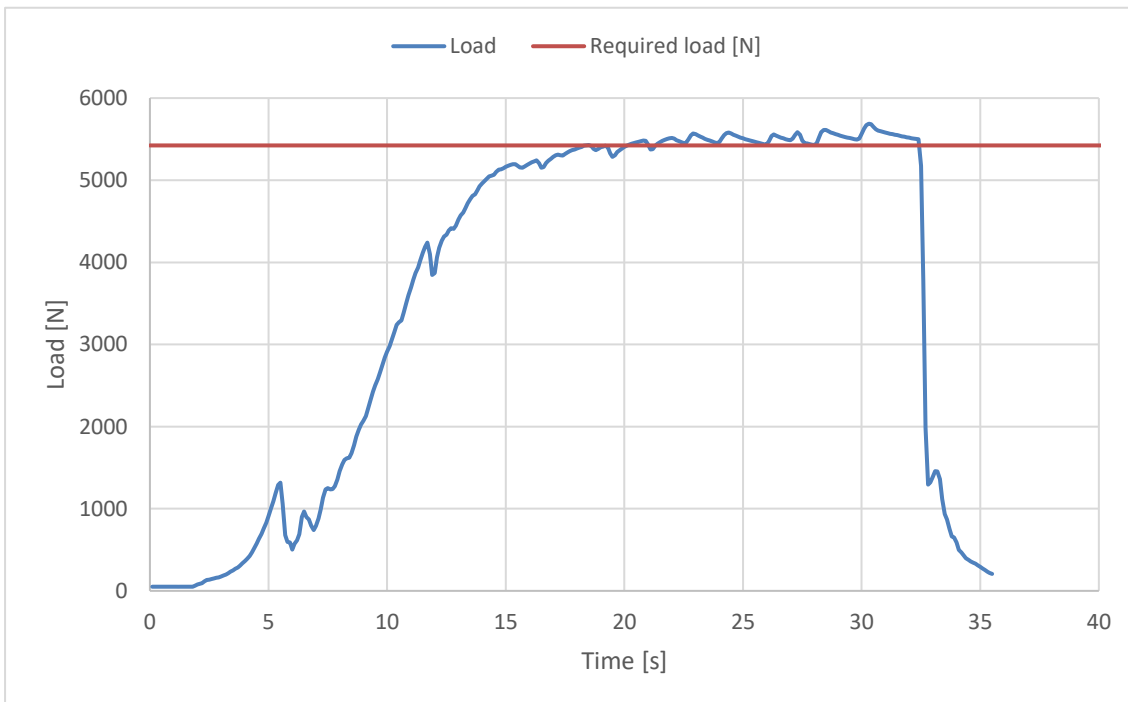
Test ID 07

Standard	EN 1651:1999
Reference	5.3.2.6
Test setup	Asymmetric, negative
Attachment points	One main riser attachment (3 or 4) downwards
Anchor points	Dummy (9)
Required load [g]	4.5
Required load [N]	5400
Minimum test duration [s]	10
Result	
Test duration [s]	11.1
Any signs of structural failure	No
Test results	POSITIVE

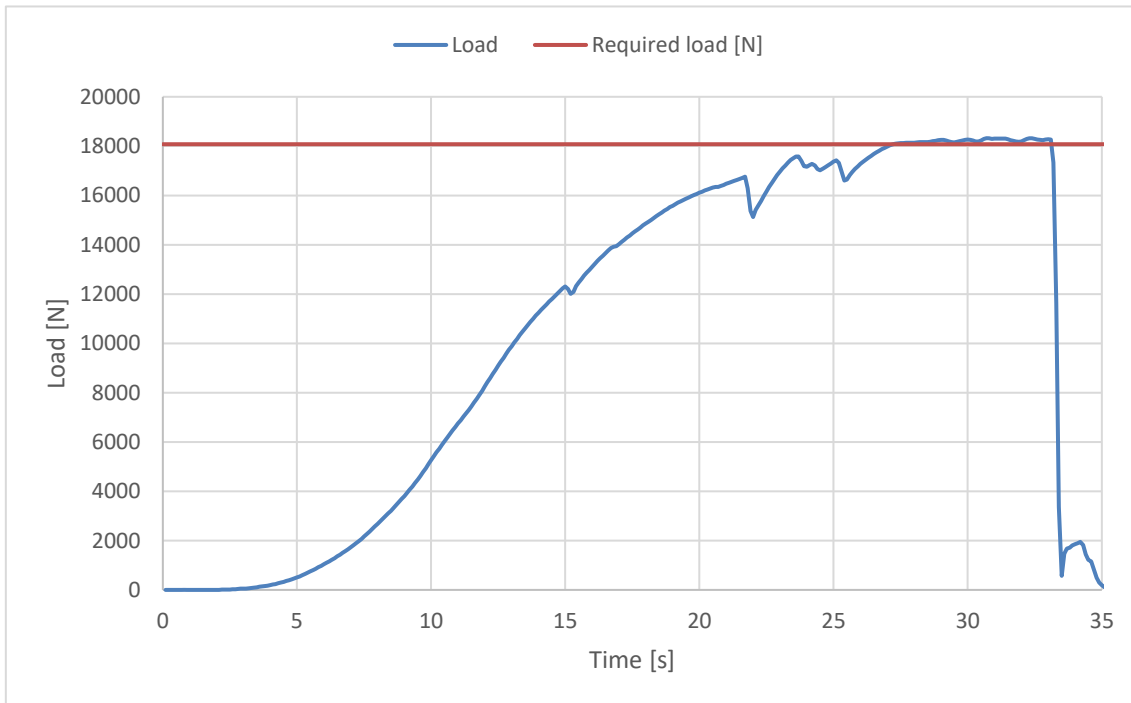
Test ID 09

Reference	5.3.2.4	
Test setup	Rescue attachments	
Attachment points	Rescue riser attachment (1,2)	
Anchor points	Dummy (B1,B2)	
Required load [g]	15	
Required load [N]	18000	
Minimum test duration [s]	5	
Result		
Test duration [s]	5.9	
Any signs of structural failure	No	
Test results	POSITIVE

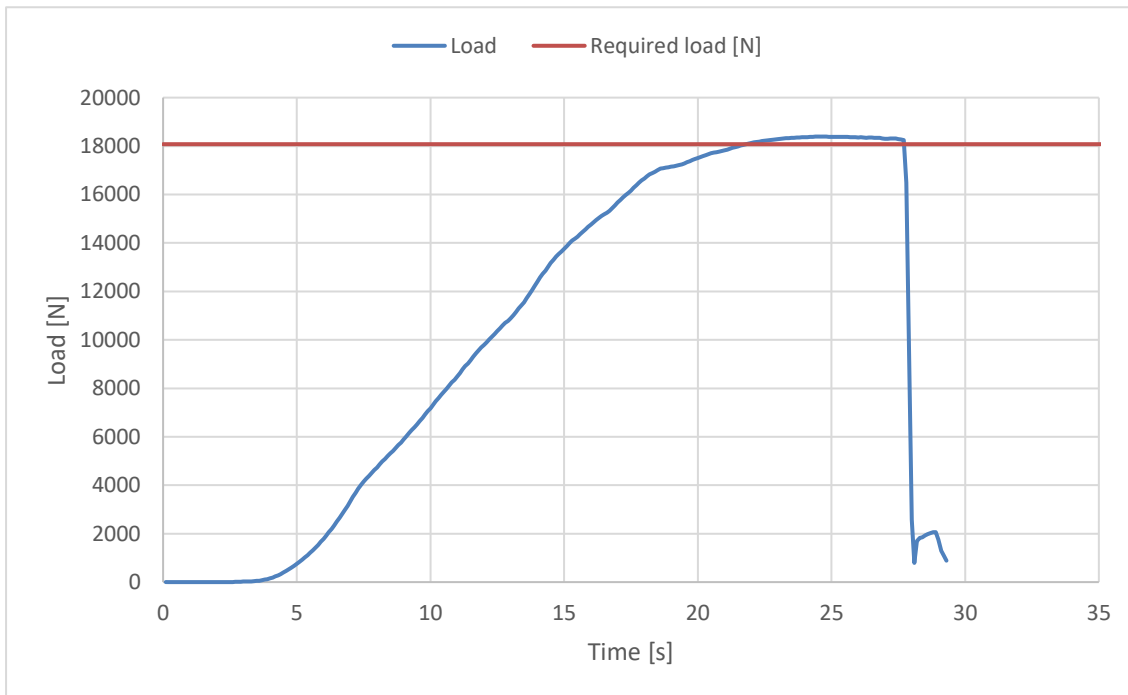
Test ID 13

Standard **EN 1651:1999**
 Reference **5.3.2.7**
 Test setup **Flying position before landing**
 Attachment points **Both main riser attachment (3,4)**
 Anchor points **Dummy (7,8)**

Required load [g] **15**
 Required load [N] **18000**
 Minimum test duration [s] **5**

Test duration [s] **5.9**
 Any signs of structural failure **No**
 Test results **POSITIVE**

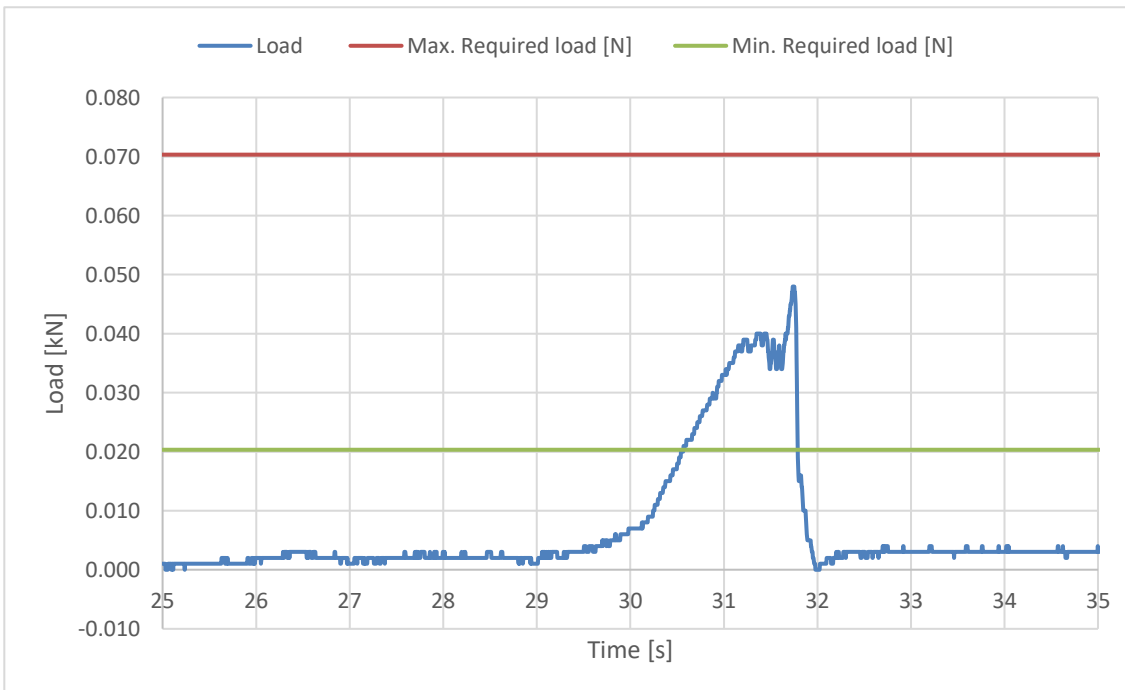
Test ID RRDT

Standard	NfL 2-565-20
Reference	6.1.5
Test setup	Default flying position
Attachment points	Sensor connect to handle, and pull in opening direction
	The test is to simulate the load required to open the emergency parachute(1st action).
Min. Required load [N]	20
Max. Required load [N]	70
Result	
Load for first action [N]	47.68
Test results	POSITIVE

Test id	- NfL 2-565-20	Setup	Min load [N]	Max. load [N]	Measured [N]	Result
RRDT	V 6.1.5	Default flying position	20	70	47.68	POSITIVE

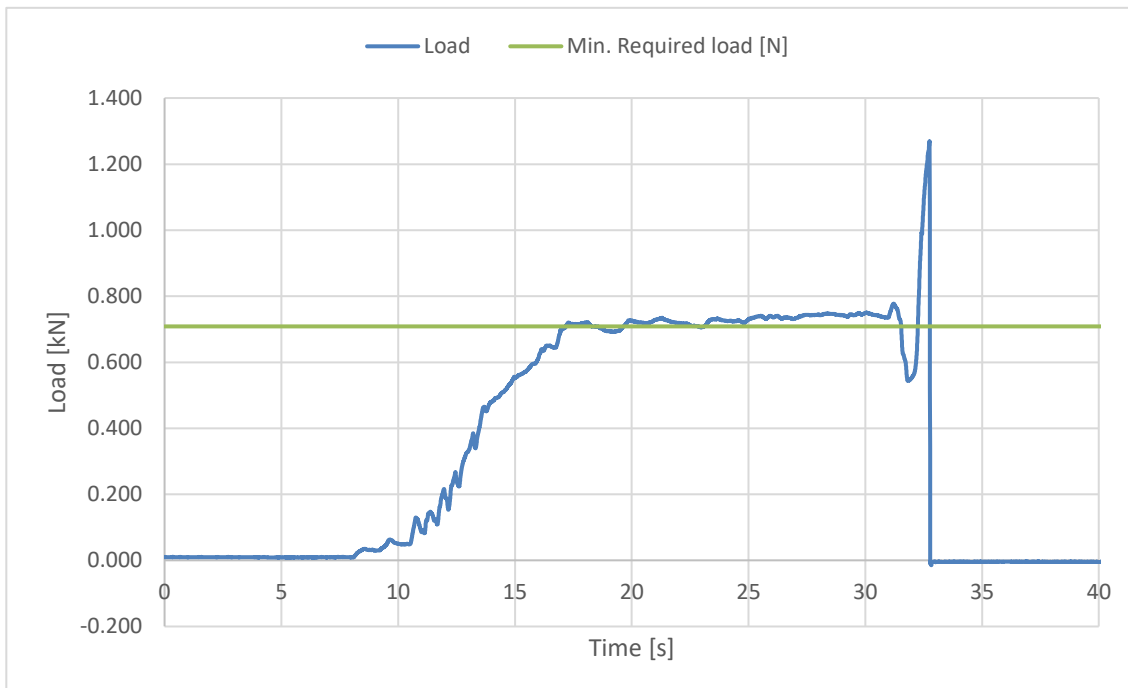
Test ID RRST

Standard	EN 12491
Reference in standard	5.3.2
Test setup	Two end points of handle
Attachment points	Sensor connect to end of handle, pull on the other side
	The handle must support min 700 N for 10 s, after measure breaking strength
Min. Required load [N]	700
Minimum test duration [s]	10
Result	
Test duration [s]:	10.6
Breaking strength [N]	1260.57
Test results	POSITIVE

Test id	- EN 12491	Setup	Req. Load [N]	Min. duration [s]	Breaking strength [N]	Result
RRST	V 5.3.2	Two end points of handle	700	10	1260.57	POSITIVE
