Harness Structural test Report

Inspection certificate number: **PH_292.2020**

Name: **Sit&Fly**
 Type: **ABS**
 Size: **260**
 Serial number: **H-09973**
 Impact pad type: ⁽¹⁾ **n/a**
 Clip-in weight [kg]: **100**
 Date of test: **14.01.2020**

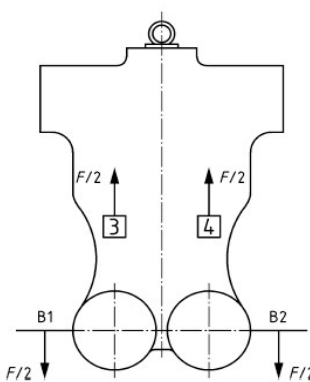
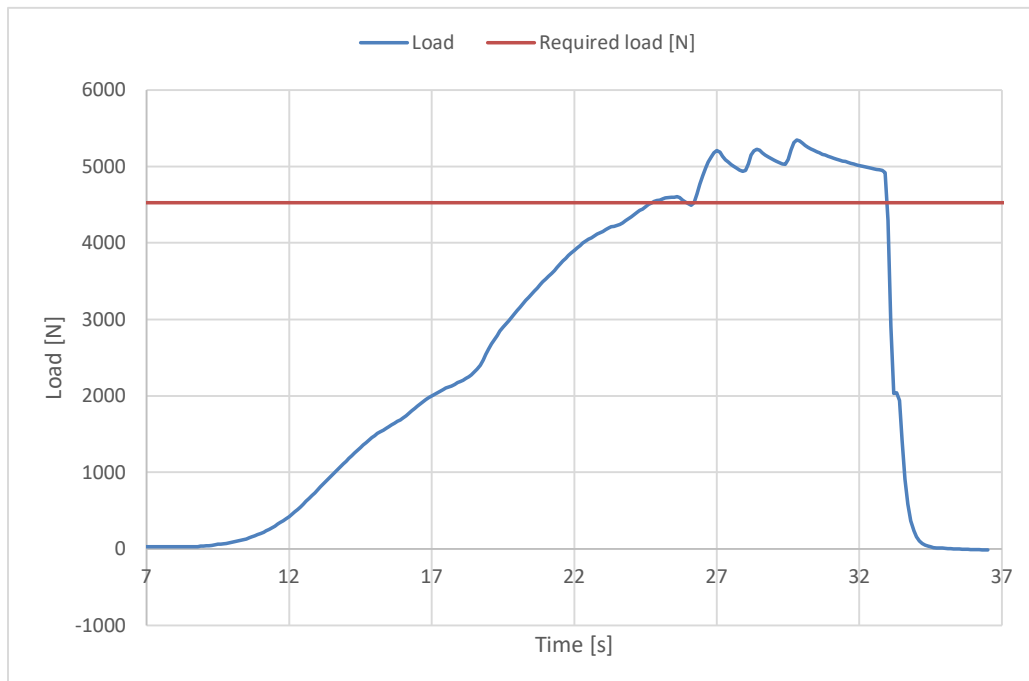
Test ID 01

Reference in standard	5.5.1.1	
Test setup	Positive symmetric load (Slippage)	
Attachment points	Both main riser attachment (3,4)	
Anchor points	Dummy (B1, B2)	
Required load [g]	4.5	
Required load [N]	4500	
Minimum test duration [s]	5	
Result		
Test duration [s]	6.7	
Any signs of structural failure	No	
Slippery test OK	Yes	
Test results	POSITIVE

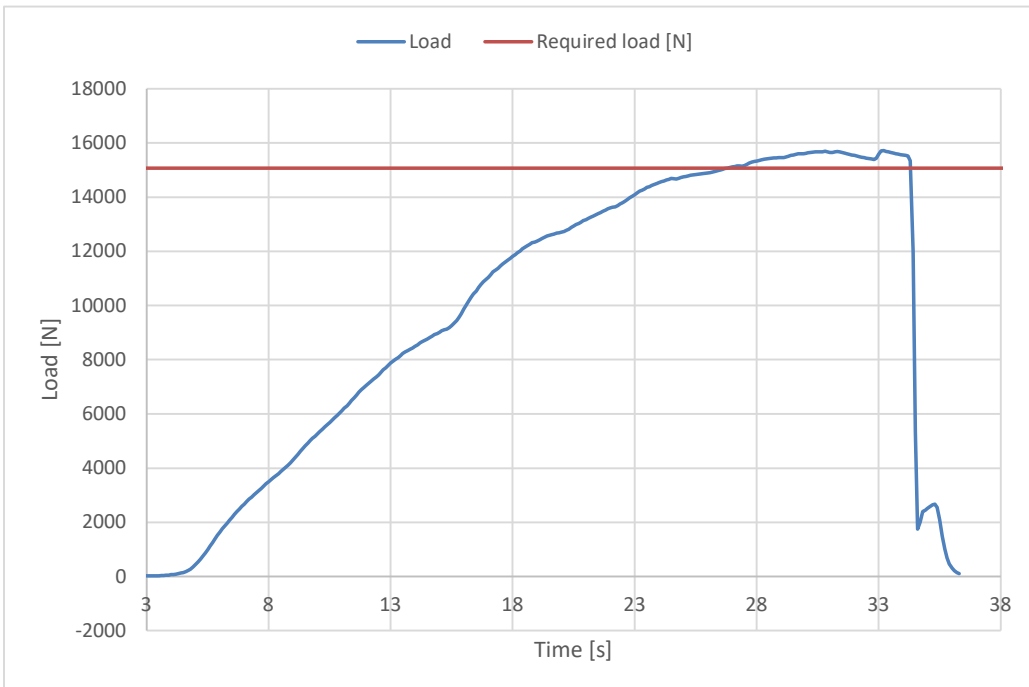
Test ID 03

Standard	EN 1651:2018	
Reference in standard	5.5.1.1b	
Test setup	Positive symmetric load	
Attachment points	Both main riser attachment (3,4)	
Anchor points	Dummy (B1, B2)	
Required load [g]	15	
Required load [N]	15000	
Minimum test duration [s]	5	
Result		
Test duration [s]	7.6	
Any signs of structural failure	No	
Slippery test OK	Yes	
Test results	POSITIVE

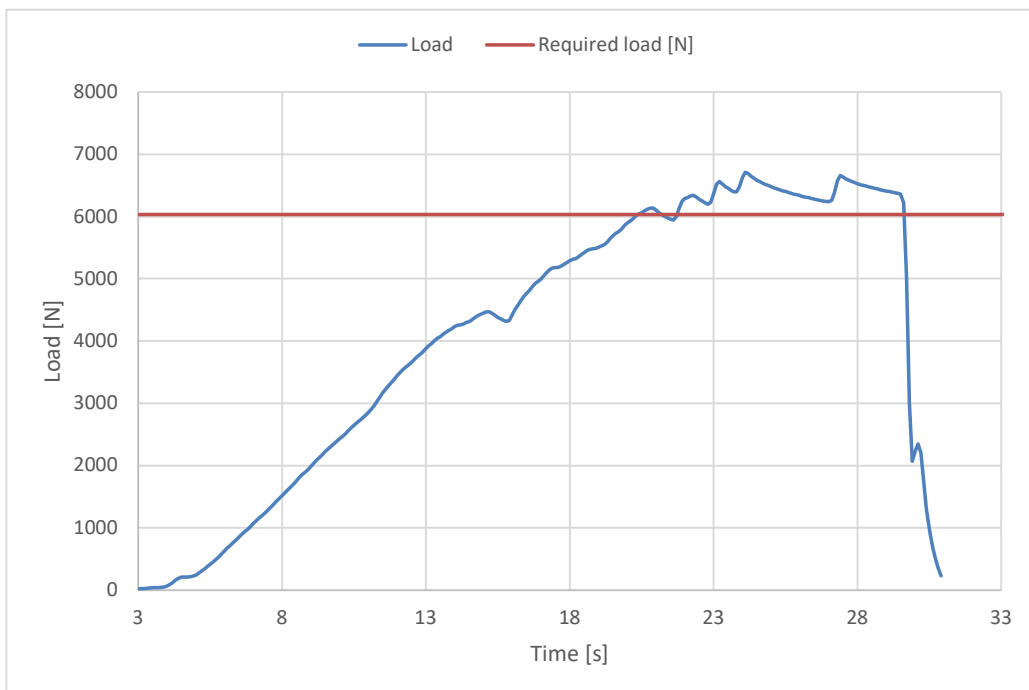
Test ID 05

Standard	EN 1651:2018
Reference in standard	5.5.1.2
Test setup	Positive asymmetric load
Attachment points	One riser attachment (3 or 4)
Anchor points	Dummy (C)
Required load [g]	6
Required load [N]	6000
Minimum test duration [s]	5
Result	
Test duration [s]	7.9
Any signs of structural failure	No
Test results	POSITIVE

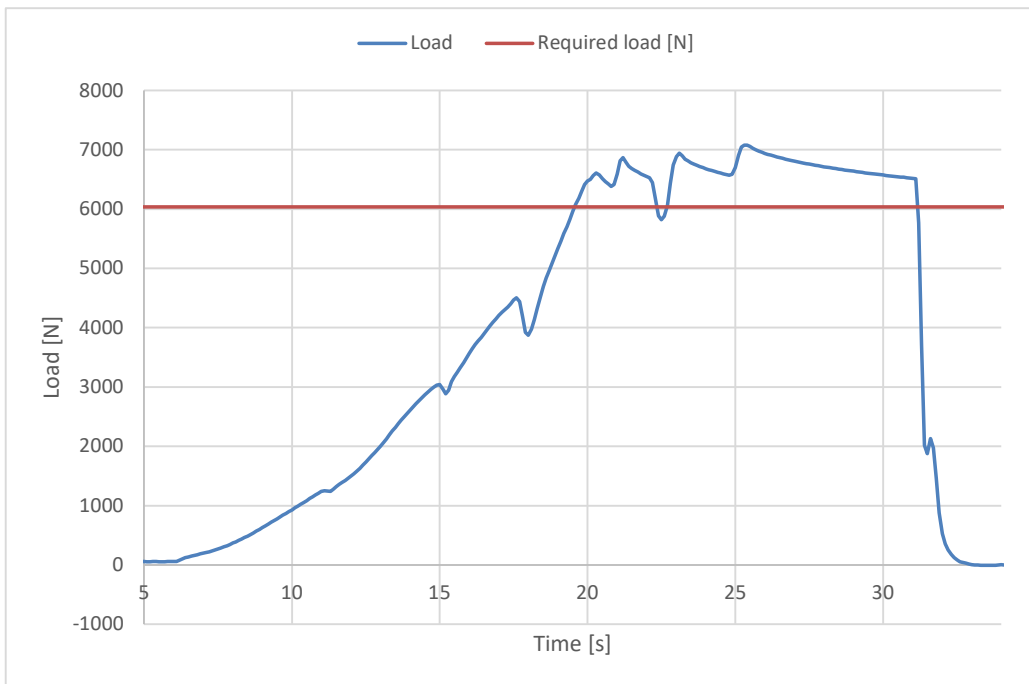
Test ID 06

Standard	EN 1651:2018
Reference in standard	5.5.1.6
Test setup	Negative symmetric load
Attachment points	Both main riser attachment (3,4)
Anchor points	Dummy (A)
Required load [g]	6
Required load [N]	6000
Minimum test duration [s]	5
Result	
Test duration [s]	8.5
Any signs of structural failure	No
Test results	POSITIVE

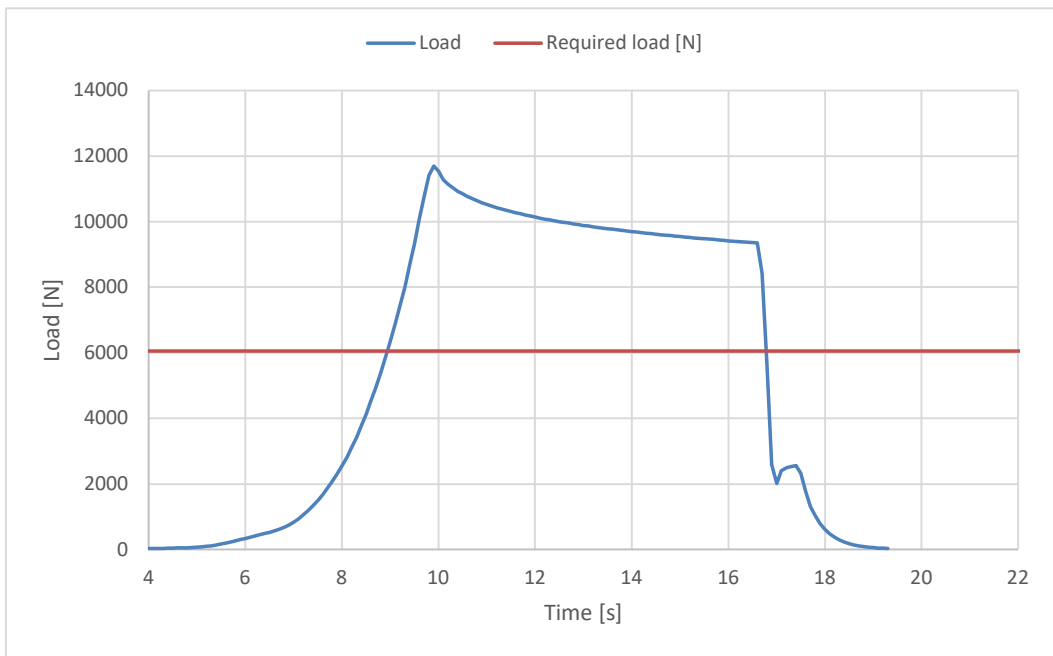
Test ID 12

Standard	EN 1651:2018
Reference in standard	5.5.1.7
Test setup	Upright (landing) position load
Attachment points	Both main riser attachment (3, 4)
Anchor points	Both legstrap of harness (no dummy)
Required load [g]	6
Required load [N]	6000
Minimum test duration [s]	5
Harness type	type a
Result	
Test duration [s]	7.8
Any signs of structural failure	No
Slippery test OK	Yes
Test results	POSITIVE
