Harness Structural test Report - NfL

Inspection certificate number: **PH_443.2024**

Name: **F*Race 2**
 Type: **ABS**
 Size: **M**
 Serial number: **struct.02**
 Impact pad type: ⁽¹⁾ **Inflatable**
 Clip-in weight [kg]: **110**
 Integrated container: **Yes**
 Date of test: **21.05.2024**

Harness Structural test

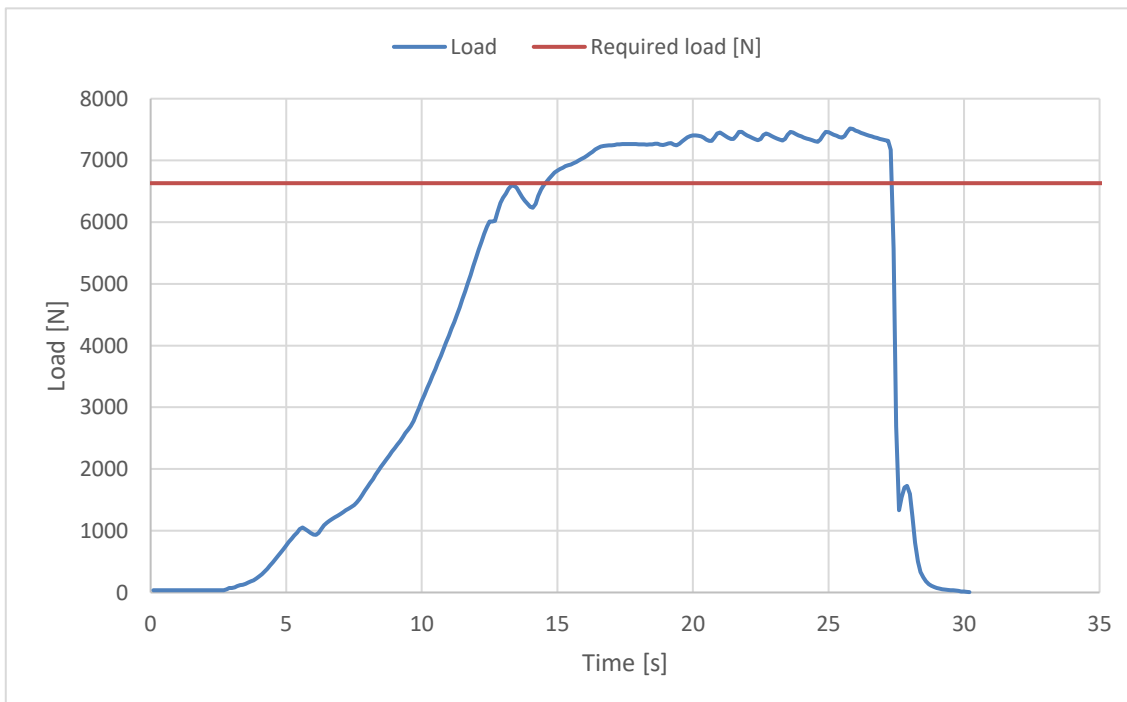
Test ID 02

Reference	5.3.2.1	
Test setup	Default flying position	
Attachment points	Both main riser attachment (3,4)	
Anchor points	Dummy (B1, B2)	
Required load [g]	6	
Required load [N]	6600	
Minimum test duration [s]	10	
Result		
Test duration [s]	12.8	
Any signs of structural failure	No	
Test results	POSITIVE

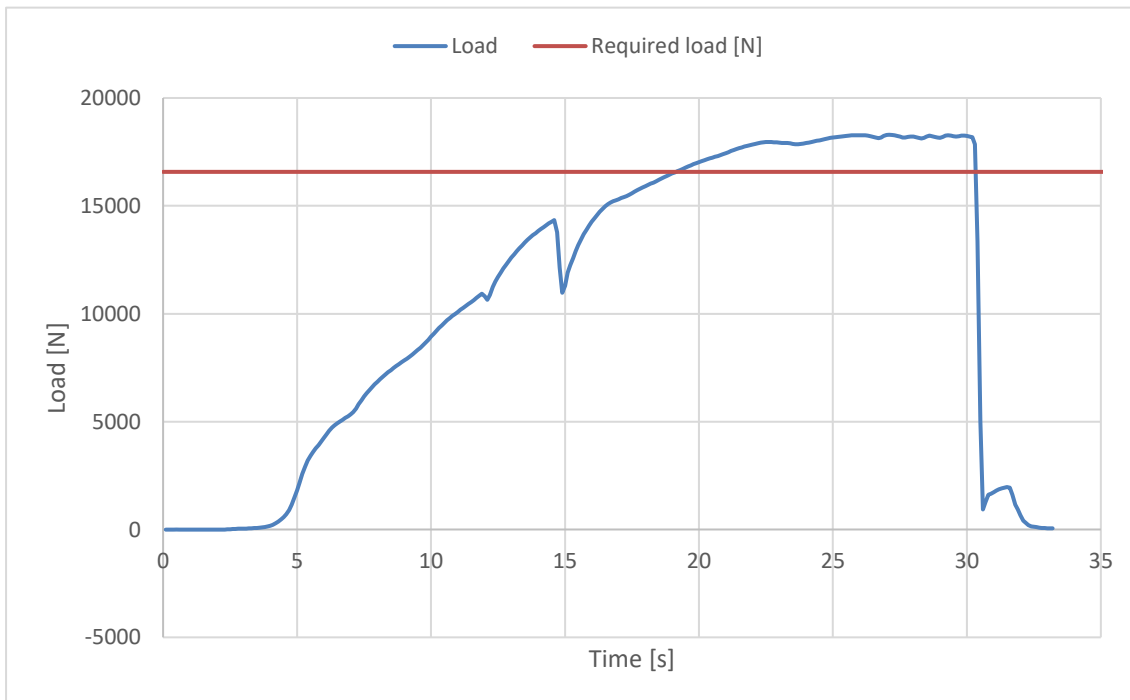
Test ID 03

Reference	5.3.2.2	
Test setup	Default flying position	
Attachment points	Both main riser attachment (3,4)	
Anchor points	Dummy (B1, B2)	
Required load [g]	15	
Required load [N]	16500	
Minimum test duration [s]	5	
Result		
Test duration [s]	11.2	
Any signs of structural failure	No	
Test results	POSITIVE

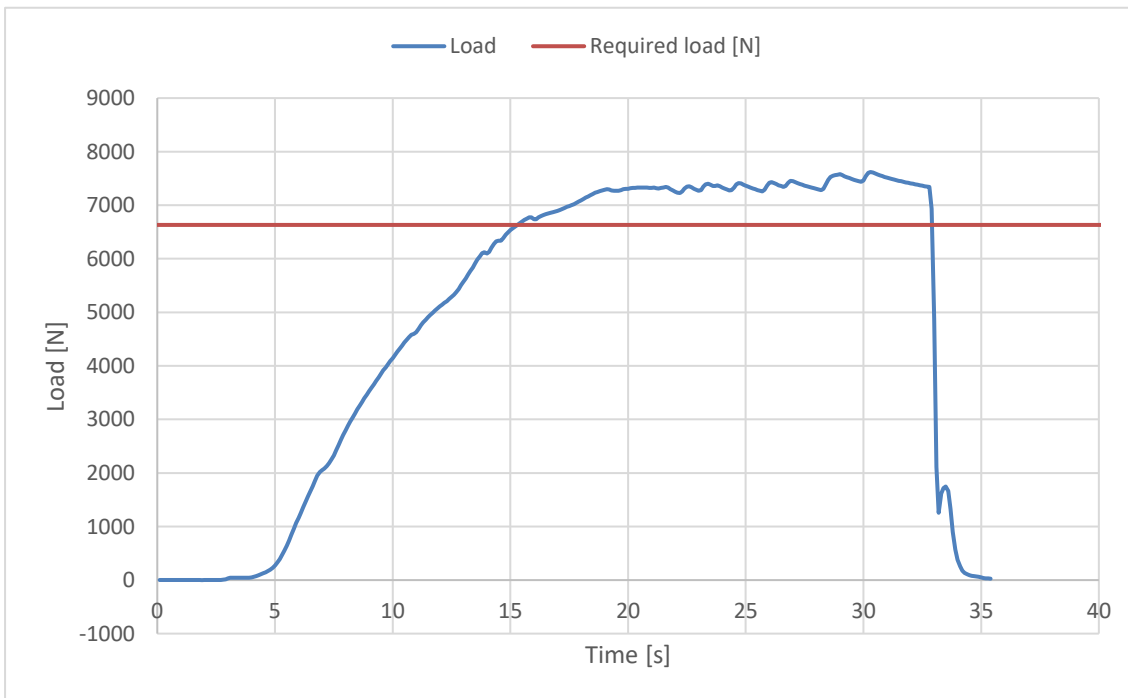
Test ID 04

Standard **EN 1651:1999**
 Reference **5.3.2.3**
 Test setup **Asymmetric, one riser**
 Attachment points **One main riser attachment (3)**
 Anchor points **Dummy (B1,B2)**

Test duration [s] **17.6**
 Any signs of structural failure **No**
 Test results **POSITIVE**

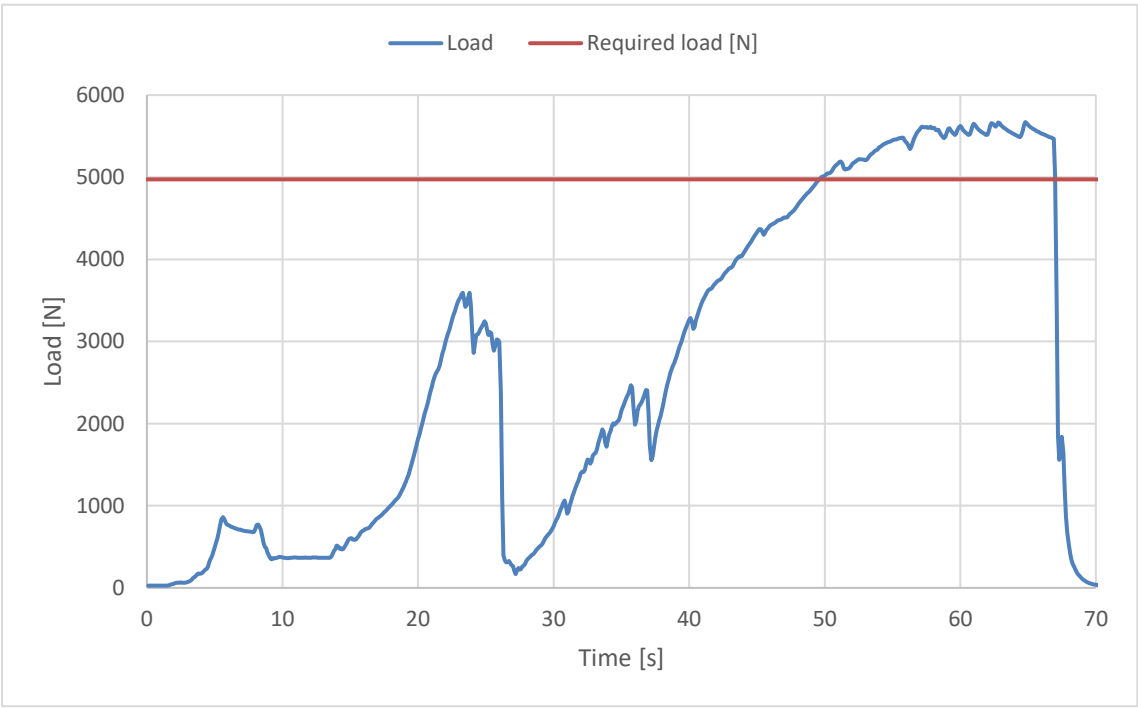
Test ID 07

Reference	5.3.2.6	
Test setup	Asymmetric, negative	
Attachment points	One main riser attachment (3 or 4) downwards	
Anchor points	Dummy (9)	
Required load [g]	4.5	
Required load [N]	4950	
Minimum test duration [s]	10	
Result		
Test duration [s]	17.5	
Any signs of structural failure	No	
Test results	POSITIVE

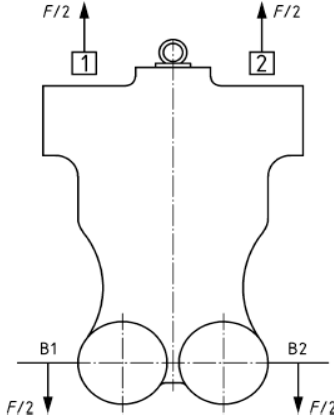
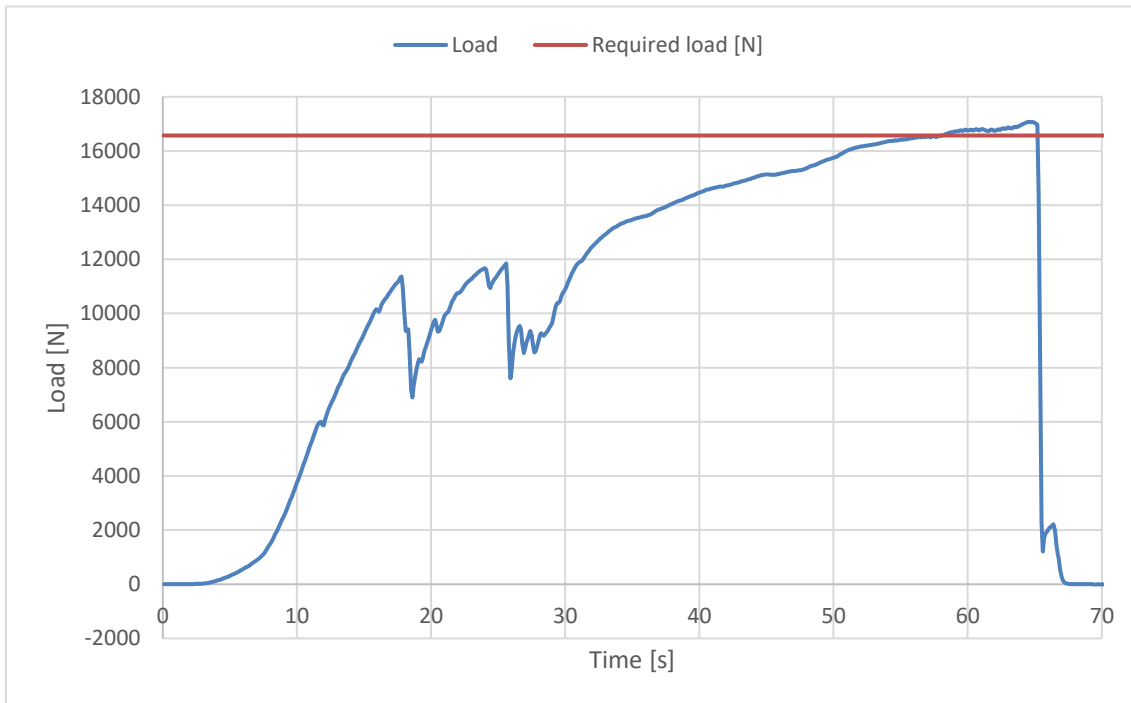
Test ID 09

Reference	5.3.2.4	
Test setup	Rescue attachments	
Attachment points	Rescue riser attachment (1,2)	
Anchor points	Dummy (B1,B2)	
Required load [g]	15	
Required load [N]	16500	
Minimum test duration [s]	5	
Result		
Test duration [s]	7.2	
Any signs of structural failure	No	
Test results	POSITIVE

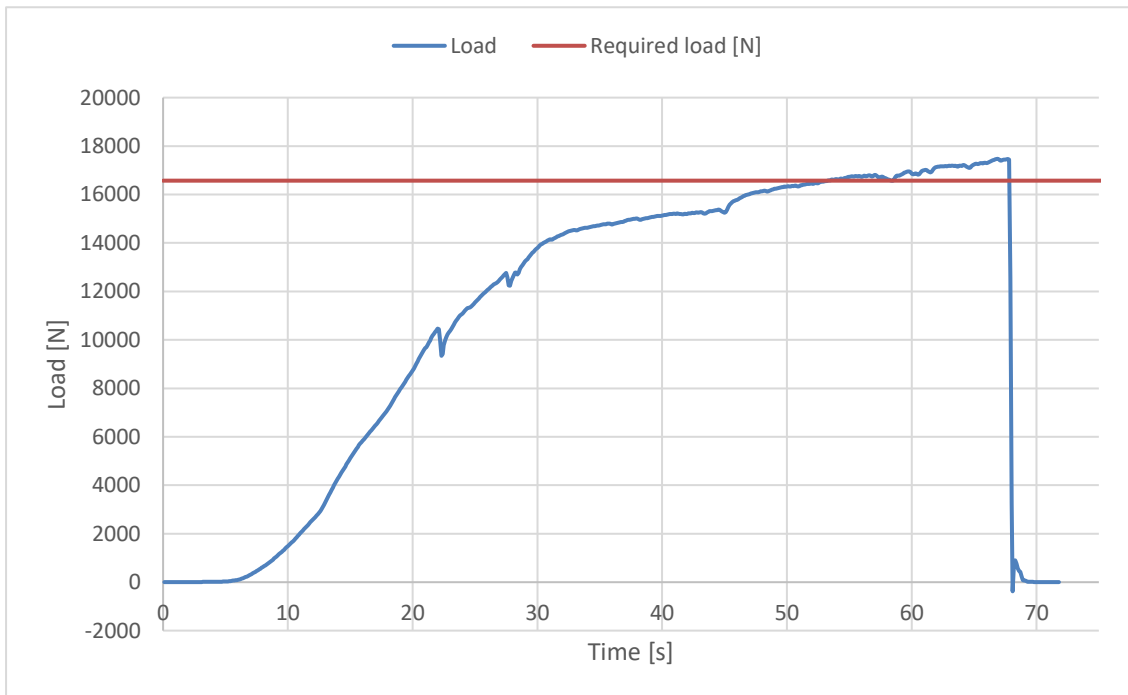
Test ID 13

Standard	EN 1651:1999
Reference	5.3.2.7
Test setup	Flying position before landing
Attachment points	Both main riser attachment (3,4)
Anchor points	Dummy (7,8)
Required load [g]	15
Required load [N]	16500
Minimum test duration [s]	5
Result	
Test duration [s]	9.3
Any signs of structural failure	No
Test results	POSITIVE

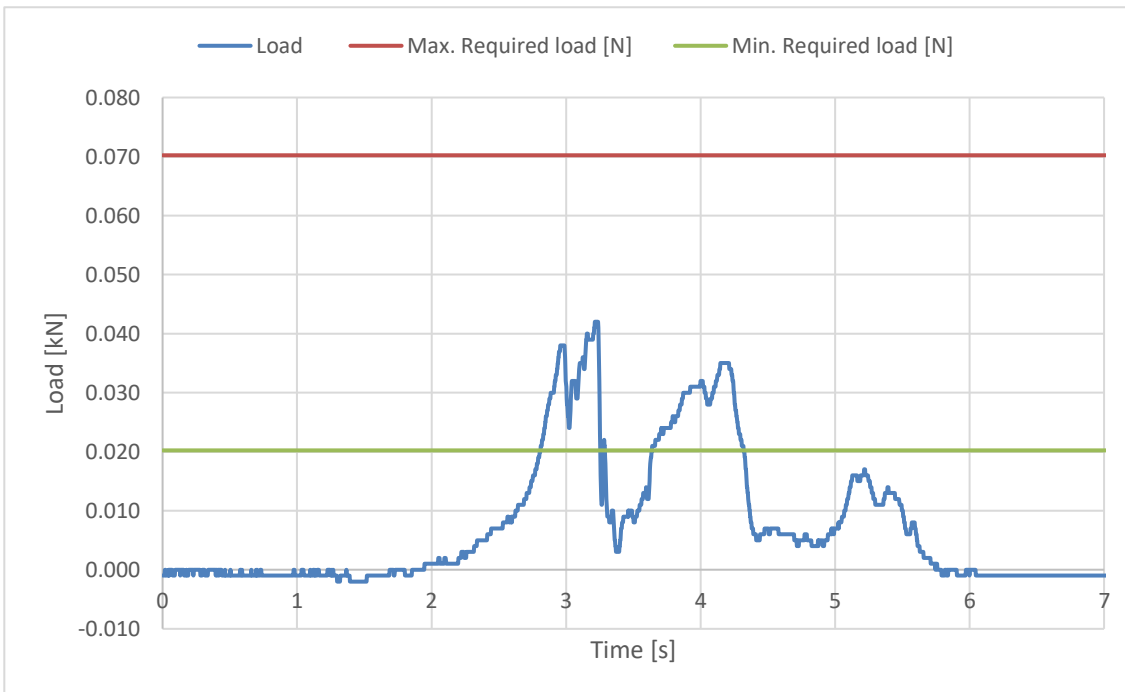
Test ID RRDT

Standard **NfL 2-565-20**
 Reference **6.1.5**
 Test setup **Default flying position**
 Attachment points **Sensor connect to handle, and pull in opening direction**
 The test is to simulate the load required to open the emergency parachute(1st action).

Load for first action [N] **41.78**
 Test results **POSITIVE**

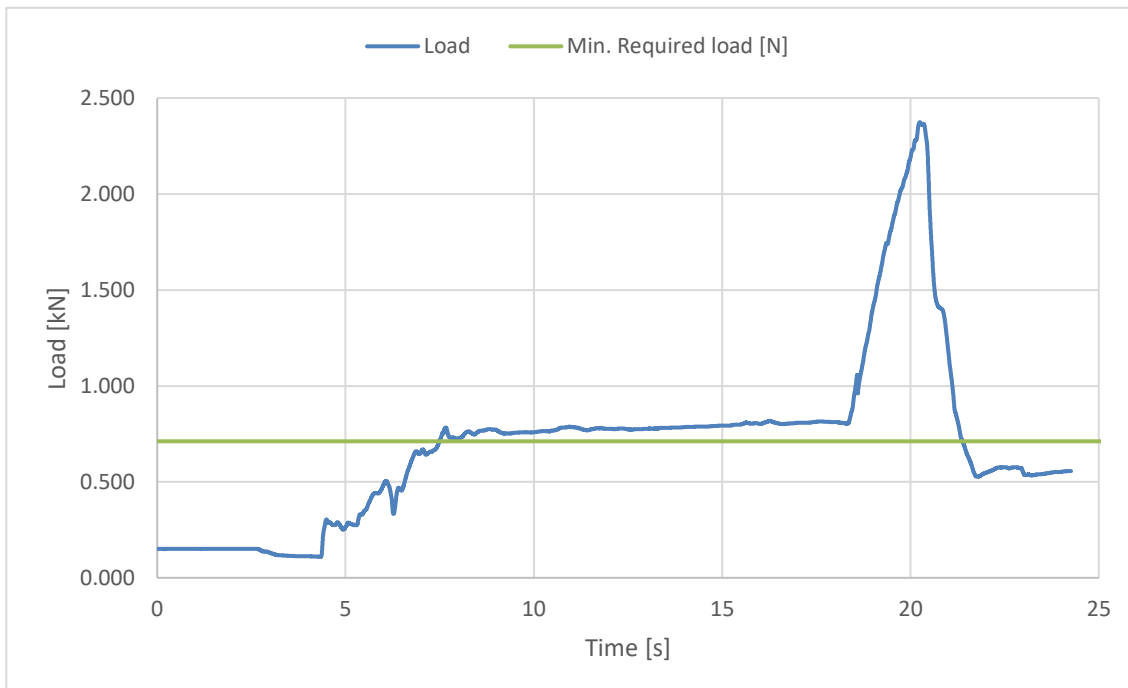
Test ID RRST

Standard	EN 12491
Reference in standard	5.3.2
Test setup	Two end points of handle
Attachment points	Sensor connect to end of handle, pull on the other side
	The handle must support min 700 N for 10 s, after measure breaking strength
Min. Required load [N]	700
Minimum test duration [s]	10
Result	
Test duration [s]:	13.9
Breaking strength [N]	2361.80
Test results	POSITIVE
