Harness Structural test Report - NfL

Inspection certificate number: **PH_415.2023**

Name: **Gii 5 Alpha**
 Type: **ABS**
 Size: **L**
 Serial number: **2856-13-6112**
 Impact pad type: ⁽¹⁾ **Foam**
 Clip-in weight [kg]: **120**
 Integrated container: **Yes**
 Date of test: **27.06.2023**

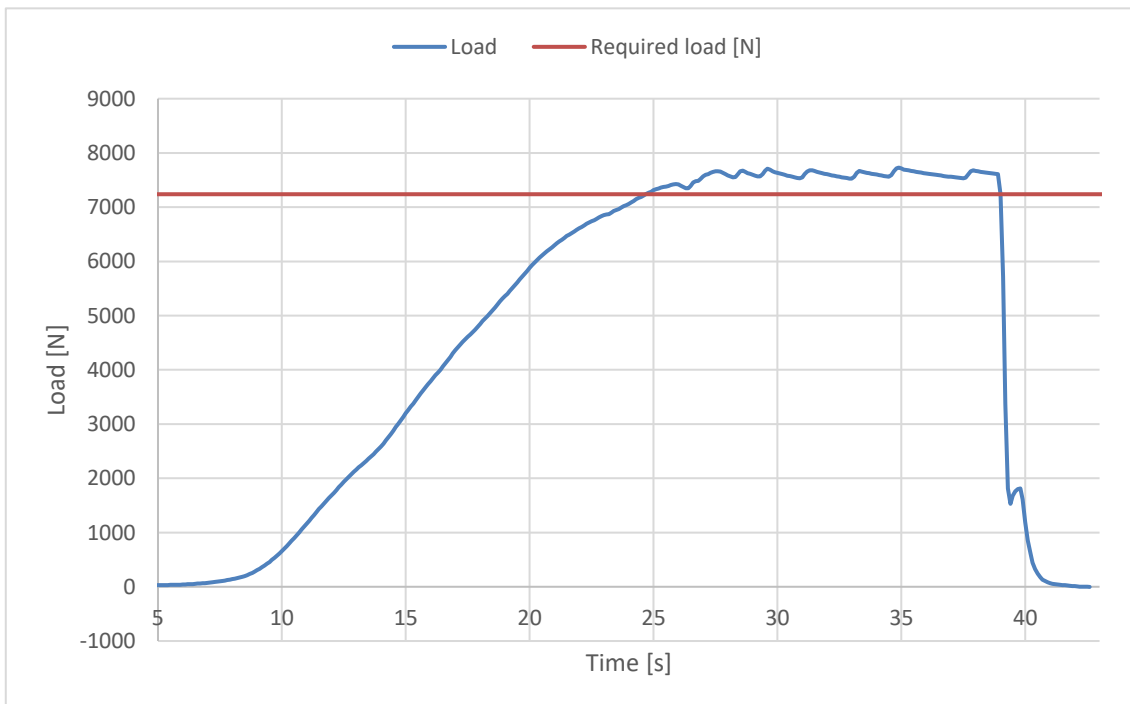
Test ID 02

Standard	EN 1651:1999
Reference	5.3.2.1
Test setup	Default flying position
Attachment points	Both main riser attachment (3,4)
Anchor points	Dummy (B1, B2)
Required load [g]	6
Required load [N]	7200
Minimum test duration [s]	10
Result	
Test duration [s]	14.3
Any signs of structural failure	No
Test results	POSITIVE

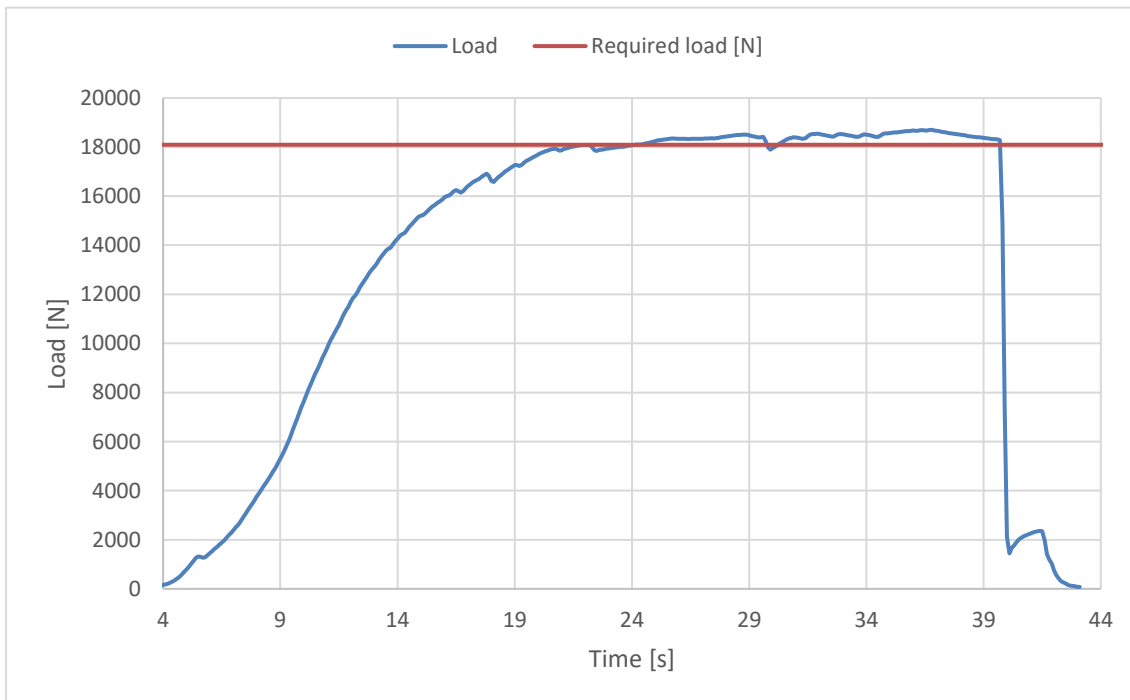
Test ID 03

Standard	EN 1651:1999
Reference	5.3.2.2
Test setup	Default flying position
Attachment points	Both main riser attachment (3,4)
Anchor points	Dummy (B1, B2)
Required load [g]	15
Required load [N]	18000
Minimum test duration [s]	5
Result	
Test duration [s]	9.5
Any signs of structural failure	No
Test results	POSITIVE

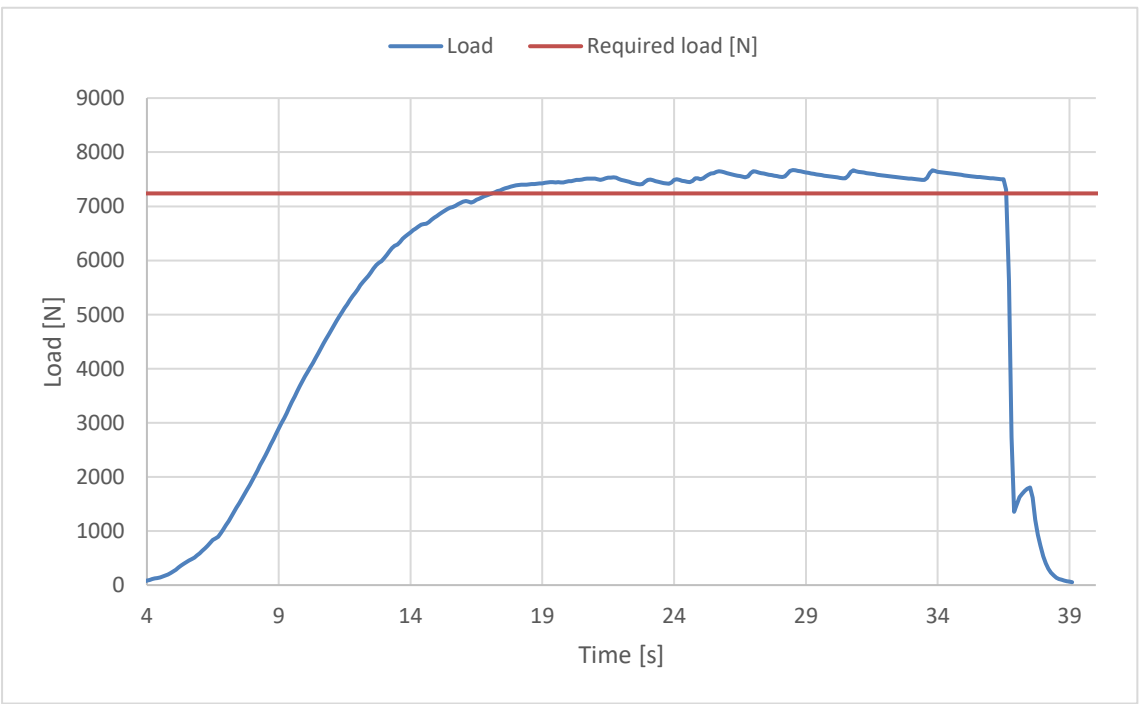
Test ID 04

Reference	5.3.2.3	
Test setup	Asymmetric, one riser	
Attachment points	One main riser attachment (3)	
Anchor points	Dummy (B1,B2)	
Required load [g]	6	
Required load [N]	7200	
Minimum test duration [s]	10	
Result		
Test duration [s]	19.5	
Any signs of structural failure	No	
Test results	POSITIVE

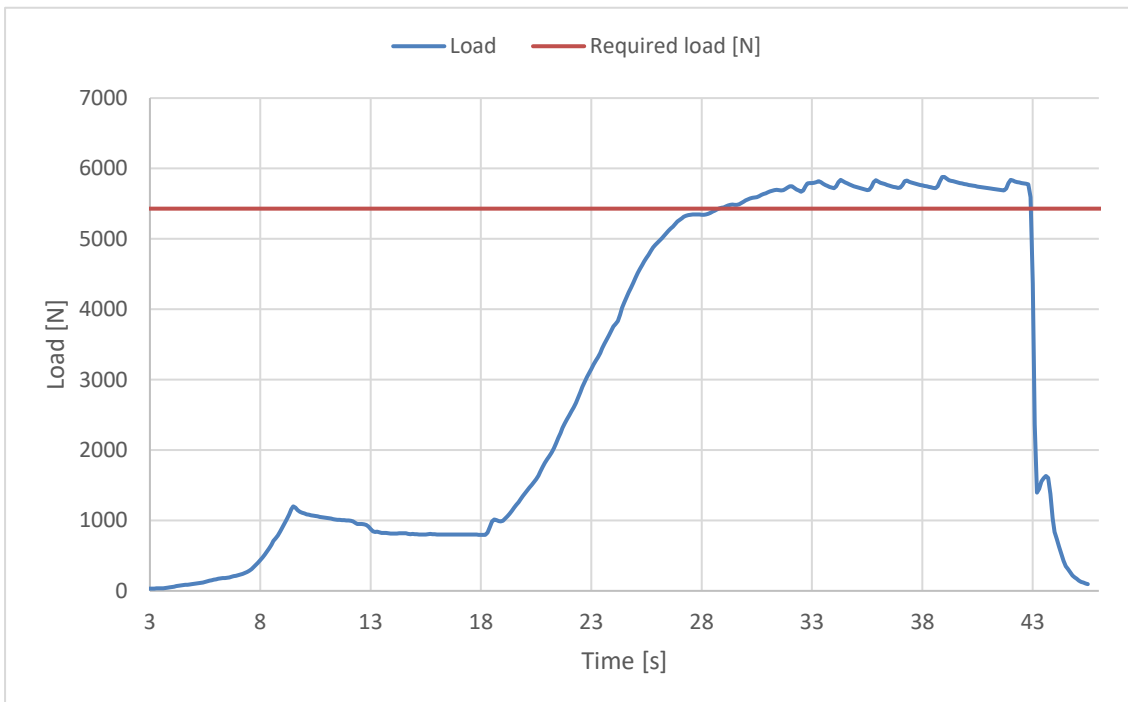
Test ID 07

Reference	5.3.2.6	
Test setup	Asymmetric, negative	
Attachment points	One main riser attachment (3 or 4) downwards	
Anchor points	Dummy (9)	
Required load [g]	4.5	
Required load [N]	5400	
Minimum test duration [s]	10	
Result		
Test duration [s]	14.2	
Any signs of structural failure	No	
Test results	POSITIVE

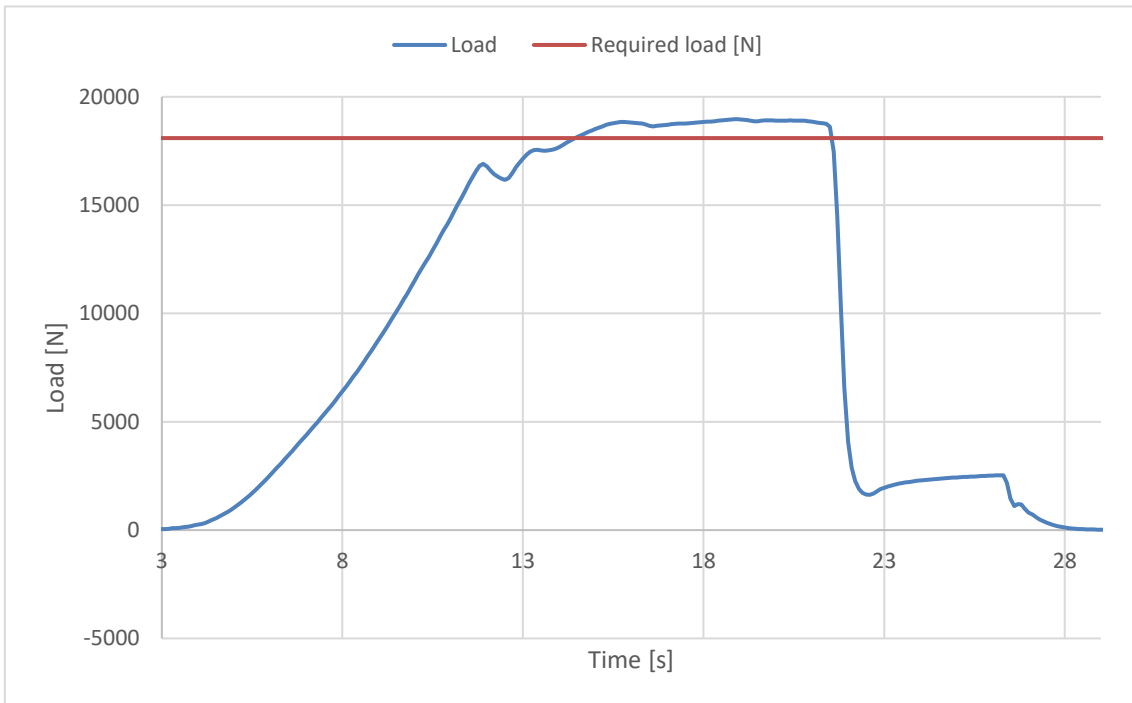
Test ID 09

Reference	5.3.2.4	
Test setup	Rescue attachments	
Attachment points	Rescue riser attachment (1,2)	
Anchor points	Dummy (B1,B2)	
Required load [g]	15	
Required load [N]	18000	
Minimum test duration [s]	5	
Result		
Test duration [s]	7.1	
Any signs of structural failure	No	
Test results	POSITIVE

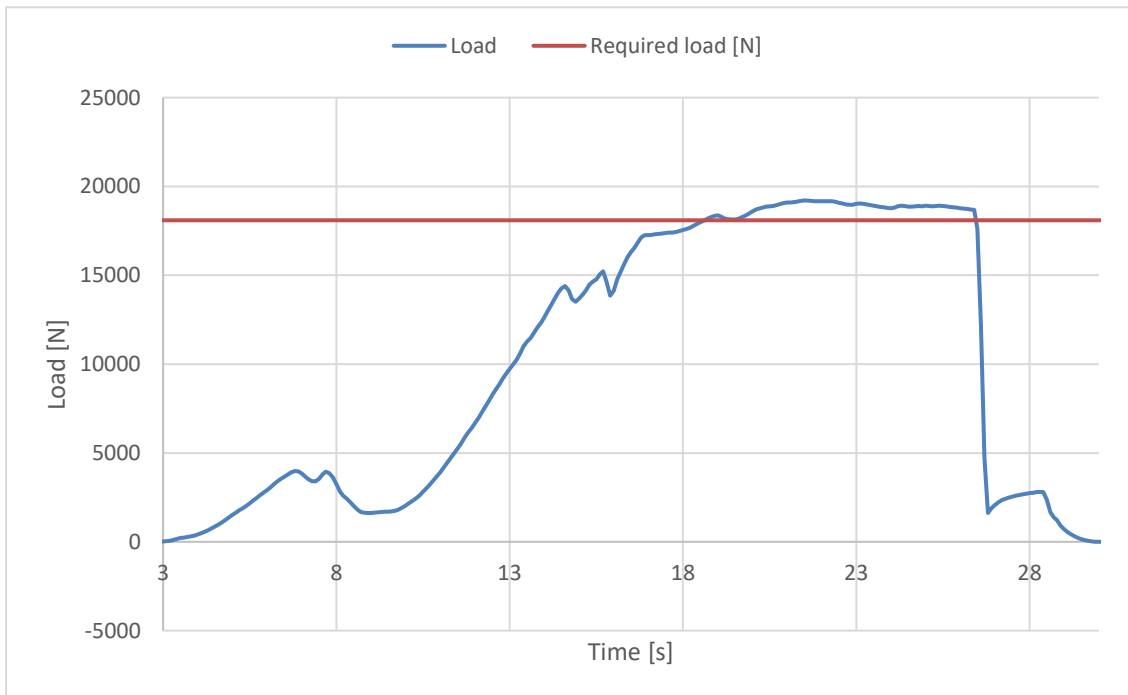
Test ID 13

Standard	EN 1651:1999
Reference	5.3.2.7
Test setup	Flying position before landing
Attachment points	Both main riser attachment (3,4)
Anchor points	Dummy (7,8)
Required load [g]	15
Required load [N]	18000
Minimum test duration [s]	5
Result	
Test duration [s]	7.8
Any signs of structural failure	No
Test results	POSITIVE

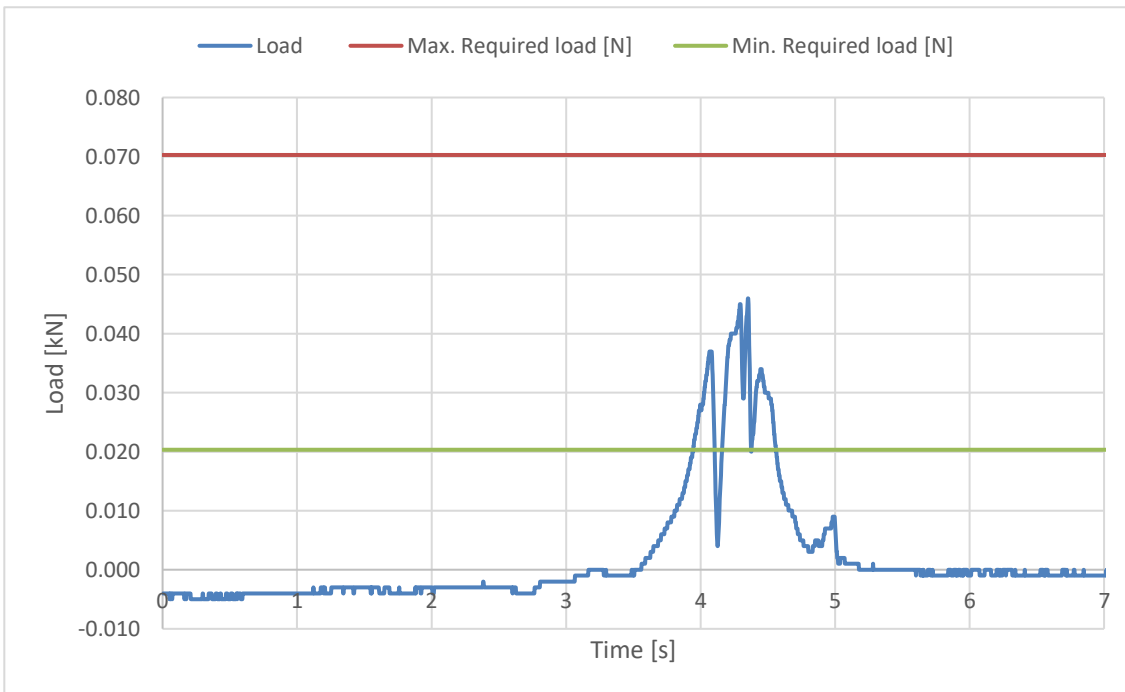
Test ID RRDT

Standard **NfL 2-565-20**
 Reference **6.1.5**
 Test setup **Default flying position**
 Attachment points **Sensor connect to handle, and pull in opening direction**
 The test is to simulate the load required to open the emergency parachute(1st action).

Min. Required load [N] **20**
 Max. Required load [N] **70**

Load for first action [N] **45.69**
 Test results **POSITIVE**

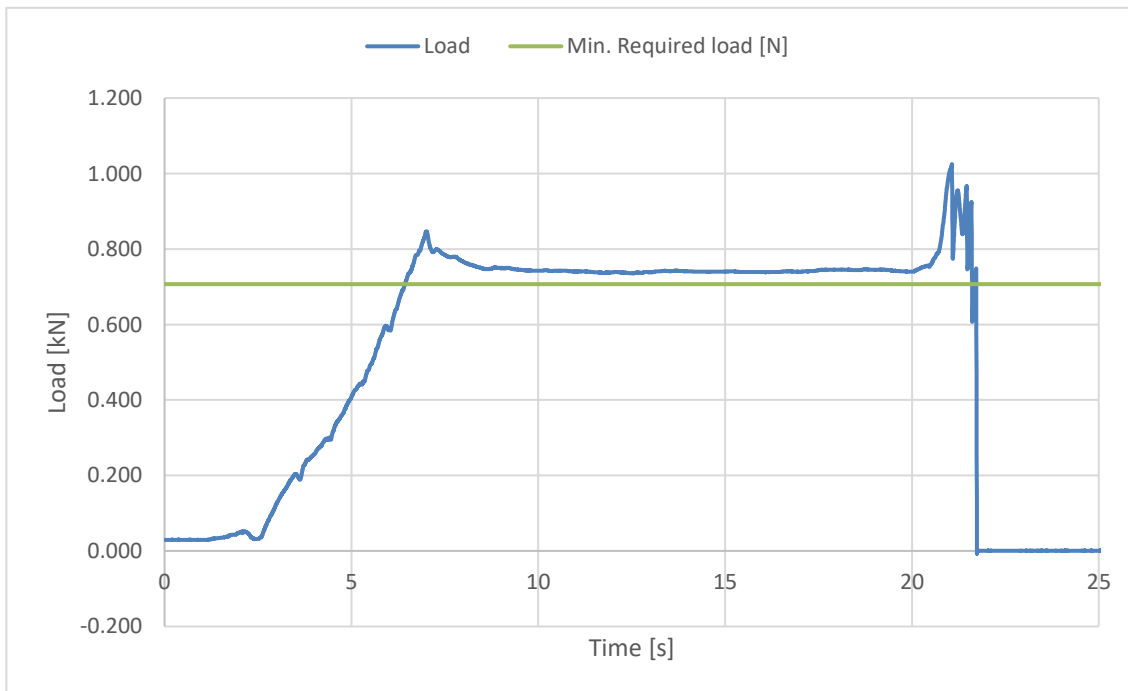
Test ID RRST

Standard	EN 12491
Reference in standard	5.3.2
Test setup	Two end points of handle
Attachment points	Sensor connect to end of handle, pull on the other side
	The handle must support min 700 N for 10 s, after measure breaking strength
Min. Required load [N]	700
Minimum test duration [s]	10
Result	
Test duration [s]:	15.2
Breaking strength [N]	1017.20
Test results	POSITIVE
