## Harness Structural test Report - NfL

Inspection certificate number: **PH\_423.2024**

Name: **Access 3**  
 Type: **ABS**  
 Size: **L**  
 Serial number: **AB3\_L\_V3**  
 Impact pad type: <sup>(1)</sup> **Airbag**  
 Clip-in weight [kg]: **120**  
 Integrated container: **Yes**  
 Date of test: **09.01.2024**

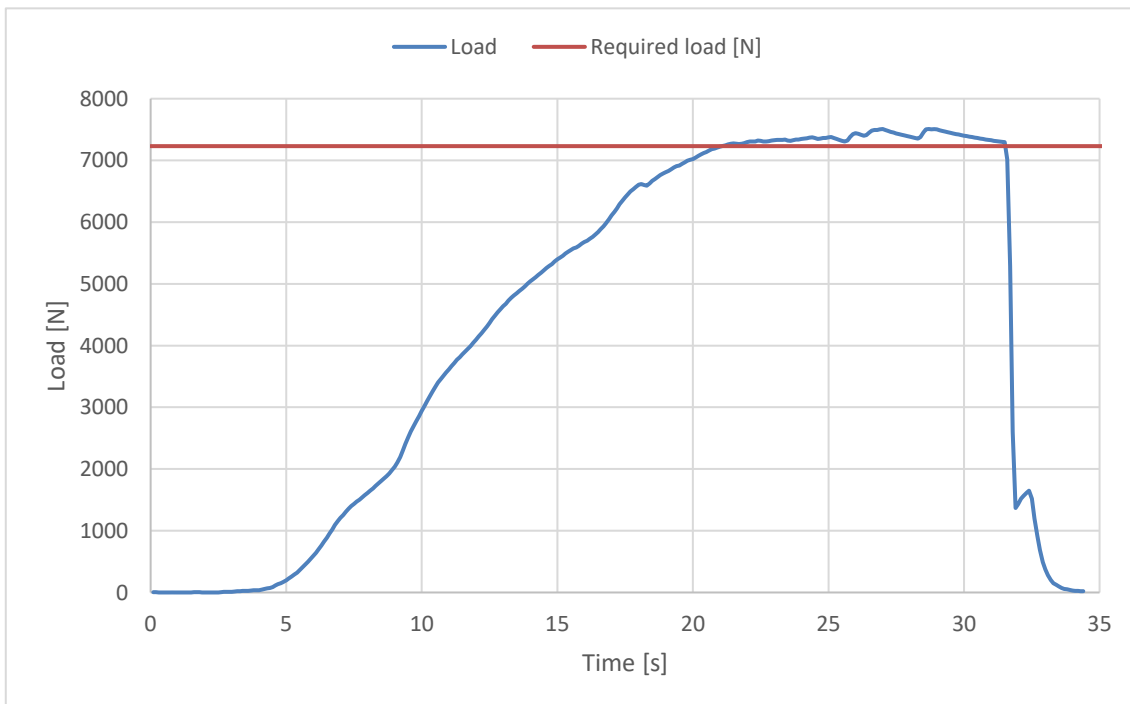
**Test ID 02**

Standard	<b>EN 1651:1999</b>
Reference	<b>5.3.2.1</b>
Test setup	<b>Default flying position</b>
Attachment points	<b>Both main riser attachment (3,4)</b>
Anchor points	<b>Dummy (B1, B2)</b>
Required load [g]	<b>6</b>
Required load [N]	<b>7200</b>
Minimum test duration [s]	<b>10</b>
<b>Result</b>	
Test duration [s]	<b>10.5</b>
Any signs of structural failure	<b>No</b>
Test results	<b>POSITIVE</b>

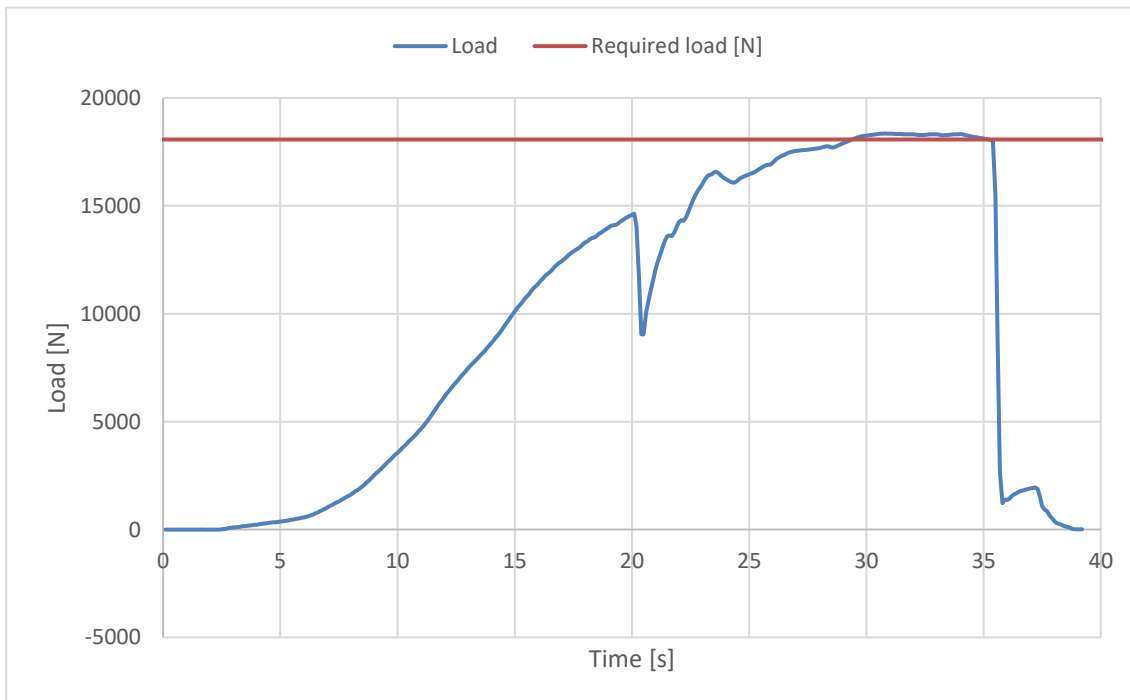
**Test ID 03**

Reference	<b>5.3.2.2</b>	
Test setup	<b>Default flying position</b>	
Attachment points	<b>Both main riser attachment (3,4)</b>	
Anchor points	<b>Dummy (B1, B2)</b>	
Required load [g]	<b>15</b>	
Required load [N]	<b>18000</b>	
Minimum test duration [s]	<b>5</b>	
<b>Result</b>		
Test duration [s]	<b>5.8</b>	
Any signs of structural failure	<b>No</b>	
Test results	<b>POSITIVE</b>

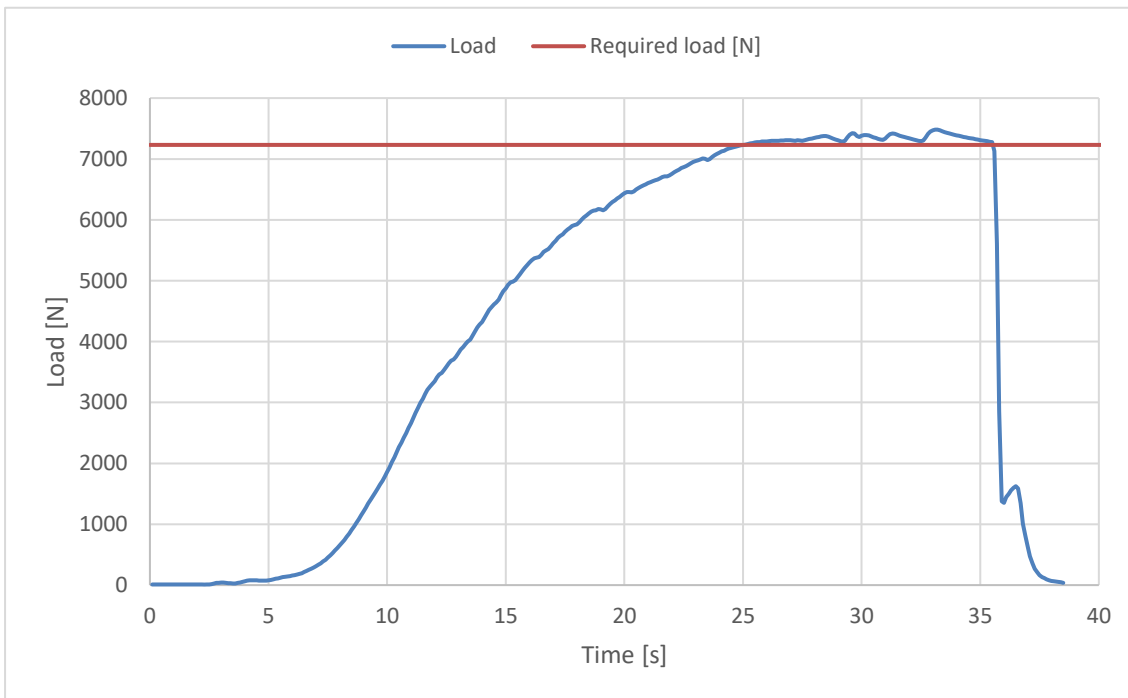
**Test ID 04**

Standard **EN 1651:1999**  
 Reference **5.3.2.3**  
 Test setup **Asymmetric, one riser**  
 Attachment points **One main riser attachment (3)**  
 Anchor points **Dummy (B1,B2)**

Required load [g] **6**  
 Required load [N] **7200**  
 Minimum test duration [s] **10**

Test duration [s] **10.6**  
 Any signs of structural failure **No**  
 Test results **POSITIVE**

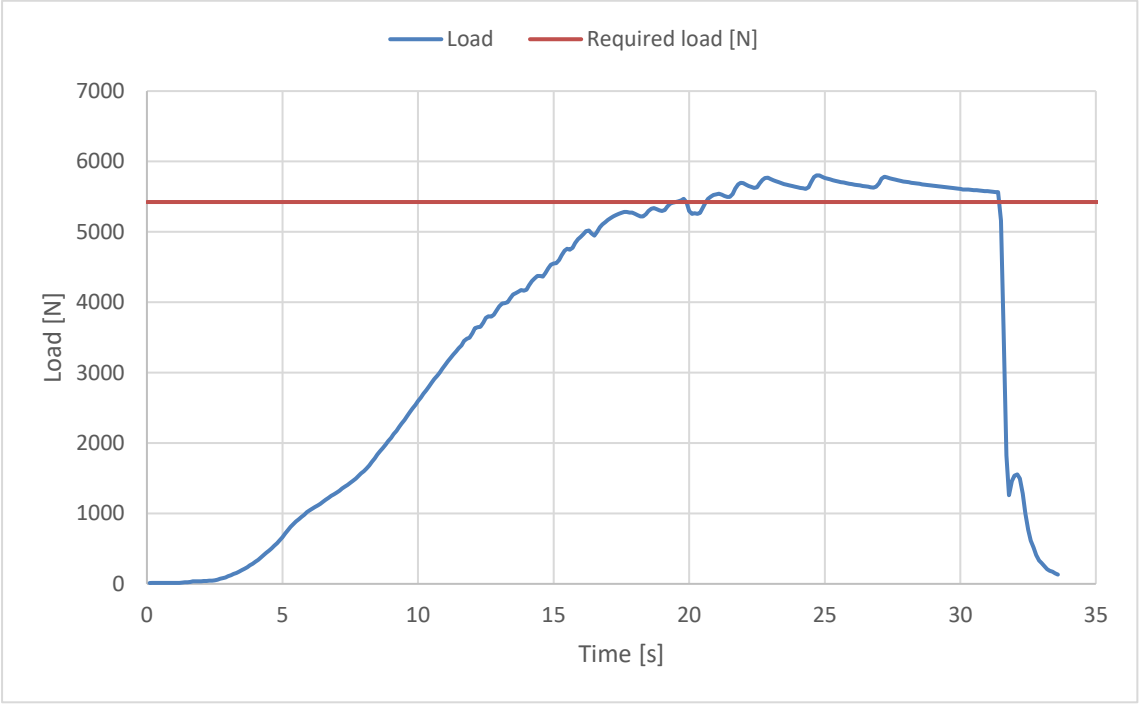
**Test ID 07**

Reference	<b>5.3.2.6</b>	
Test setup	<b>Asymmetric, negative</b>	
Attachment points	<b>One main riser attachment (3 or 4) downwards</b>	
Anchor points	<b>Dummy (9)</b>	
Required load [g]	<b>4.5</b>	
Required load [N]	<b>5400</b>	
Minimum test duration [s]	<b>10</b>	
<b>Result</b>		
Test duration [s]	<b>10.8</b>	
Any signs of structural failure	<b>No</b>	
Test results	<b>POSITIVE</b>

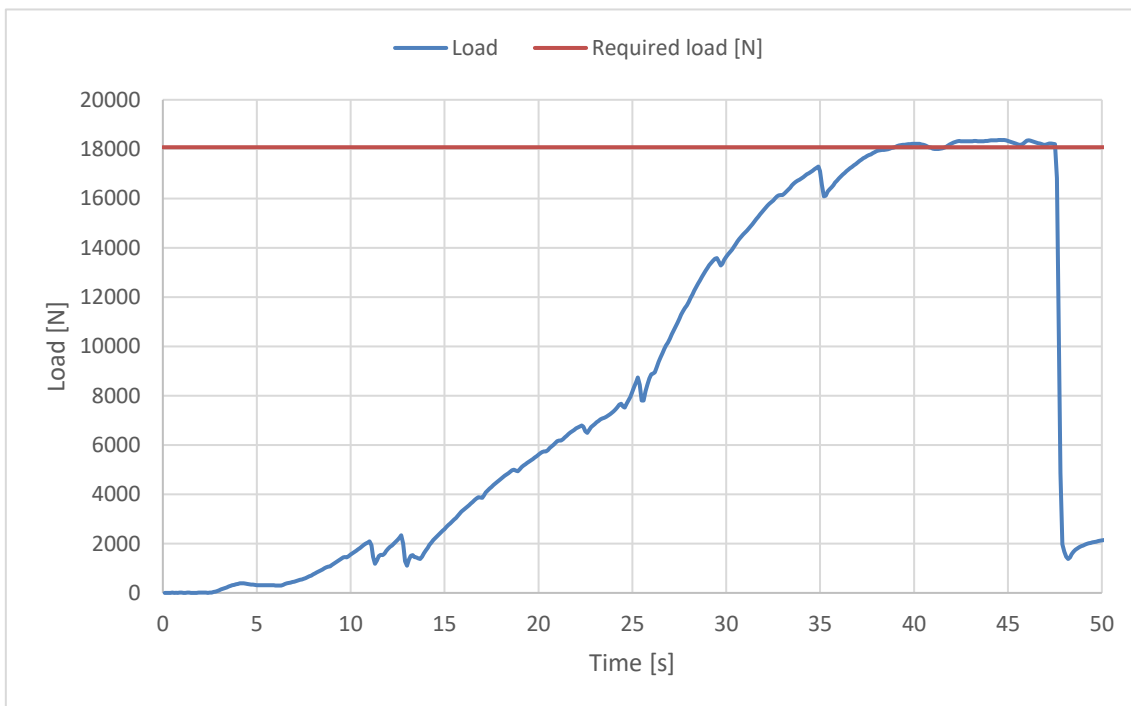
**Test ID 09**

Standard	<b>EN 1651:1999</b>
Reference	<b>5.3.2.4</b>
Test setup	<b>Rescue attachments</b>
Attachment points	<b>Rescue riser attachment (1,2)</b>
Anchor points	<b>Dummy (B1,B2)</b>
Required load [g]	<b>15</b>
Required load [N]	<b>18000</b>
Minimum test duration [s]	<b>5</b>
<b>Result</b>	
Test duration [s]	<b>5.9</b>
Any signs of structural failure	<b>No</b>
Test results	<b>POSITIVE</b>

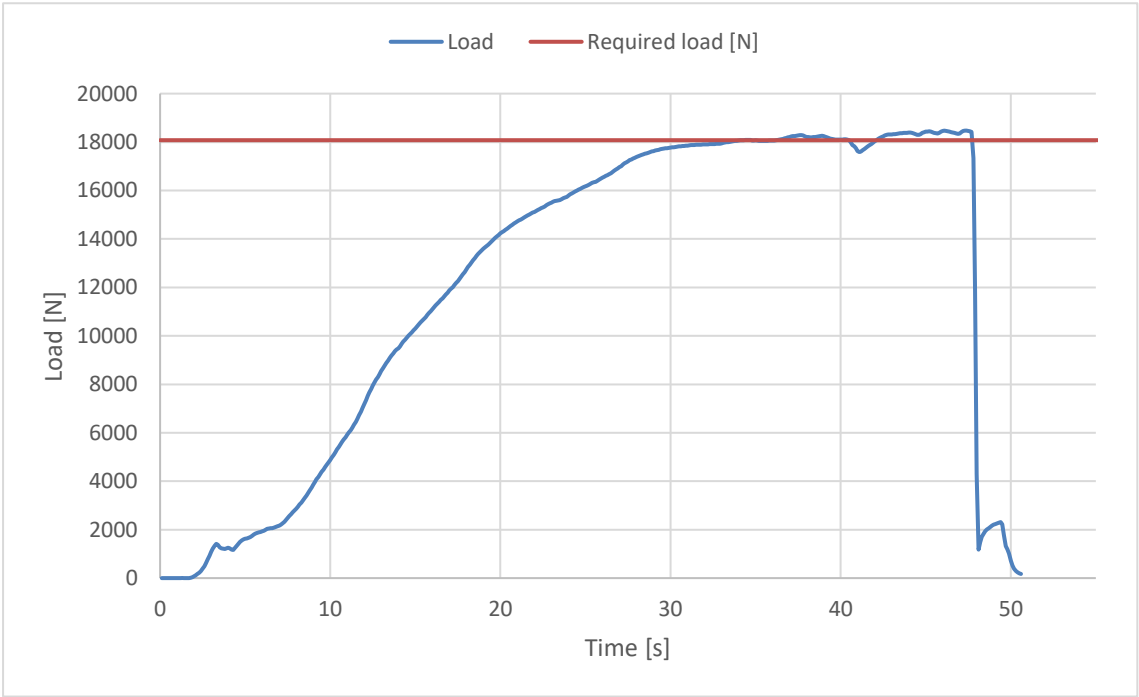
**Test ID 13**

Standard	<b>EN 1651:1999</b>
Reference	<b>5.3.2.7</b>
Test setup	<b>Flying position before landing</b>
Attachment points	<b>Both main riser attachment (3,4)</b>
Anchor points	<b>Dummy (7,8)</b>
Required load [g]	<b>15</b>
Required load [N]	<b>18000</b>
Minimum test duration [s]	<b>5</b>
<b>Result</b>	
Test duration [s]	<b>5.7</b>
Any signs of structural failure	<b>No</b>
Test results	<b>POSITIVE</b>

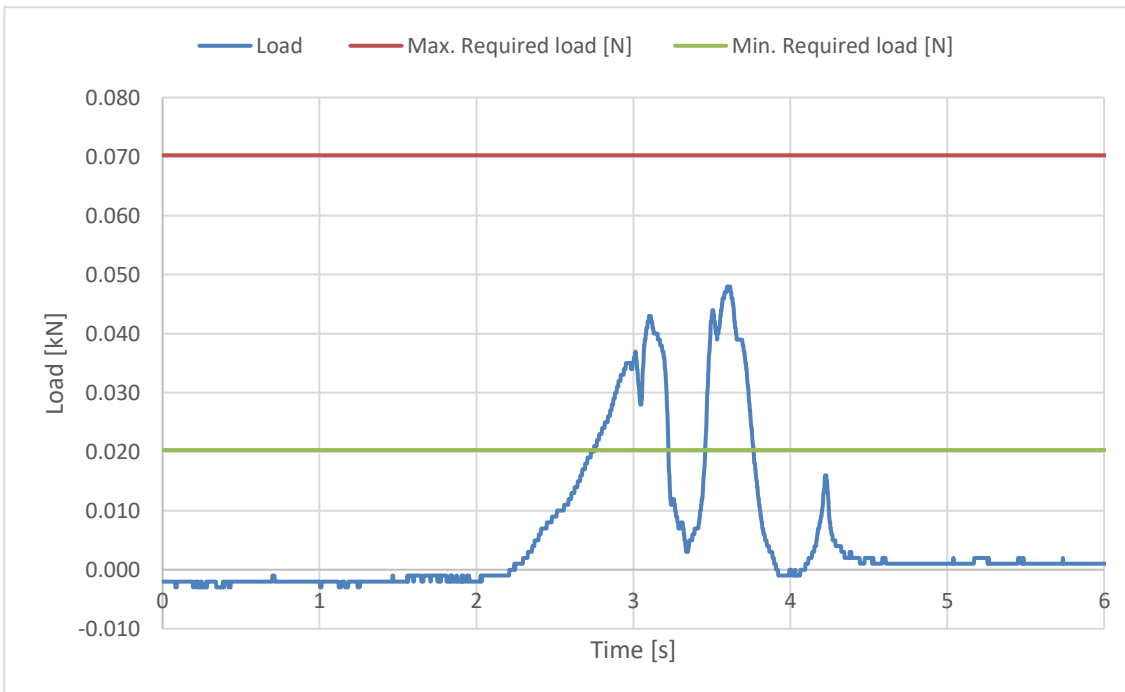
**Test ID RRDT**

Standard	<b>NfL 2-565-20</b>
Reference	<b>6.1.5</b>
Test setup	<b>Default flying position</b>
Attachment points	<b>Sensor connect to handle, and pull in opening direction</b>
	The test is to simulate the load required to open the emergency parachute(1st action).
Min. Required load [N]	<b>20</b>
Max. Required load [N]	<b>70</b>
<b>Result</b>	
Load for first action [N]	<b>47.75</b>
Test results	<b>POSITIVE</b>

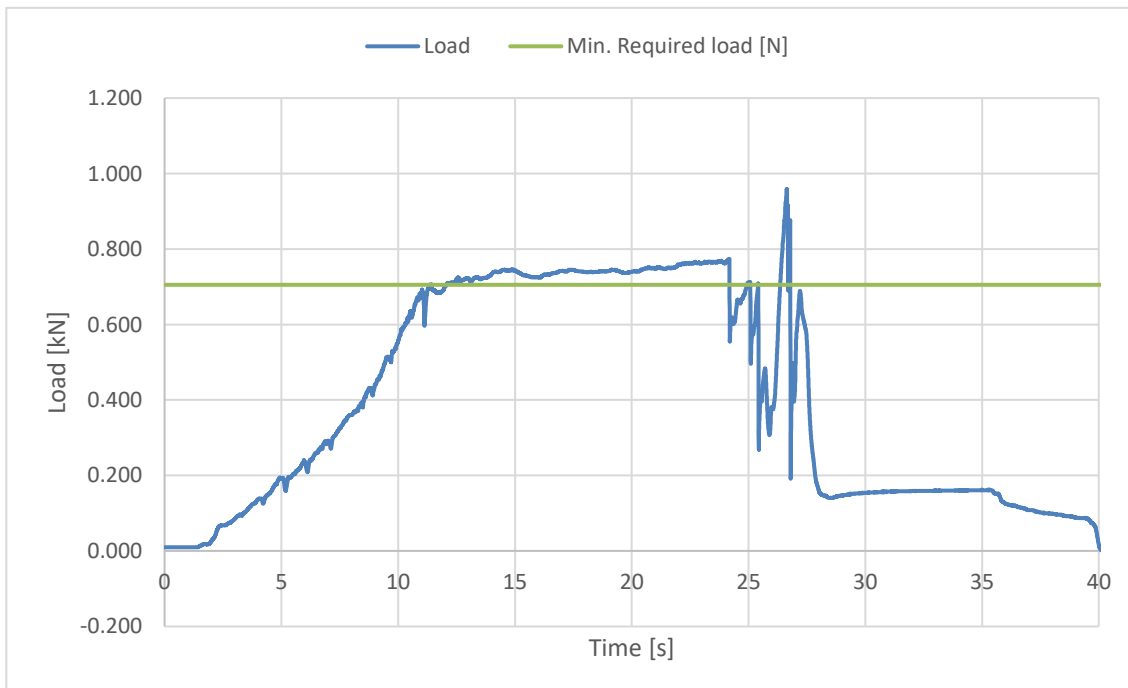
**Test ID RRST**

Standard	<b>EN 12491</b>
Reference in standard	<b>5.3.2</b>
Test setup	<b>Two end points of handle</b>
Attachment points	<b>Sensor connect to end of handle, pull on the other side</b>
	The handle must support min 700 N for 10 s, after measure breaking strength
Min. Required load [N]	<b>700</b>
Minimum test duration [s]	<b>10</b>
<b>Result</b>	
Test duration [s]:	<b>12.1</b>
Breaking strength [N]	<b>954.07</b>
Test results	<b>POSITIVE</b>
