## Harness Spreader Report

Inspection certificate number: **MISC 155.2020**

Name Spreader **Rigid Gradient 320 mm**  
 Max Load [kg]: **240**  
 Serial number: **n/a**  
 Date of reception: **30.07.2020**

Airworthiness Requirements **LTF NfL II 91/09**

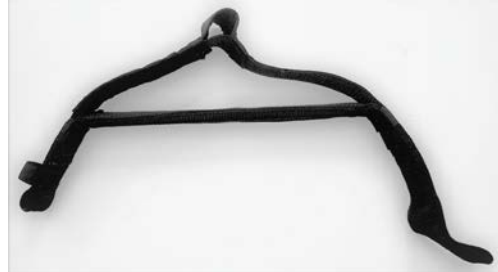
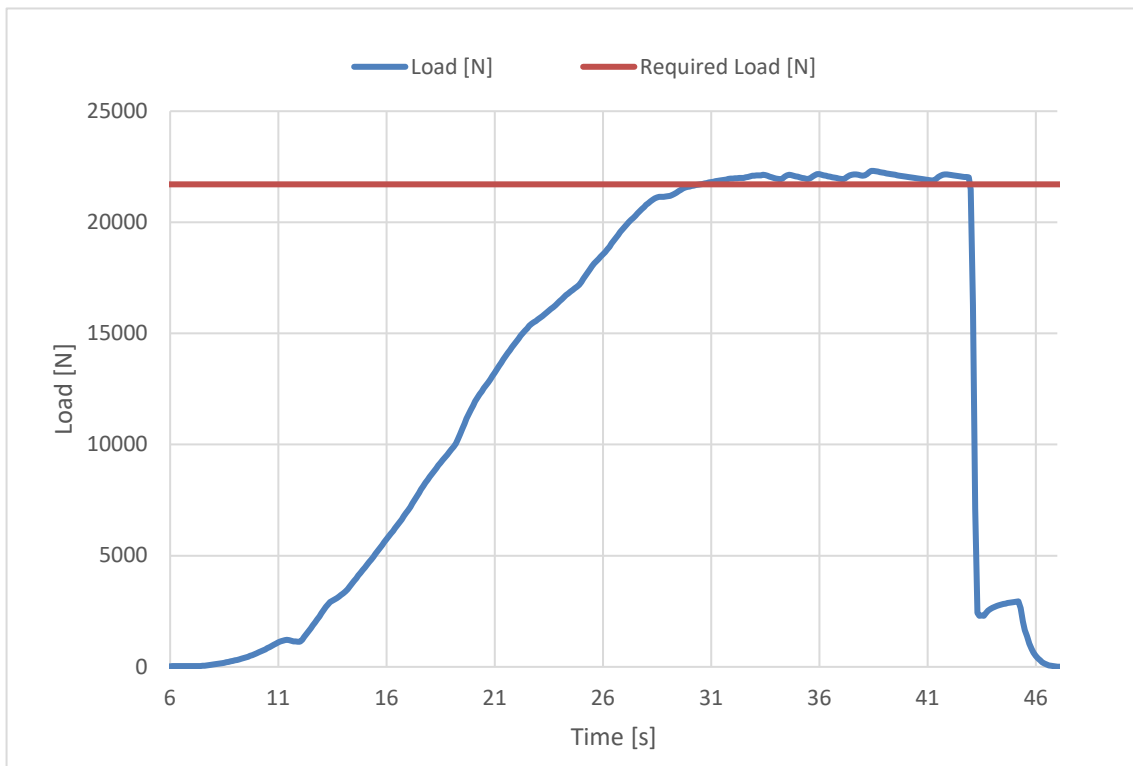
**Test 1**

Standard	<b>LTF NfL II 91/09</b>
Test setup	<b>Induced load from the pilot and a heavy passenger (short) to the main point</b>
Min. Required load [g]	<b>9</b>
Min. Required load [N]	<b>21600</b>
Min. Required duration [s]	<b>10</b>
<b>Result</b>	
Test duration [s]	<b>12.5</b>
Any signs of structural failure	<b>No</b>
Test results	<b>POSITIVE</b>

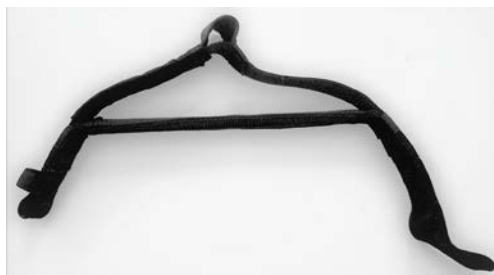
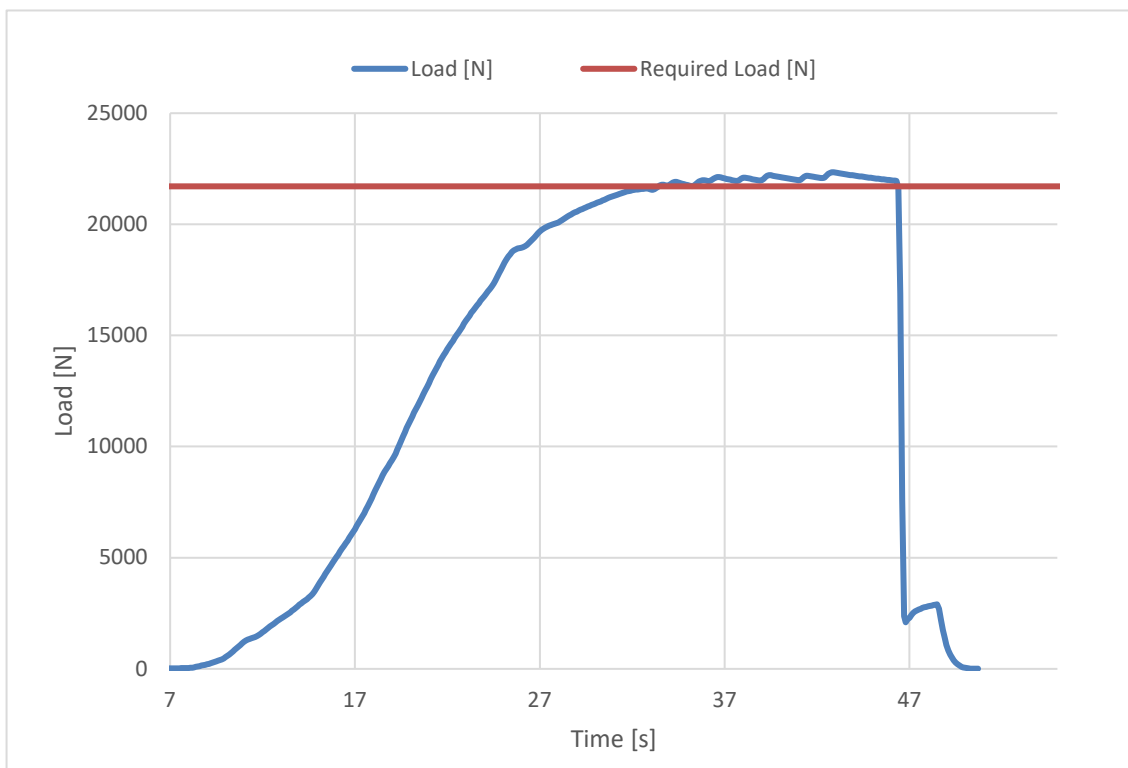
**Test 2**

Standard	<b>LTF NfL II 91/09</b>
Test setup	<b>Induced load from the pilot and a light passenger (long) to the main point</b>
Min. Required load [g]	<b>9</b>
Min. Required load [N]	<b>21600</b>
Duration [s]	<b>10</b>
<b>Result</b>	
Test duration [s]	<b>12.9</b>
Any signs of structural failure	<b>No</b>
Test results	<b>POSITIVE</b>

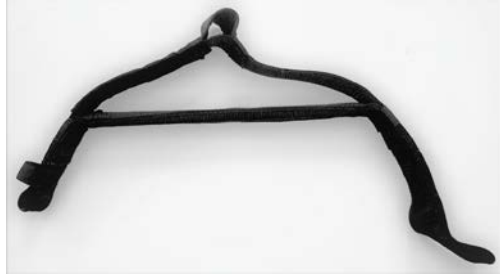
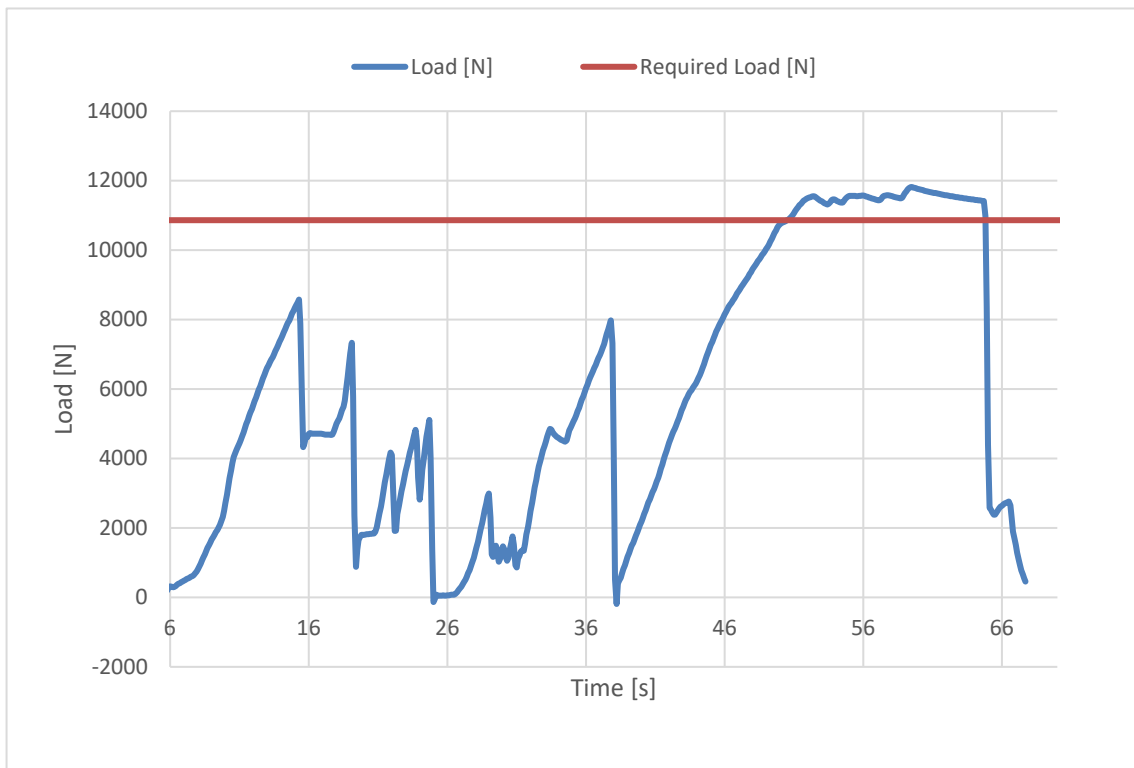
**Test 5**

Standard	<b>LTF NfL II 91/09</b>
Test setup	<b>Induced load from the main point to between the spreader bar</b>
Min. Required load [g]	<b>4.5</b>
Min. Required load [N]	<b>10800</b>
Duration [s]	<b>10</b>
<b>Result</b>	
Test duration [s]	<b>14.3</b>
Any signs of structural failure	<b>No</b>
Test results	<b>POSITIVE</b>
